SI B64 01 13
Heating and Air Conditioning

February 2013
Technical Service

IHKA Operating Panel Buttons Are Peeling

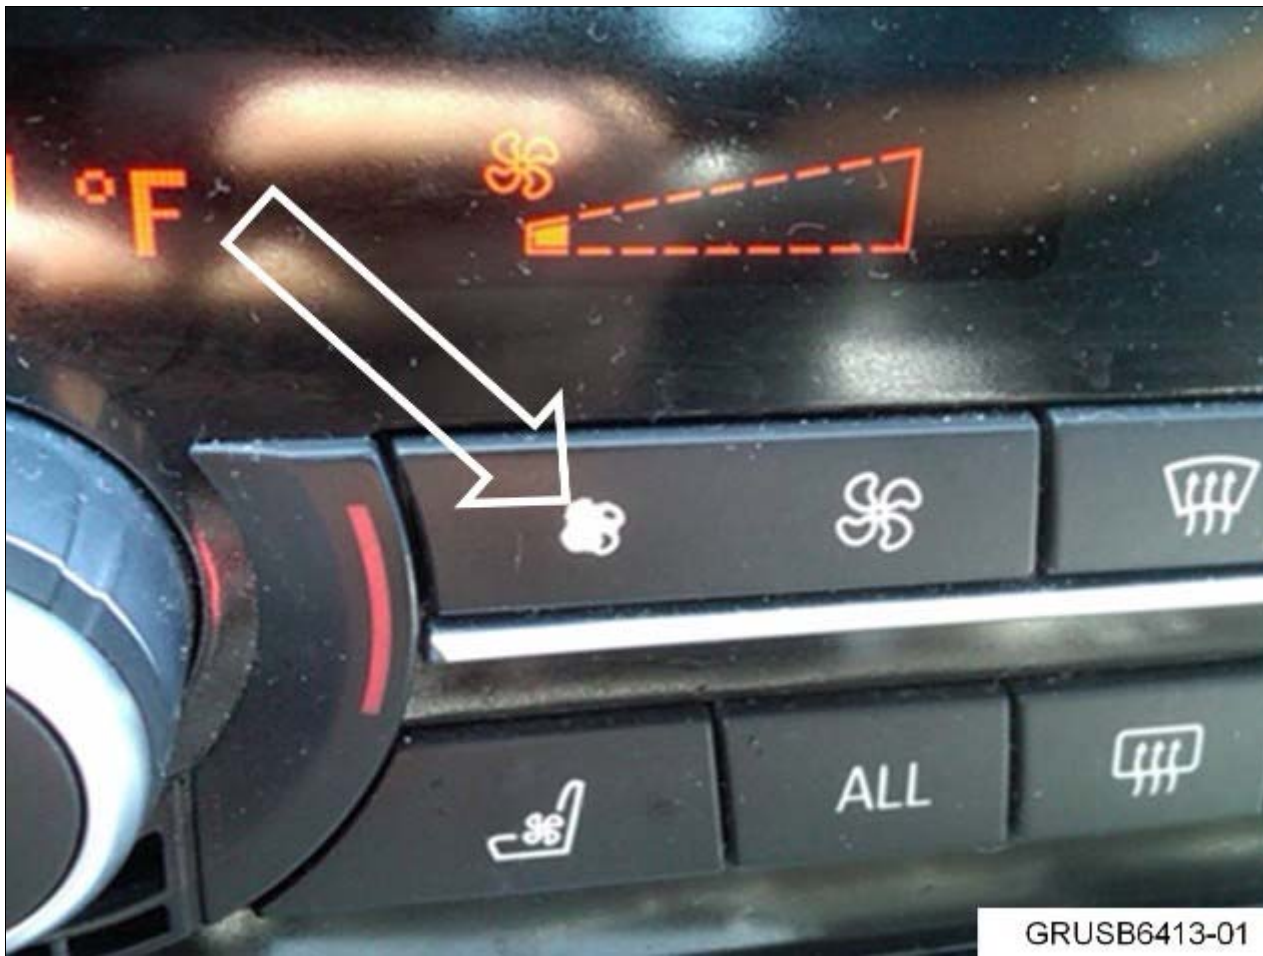
The surface is peeling off one or more of the IHKA operating panel buttons, and the button symbol may become unreadable.

Ingredients in certain skin care products, including sunscreens and hand lotions, causes the button surface to peel.

In the picture below, you can clearly see how the low fan speed button is just starting to peel. Two of the four fan blades are missing from the button symbol, and soon the entire symbol will be gone.

Replacement buttons for the IHKA panel are expected to become available in March 2013. If you encounter a customer issue with peeling buttons, ask the customer if he or she can wait until the separate buttons become available. This short delay would reduce the replacement of the complete IHKA control panel, and save the customer increased costs.

If the customer insists on a repair **before** the replacement buttons are available, the complete IHKA panel may be replaced.

Once the replacement buttons are available, this Service Information will be updated with the relevant parts information, and the complete IHKA panel should not be replaced for this damaged button issue.
