**NUMBER:** 09-005-15

Right Side Engine Cover Missing With Shaker Package

2015 (LA) Dodge Challenger

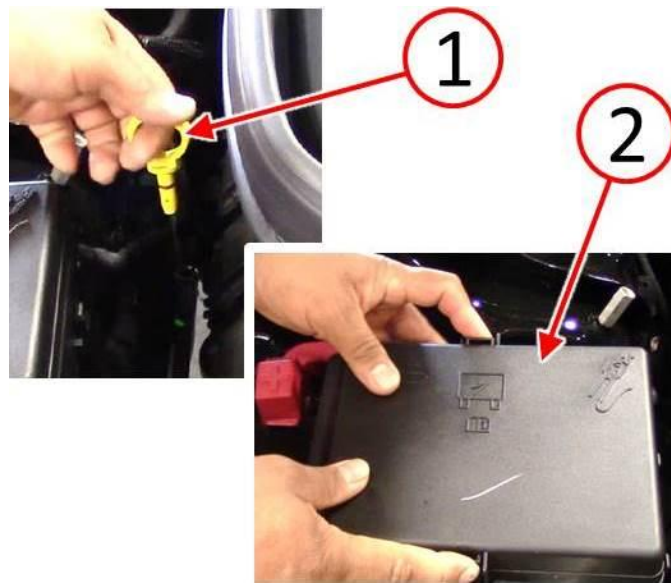
**Fig. 2 Oil Level Indicator - Power Distribution Center Cover**

- 1 - Oil Level Indicator
- 2 - Power Distribution Center Cover

- 
3. Install the right side engine wiring protector cover from the PARTS REQUIRED section of this bulletin.
  4. Remove the oil level indicator (1) from the engine and place aside. Ensure not to contaminate the end of the oil level indicator (Fig. 2).
  5. Depress the two release tabs on the sides of the power distribution center cover (2) and place the cover aside (Fig. 2).

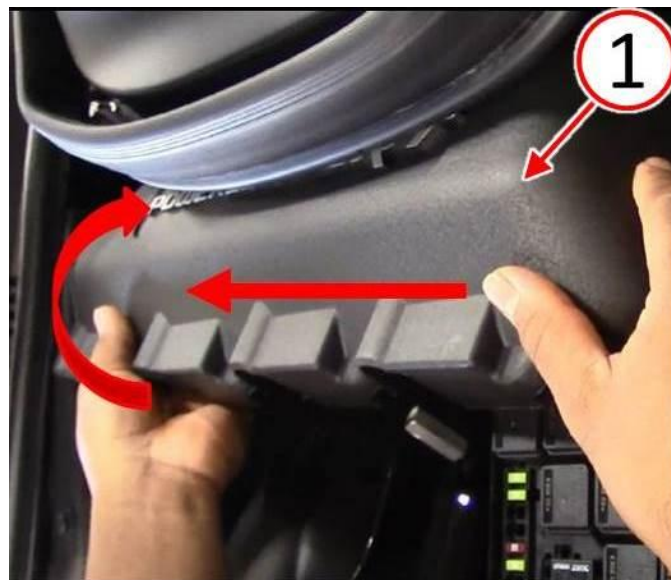
**Fig. 3 Install Engine Cover**

- 1 - Engine Cover

6. Tilt the engine cover (1) and slide it under the air scoop base plate (Fig. 3).

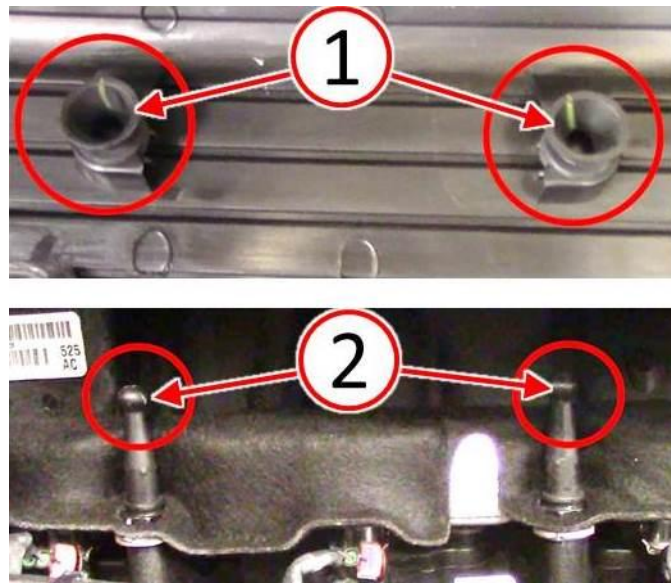
**Fig. 4 Engine Cover Attachment Feature**

- 1 - Attachment Sockets Inside Engine Cover
- 2 - Attachment Studs On Engine Head

7. Align the attachment sockets on the inside of the engine cover (1) with the attachment studs (2) on the engine head (Fig. 4).

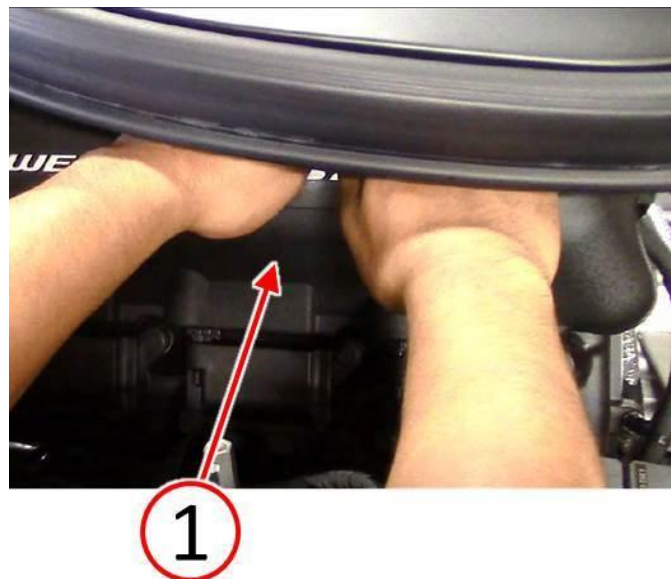
**Fig. 5 Secure Engine Cover**

- 1 - Engine Cover

- 
8. Apply firm hand pressure to the two attachment points until the engine cover (1) snaps in place (Fig. 5).

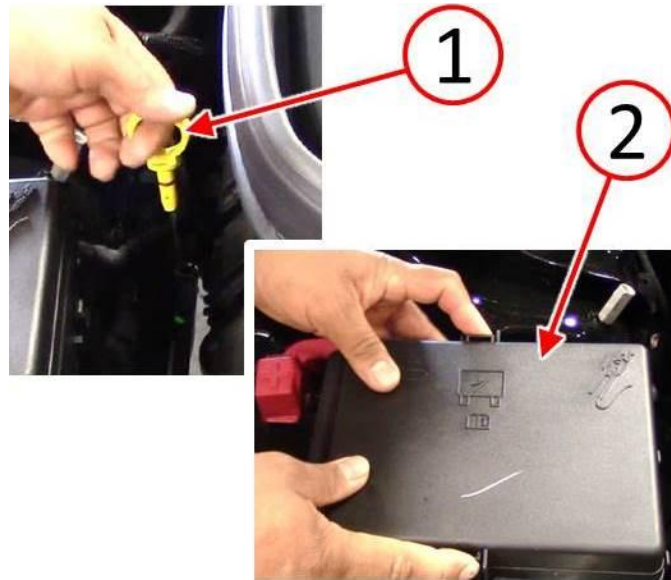
**Fig. 6 Oil Level Indicator - Power Distribution Center Cover**

- 1 - Oil Level Indicator
- 2 - Power Distribution Center Cover

- 
9. Install the cover (2) on the power distribution center (Fig. 6).

10. Install the oil level indicator (1) to the engine (Fig. 6).
