**NUMBER:** 08-034-15

Wire Harness Hanging Down From Rear Bumper Fascia

This bulletin involves attaching the park assist and/or blind spot detection wire harness to the rear bumper fascia.

2011 - 2014	(RT)	Chrysler Town And Country Chrysler Voyager / Grand Voyager Dodge Caravan
-------------	------	--

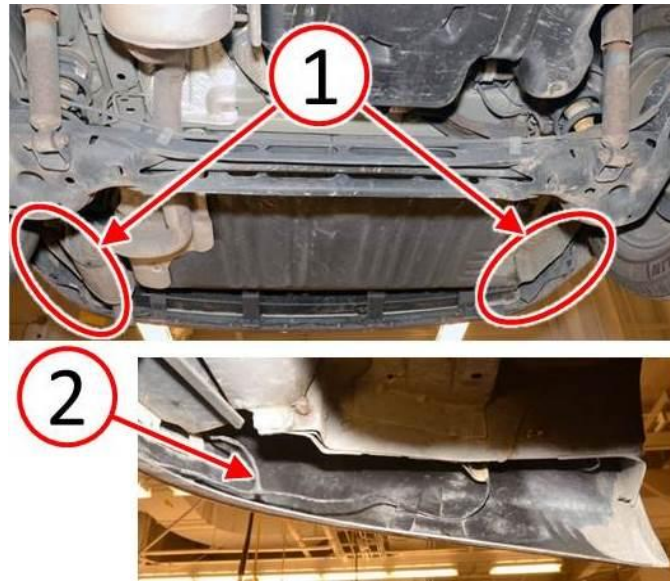
***Fig. 1 Wire Harness Loose Not Securely Attached***

The customer may describe a wire harness hanging down from the rear bumper fascia.

- 1 - Inspection Areas
- 2 - Loose Wire Harness

1. Is the park assist and/or blind spot detection working properly?
  - a. YES>>> Continue with the Repair Procedure [Step #2](#).
  - b. NO>>> Problems with park assist and/or blind spot detection should be repaired first before continuing with this bulletin. Normal diagnosis should be performed.
2. Inspect the wire harness on the right and left side of the rear fascia (1) for looseness, wire harness (2) not securely attached to the rear fascia ([Fig. 1](#)).
3. Is the wire harness loose, not securely attached to the rear fascia? (2) ([Fig. 1](#)).
  - a. YES>>> Continue with the Repair Procedure [Step #4](#).
  - b. NO>>> This Bulletin does not apply. Normal diagnosis should be performed.

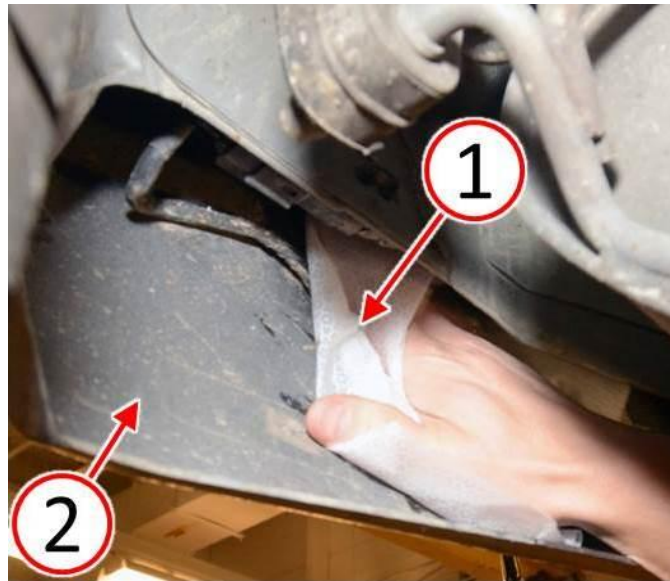
**Fig. 2 Clean Rear Fascia Inside Surface**

- 1 - Clean Rag
- 2 - Rear Fascia Inside Surface

**NOTE: Surface must be free of all dirt, debris, wax, road tar, grease, and oil in the tape application area.**

4. Using a clean rag (1), thoroughly clean the wire harness and the inside surface of the rear fascia (2) on the right and left sides with wax and grease remover then isopropyl alcohol ([Fig. 2](#)).

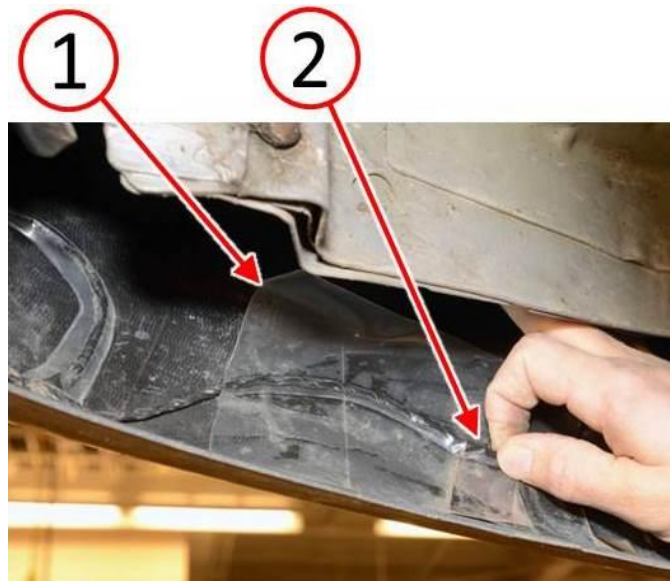
**Fig. 4 Apply Tape**

1 - Tape

2 - Pinch Tape Around Wire Harness

7. Apply the tape (1) to the wire harness pinching the tape (2) around the harness to reduce gaps and voids before smoothing the tape out against the fascia inner surface (Fig. 4).

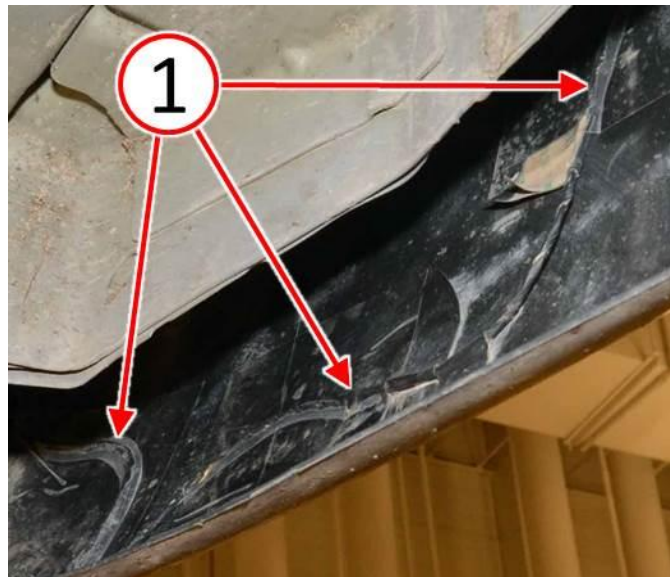
**Fig. 5 Wire Harness Securely Attached**

1 - Wire Harness Taped Flat

- 
8. Ensure the wire harness lays flat and the three pieces of tape are firmly applied to the fascia inner surface with as few bubbles and voids as possible (Fig. 5).
