SERVICE INFORMATION BULLETIN

APPLICABILITY: 2015-2019MY WRX

NUMBER: 06-66-18

SUBJECT: Front Brake Rotor- Design Change

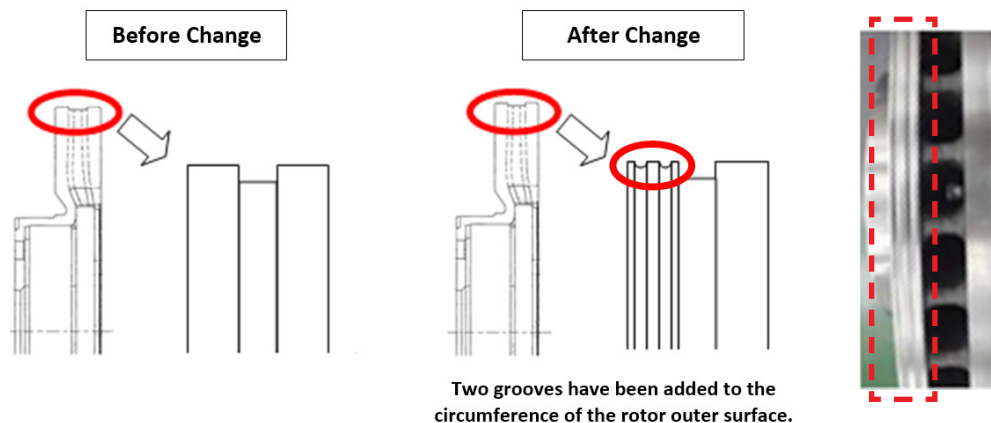
Two grooves have been added to the circumference of the rotor outer surface.

The part number for the new brake rotor is **26300AL010**. The new and old-style rotors are interchangeable as there is no change in performance. A combination of a new and an old-style rotor on the same car is acceptable.
