Slide Door Abnormal Operation

YEAR(S)	MODEL(S)	ADDITIONAL INFORMATION
2011 - 2018	Sienna

Some 2011 – 2018 model year Sienna vehicles may exhibit a condition where the slide door's — power or manual — front and rear latches may not latch simultaneously due to corrosion on the latch lever pin of the front lock assembly. Additionally, some 2011 – 2015 model year Sienna vehicles may exhibit a condition where the power slide door does not close properly due to internal corrosion in the latch switch of the rear lock assembly. Follow the procedures in this bulletin to address these conditions.

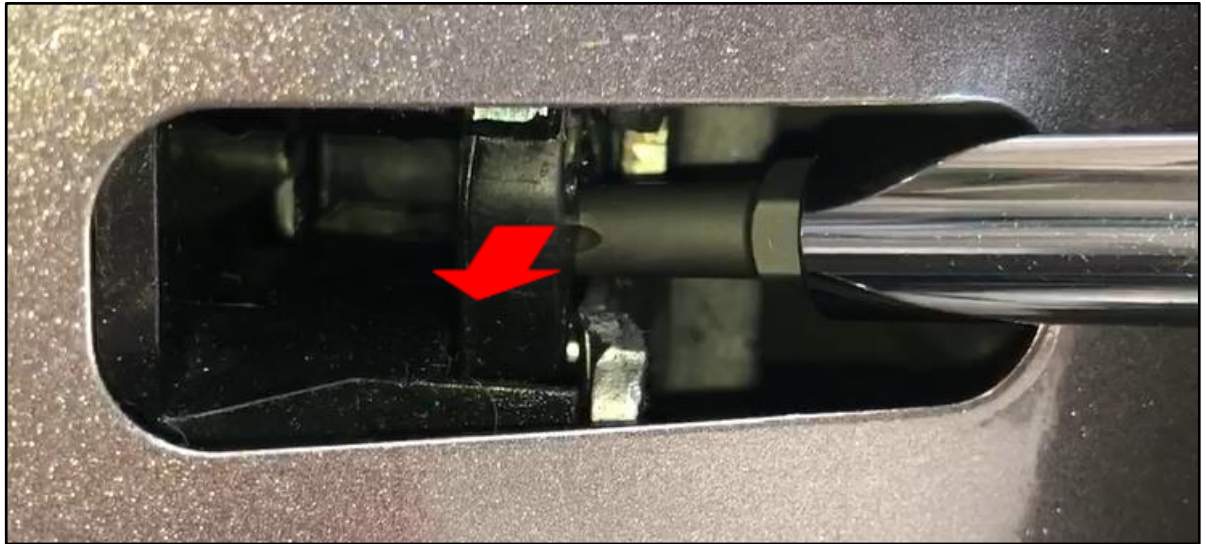
Figure 2.

- B. With the pawl latched, pull the screwdriver toward you to see if the pawl releases.

Does the pawl release when pulled toward you?

- **YES** — Proceed to the Front Lock Assembly and Striker Replacement procedure.
- **NO** — This bulletin does NOT apply. Continue diagnosis using the applicable Repair Manual.

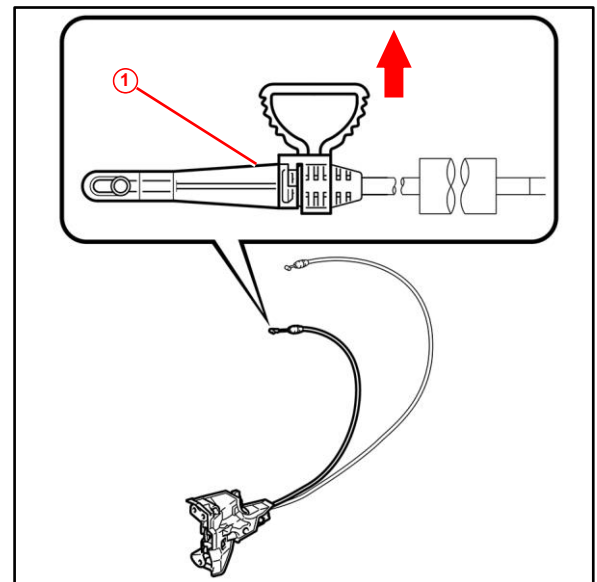
Figure 7.

E. Remove the clamp.

1	Clamp
---	-------

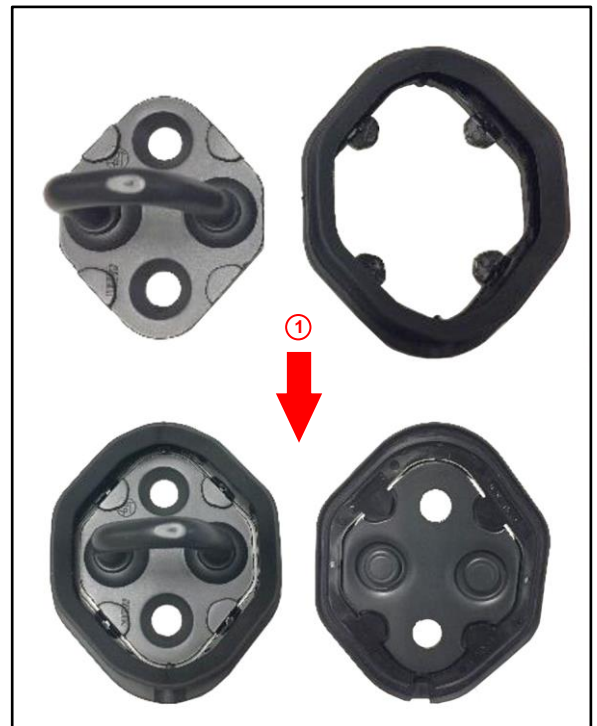
Figure 9.

4. Install the NEW striker and striker cover.
 - A. Check the installation direction of the front striker and assemble the striker and striker cover.

1	Bottom
----------	---------------

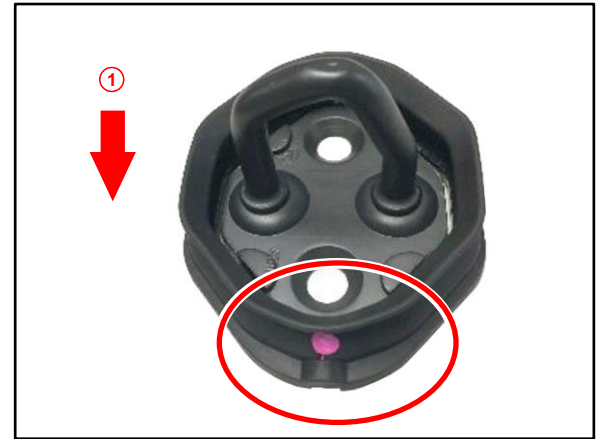
Figure 10.

- B. Check the striker direction, then set the striker and cover to the body. The pink marking should be located at the bottom.
 - C. Apply thread lock or Loctite™ on the screws.
 - D. Using a T40 TORX socket wrench, install the screws.
- Torque: 23 N*m (235 kgf*cm, 17 ft*lbf)**

1	Bottom
----------	---------------
