## Fuel Fill Door Rear Edge Does Not Line Up

Year	Model	Trim	VIN Range
2017-19	MDX	ALL	VINs that start with 5J8YD
2017-19	MDX Sport Hybrid	ALL	VINs that start with 5J8YD

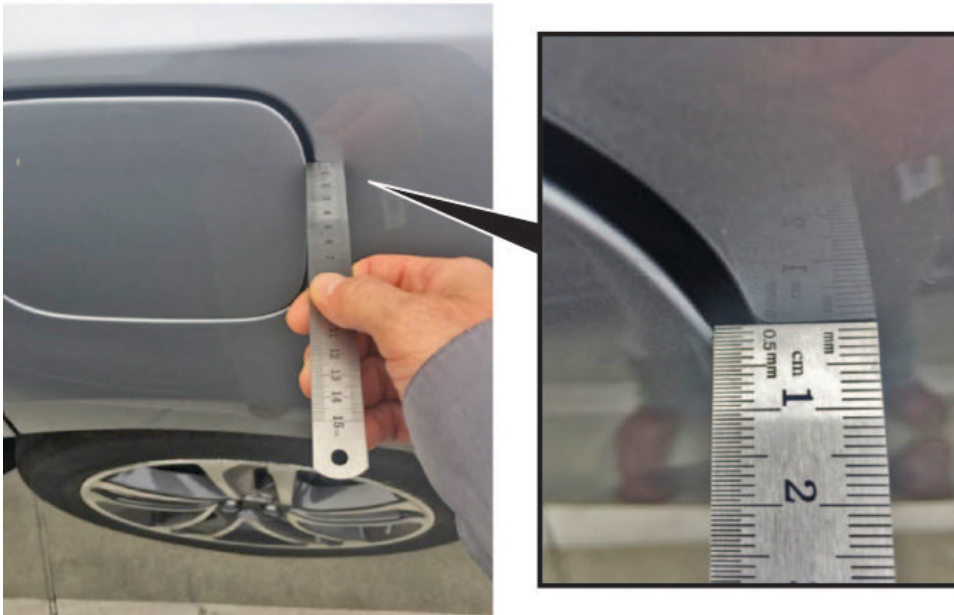
1. Check if the rear of the fuel filler door sticks out more than **1 mm**.

- If it does, go to step 2.
- If it does not, this bulletin does not apply. Continue with normal troubleshooting.

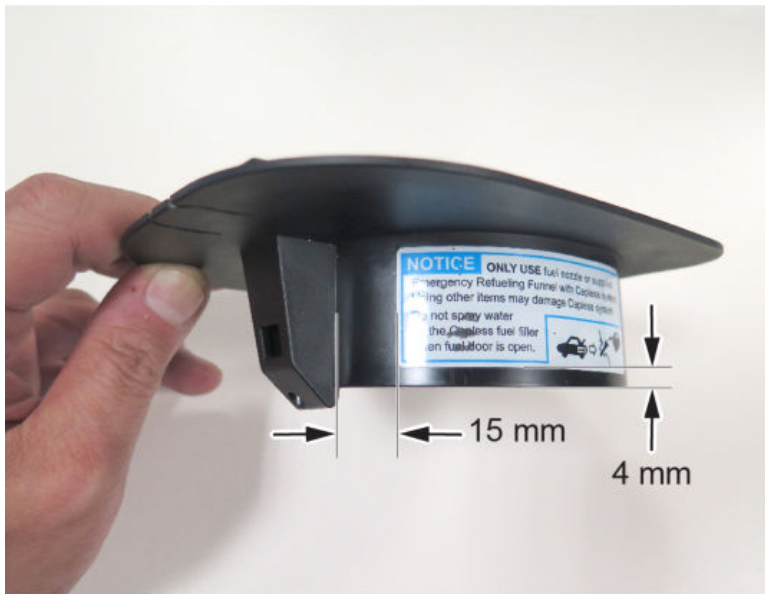
**P/N 17669-TG7-A01** (Capless Information)

2. Apply the fuel filler caution labels to the new fuel filler lid cover as shown. Make sure the new lid is clean and grease-free, especially on the surfaces where the labels will be applied.

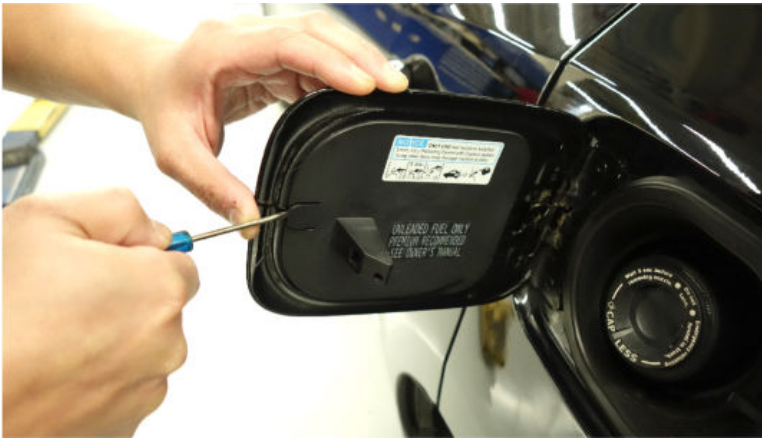
3.1. Lift the fuel filler lid locking tab.

The original fuel filler lid cover may be a flat type like the one shown below, or it may be a hooded type like the one shown in step 2. All the replacement lids will be the hooded type.

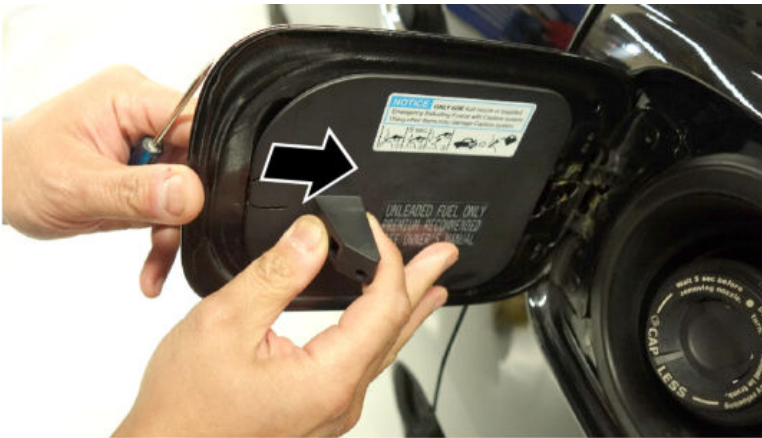
3.2. Slide the lid towards the fuel fill door hinge.

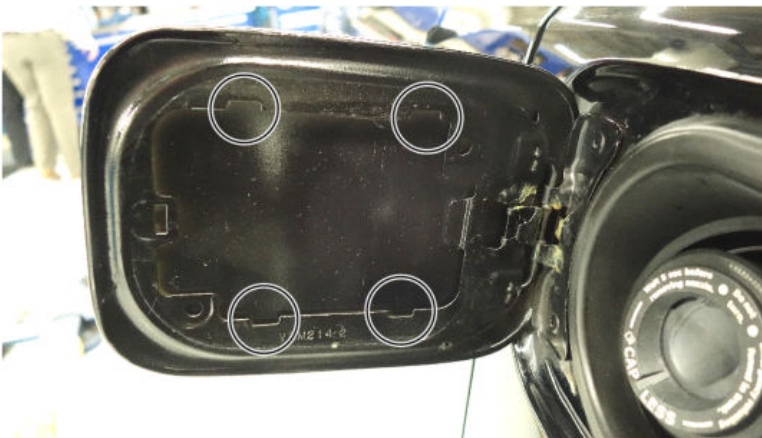
3.3. Slide the lid until the four tabs disengage from the slots in the fuel fill door.

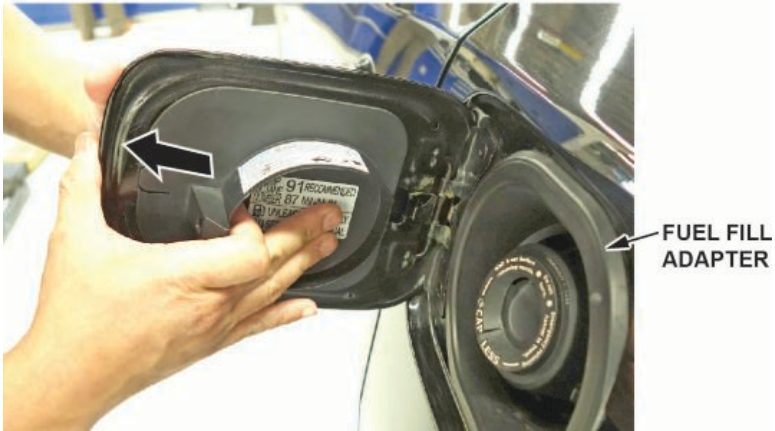
4. Installation of the new fuel filler lid is the reverse of removal. Verify all the tabs are engaged, and slide the lid away from the fuel fill door hinge until it clicks. This indicates the fuel filler lid cover is secured and correctly installed.

5. Make sure the fuel fill door closes and latches without contact or interference from the mis-fuel inhibit device and surrounding area.
6. Make sure the fuel fill door release works correctly when using the fuel fill door release button. If the fuel fill door still sticks out more than **1 mm**, check the fuel filler adapter for broken clips or mis-installation. If the adapter is OK, do normal troubleshooting.
