# SERVICE BULLETIN

Classification: EL17-003b	Reference: NTB17-015b	Date: November 30, 2018
------------------------------	--------------------------	----------------------------

## CUSTOMER SATISFACTION INITIATIVE 2G TELEMATICS HARDWARE REPLACEMENT

**APPLIED VEHICLE:** 2011-2015 LEAF (ZE0) - **With navigation only**

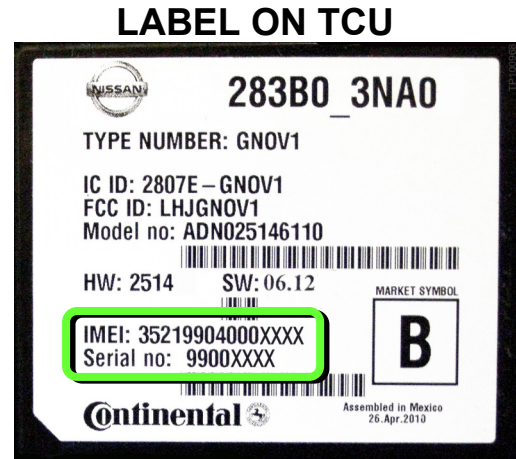
Figure 21

- a. VIN.
- b. International Mobile Equipment Identity Number (IMEI) of the original TCU. This number is located on the TCU.
- c. IMEI Number of the replacement TCU. This number is located on the TCU.
- d. Serial Number of the replacement TCU. This number is located on the TCU.

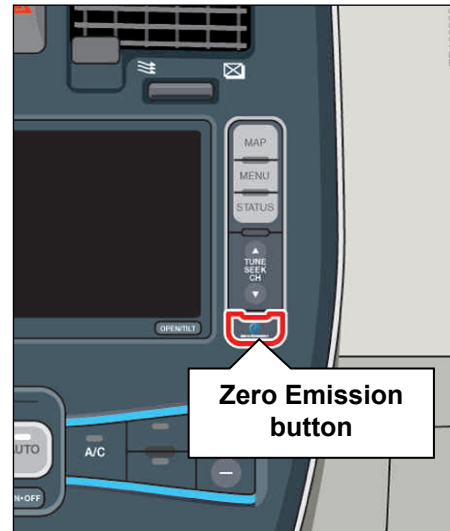
Figure 26

1. Press the **Zero Emission** button on the Multifunction Control Panel (Figure 26).

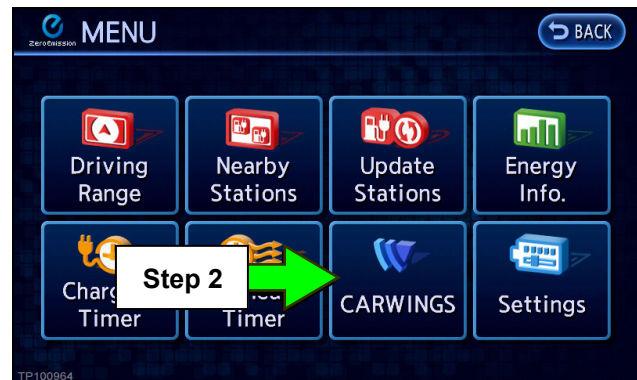
Figure 27

2. Select **CARWINGS**) and then **CARWINGS Settings**.

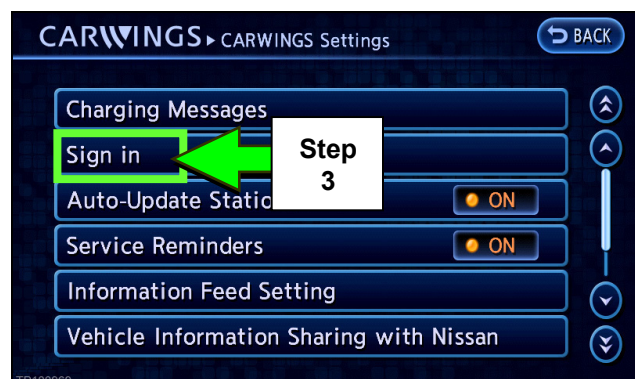
Figure 28

3. Select **Sign in**.
