GROUP BOD	MODEL 2012-2015MY Optima (QF) With Panorama Sunroof
	NUMBER 185	DATE January 2019
TECHNICAL SERVICE BULLETIN		
SUBJECT: PANORAMA SUNROOF CREAK OR RATTLE NOISE

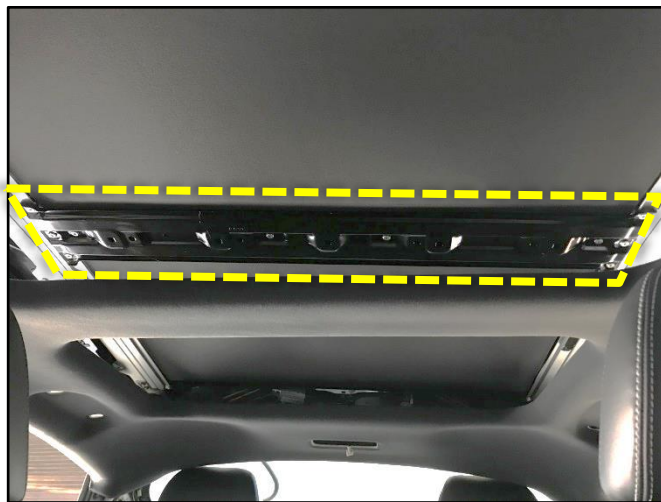
This bulletin provides the procedure to apply felt tape on the panorama sunroof crossmember on some 2012-2015MY Optima (QF) vehicles, equipped with panorama sunroof, produced from August 31, 2011 through September 22, 2015, which may experience a slight creaking or rattle noise at the sunroof area. Follow the procedure in this bulletin to apply felt tape on the sunroof crossmember assembly and crossmember mounts.
