Technical product information

Topic	Brake noise identification
Market area	Bentley: worldwide (2WBE),Hongkong-Macau (5HK)
Brand	Bentley
Transaction No.	2052785/1
Level	EH
Status	Approval
Release date

Object of complaint	Complaint type	Position
running gear -> brakes, brake control -> service brake	noise, vibration -> noise

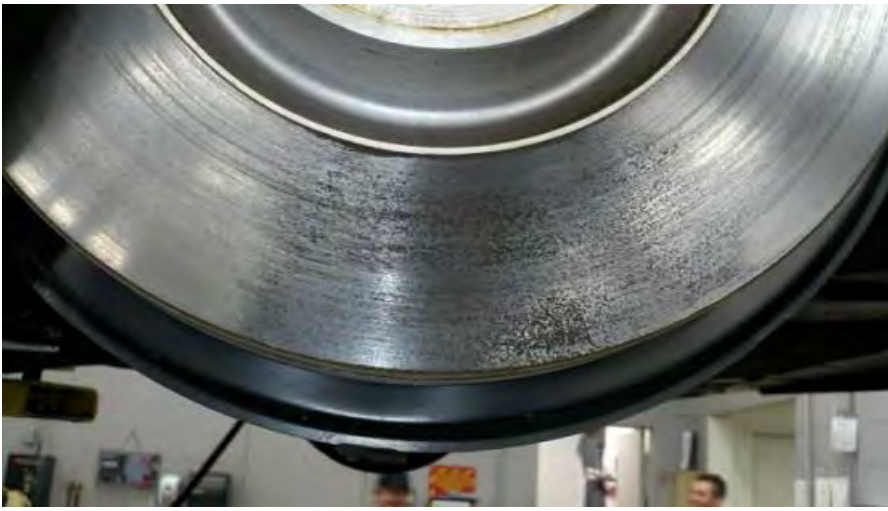
Figure 4

8. There are 'pad marks' on the brake disc as a result of the brake pad material transferring to the discs. This can occur when a vehicle has been stood for long periods of time in a wet or snowy environment (Figure 4).
