## Advanced Technical Information

Cayenne (92A)  
1816 9431

## Tail Light Defective Warning in the Instrument Cluster

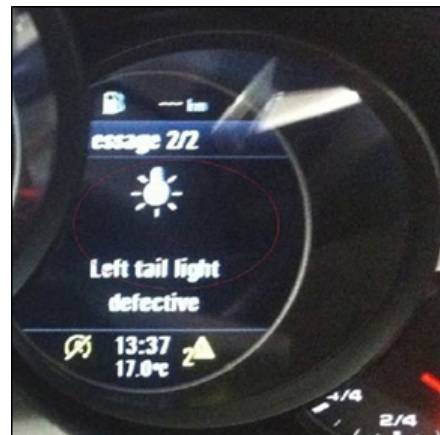
Figure 1

The driver receives a warning message in the instrument cluster indicating that a tail light is not working. (See Figure 1.) However, in some cases, the tail light actually does work as observed from outside the vehicle.

The workshop confirms the customer's observation along with fault codes 880FOE or 880F1E in the rear BCM module. However, the tail light may be working.

New guided fault finding is available in the PIWIS tester as of release 37.000. Consult this repair advice first.

The alternate solution is to replace at least one of the tail lights based on these failure modes:

- A) **False warning.** If the warning message is present and all the tail lights are lighted, the likely causative part is the outer tail light. Be sure to order replacement parts from the part numbers listed below.

- B) **Actual tail light outage.** If the warning is present and any of the tail lights are not lighted, replace that tail light as usual.

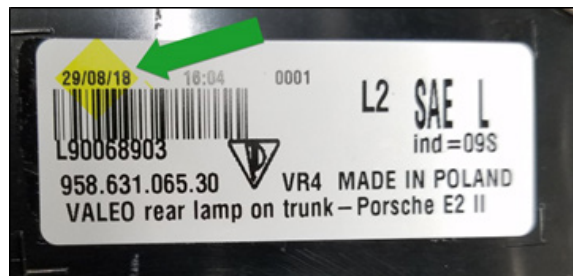
Figure 2

**Please note:** In either case, replacement tail lights (both inner and outer) should have a production date after September 15, 2017. Figures 2 and 3 have examples of **good** and **bad** dates. The labels shown in these illustrations can be found on the tail light itself and these labels should be used. The labels on the box and other labels may show dates that are not relevant to this issue and these should not be used.
