Loose M6 Screws Securing PCCB Rotors to Wheel Hub

| Model | Model Year | Model Type | VIN Range | Vehicle Specific Equipment |
|---|---|---|---|---|
| 911T/ GT2RS, GT3 and GT3RS | 2017-on | (991) | N/A | With Option I450 PCCB Brakes |

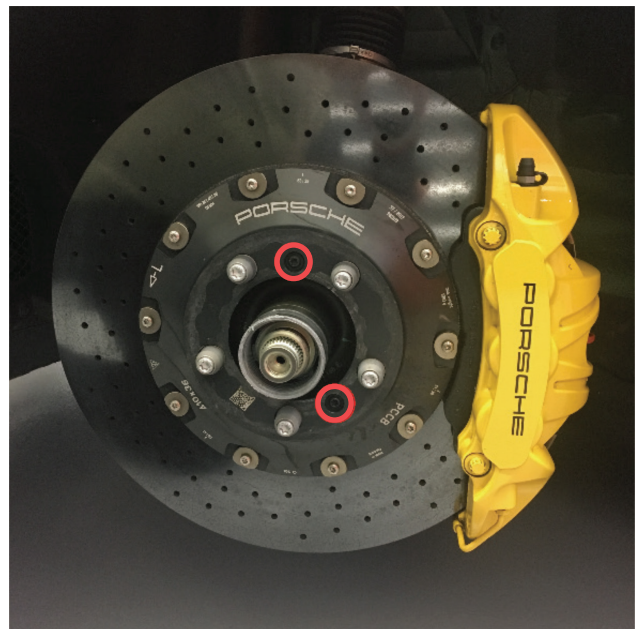
The M6 screws securing the PCCB rotor assembly to the wheel hub may loosen during use.

- The threads of the original M6x12 mm screw fasteners, used to secure the rotor to each wheel hub:
 - Were not coated with a microencapsulated thread locking compound.
- Were only tightened to 5 Nm.
 - Thermal cycling and vibration may cause these screws to loosen.
 - Therefore, the original screws are to be replaced with M6x10 mm screws.
- New screws have microencapsulated coating on the threads.
- Tightened to 10 Nm.
 - This is to be done during routine wheel/brake service.
 - A separate repair service to replace these screws should not be initiated.
 - The new, microencapsulated screws must be replaced each time they are removed in the future.

Note: Any loosened screws are fully captivated within their recessed locations and will not cause any type of mechanical damage or safety issue.

During routine wheel/brake service, replace the old type screws (99901502509) with the new type screws (99907357201). Tighten to 10 Nm.
