# Technical Service Bulletin

## 60 Noises in sunroof mechanism

60 18 23 2050904/2 December 5, 2018. Supersedes Technical Service Bulletin Group 60 number 18-22 dated March 29, 2018 for reasons listed below.

Model(s)	Year	VIN Range	Vehicle-Specific Equipment
A3	2018	000001 - 050429	Not Applicable

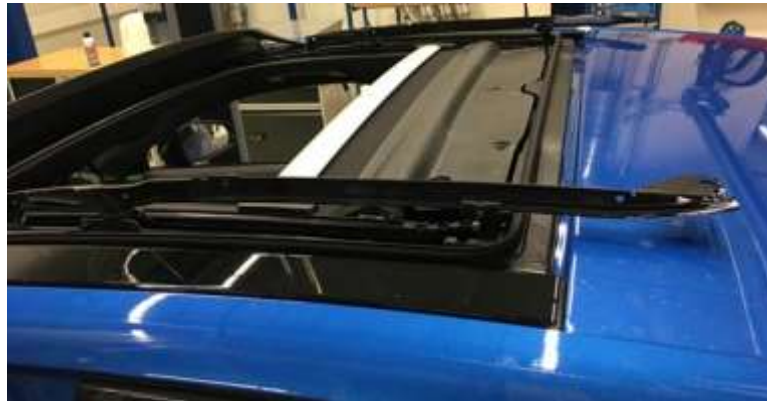
During a certain production period the sunroof mechanism sliding rails were contaminated with a lubricant incompatible with the approved lubricant. When the correct approved lubricant was applied to these contaminated areas the correct lubricant did not adhere to these areas. These areas were then susceptible to noises when in contact with adjacent components of the sunroof mechanism.

*Figure 1. Sliding rails exposed showing the area of contamination.*

1. The areas of contamination will need to be thoroughly cleaned and dried, then the correct lubricant can be applied. Open the Panoramic sunroof fully. While Figure 1 shows the glass panel removed for clarity, the glass panel does not need to be removed to perform this operation.

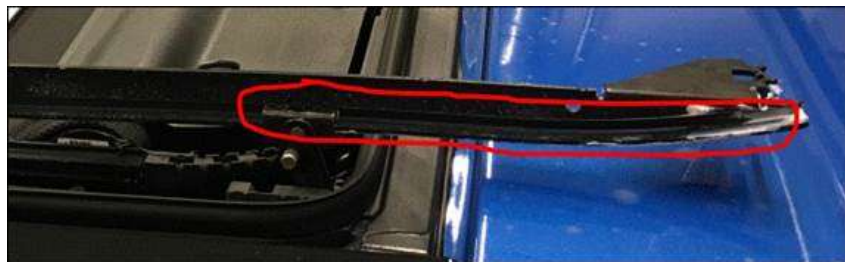
*Figure 2. Area of the sliding rail to be cleaned.*

2. Thoroughly clean the areas of the sliding rails shown in the illustration with All Purpose Cleaner G 065567A2 and a lint free cloth. The area to clean is 15 cm from the rearmost edge of the rail. Perform this cleaning procedure to both sides.

3. Finally, lubricate the cleaned areas with Special Lubricant G 060567A2. Perform this lubrication to both sides as well.

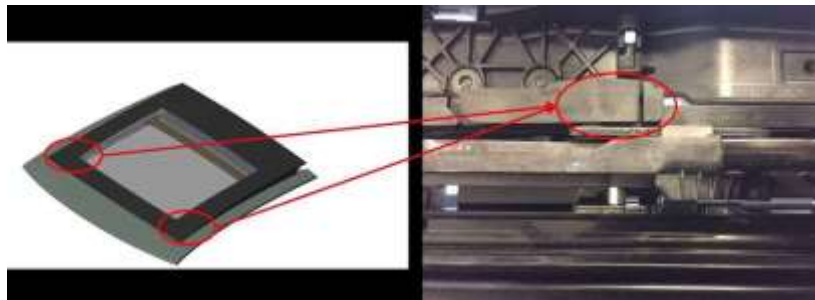
*Figure 3. Locking mechanism in the guide rail.*

4. Completely open the glass lid. The picture (Figure 3) shows the locking mechanism in the guide rail.

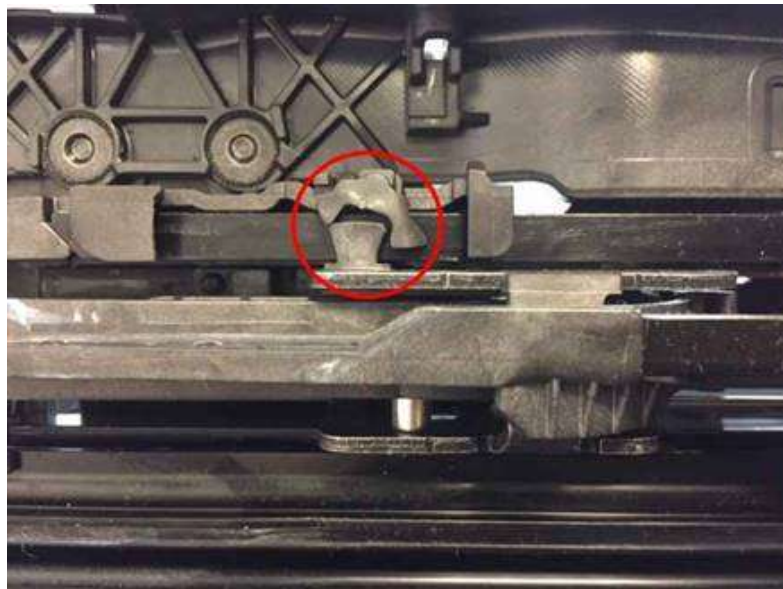
The two components in the circle touch each other and rattle when the glass panel is tilted. To fix the rattle, grease must get between the components.

*Figure 4. Part that causes noise.*

5. In the next picture (Figure 4) the cover has been removed to show what causes the noises.

Please do not remove anything here.

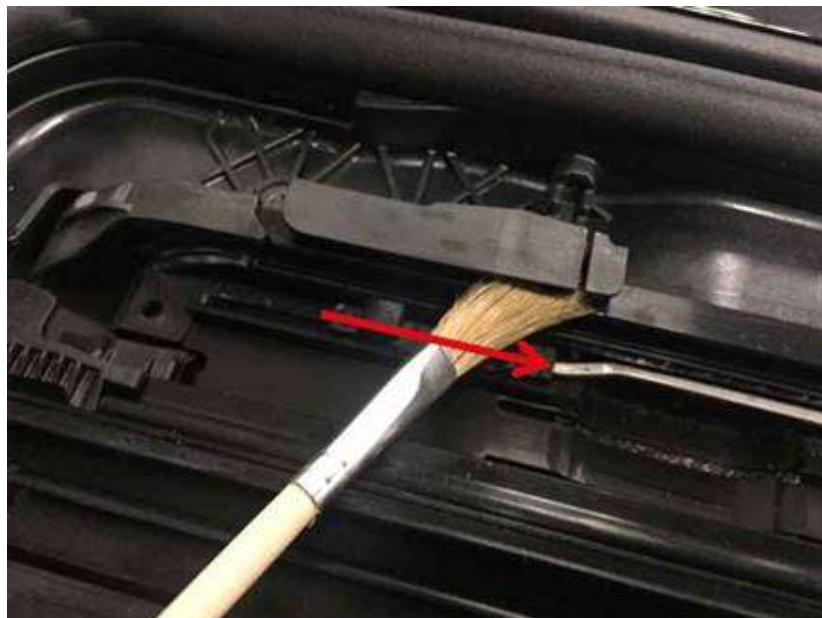
*Figure 5. How to apply grease.*

6. Apply a pea-size amount of grease on a small brush. Use the special paste **G 052 141 A2**. Move the brush (as shown in the Figure 5) **from front to back** through the locking mechanism.

The direction of the movement is very important, otherwise major damage could be caused to the roof system and the body.

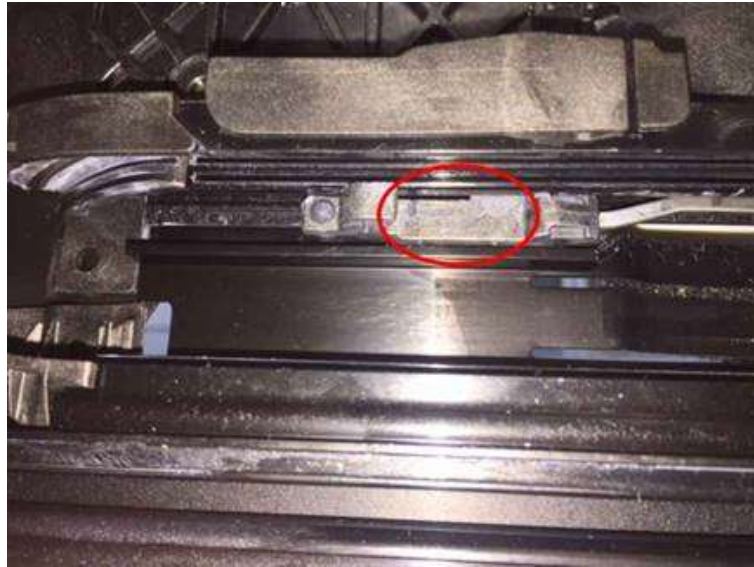
*Figure 6. Unlocked mechanism.*

7. The next picture (Figure 6) shows the mechanism unlocked.

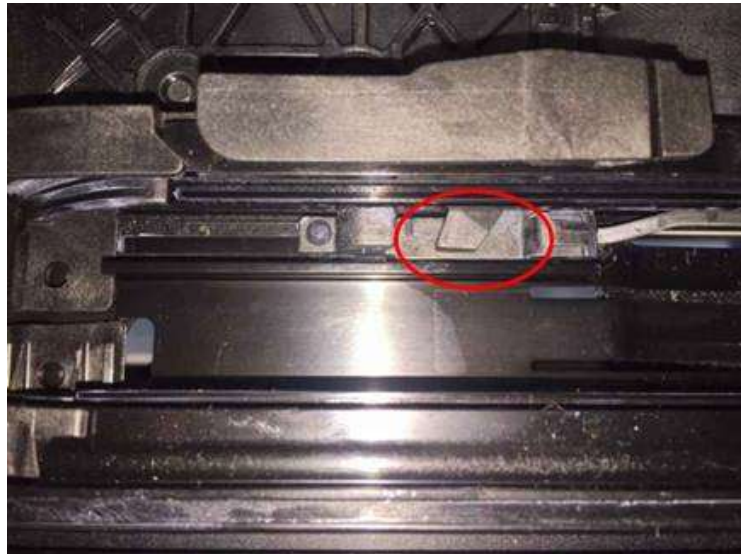
*Figure 7. Locked mechanism.*

8. The following picture (Figure 7) shows the mechanism locked.

**At the end of the repair the mechanism must be locked.**
