SUBJECT: Customer Satisfaction Program 18N03 - Supplement #2

Certain 2015-2018 Model Year F-150 and 2017-2018 Model Year F-250-F-550

Vehicles - Door Latch Freezing Concerns

Supplement #2

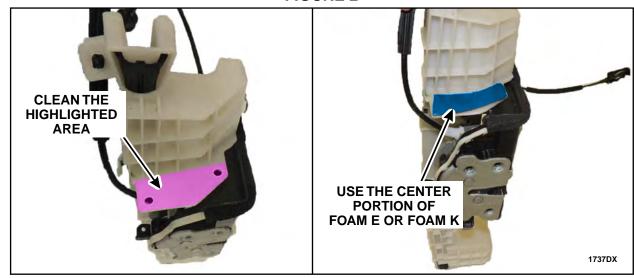
FIGURE 3

- 4. Through the exterior front door handle opening, inspect for a rubber water shield installed on top of the door latch. See Figure 2.
- 5. If a rubber water shield is present, remove and discard the two attaching clips and the rubber water shield.
- 6. Clean the surface area where the water shield covered with isopropyl alcohol and a clean shop cloth. Use part of the center portion of Foam E (refer to Figure 11) or some locally acquired body tape to seal the holes the attaching clips were previously installed in. See Figure 3.

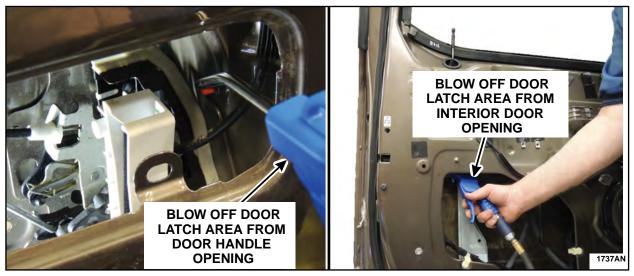
FIGURE 4

7. Using compressed air, blow out any debris or residual water from the door latch assembly, exterior door handle mechanism, and cables. See Figure 4.

NOTE: Driver rear door latch shown, all door latches similar.

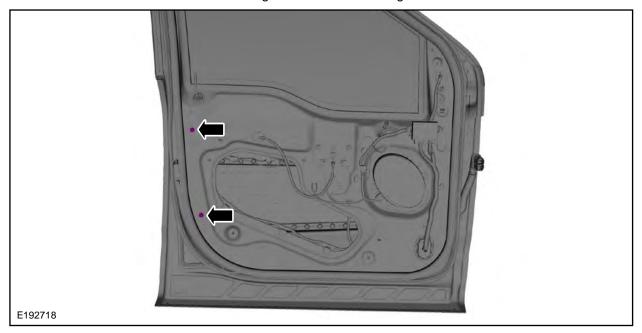
FIGURE 5

8. Loosen but do not remove the two door glass run bolts. See Figure 5.

- 13. Tighten the two door glass run bolts. See Figure 5.
  - 8 Nm (71 lb.in).
- 14. Tighten the three door latch bolts. See Figure 6.
  - 8 Nm (71 lb.in).
- 15. Refer to Figure 9 to determine if the door latch is equipped with the *new* style lock rod.

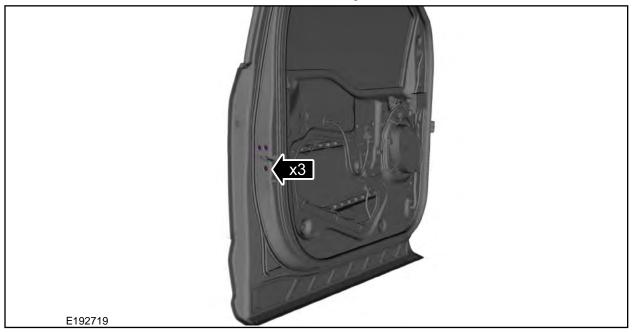
FIGURE 6

9. Loosen but do not remove the 3 door latch bolts. See Figure 6.

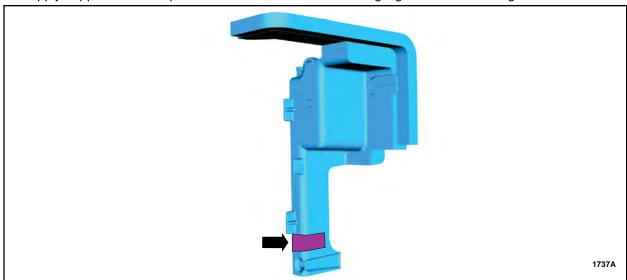
FIGURE 7

10. Apply supplied Foam Tape to the *new* water shield in the highlighted area. See Figure 7.

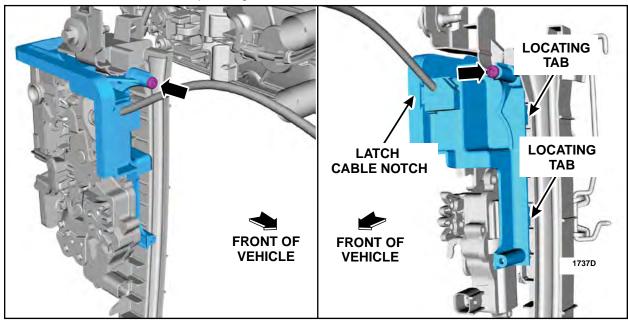
FIGURE 8

11. With the latch and door glass run assembly loose inside the door panel, install the door latch water shield into position. See Figure 8.

NOTE: Driver door latch shown, passenger door latch similar.

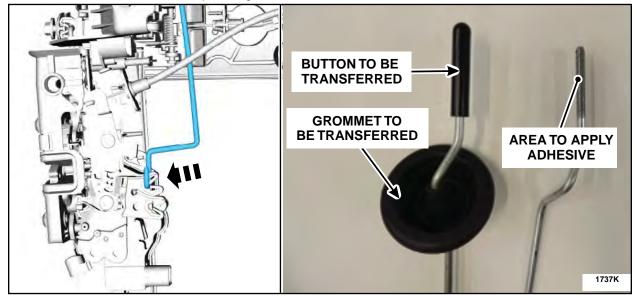
FIGURE 10

- 17. Replace the lock rod and transfer the necessary components. See Figure 10.
  - a. Transfer the grommet and button from the original lock rod to the *new* lock rod.
  - b. Apply a bead of Motorcraft® Instant Gel Adhesive TA-19-C or equivalent to the lock rod prior to threading the button onto the *new* lock rod.
  - c. When threading the button onto the *new* lock rod, stop threading when some resistance is met.
  - d. Ensure both front lock rod buttons are installed at similar heights.
  - e. Reinstall the lock rod.

**NOTE**: Driver door latch shown, passenger door latch similar.

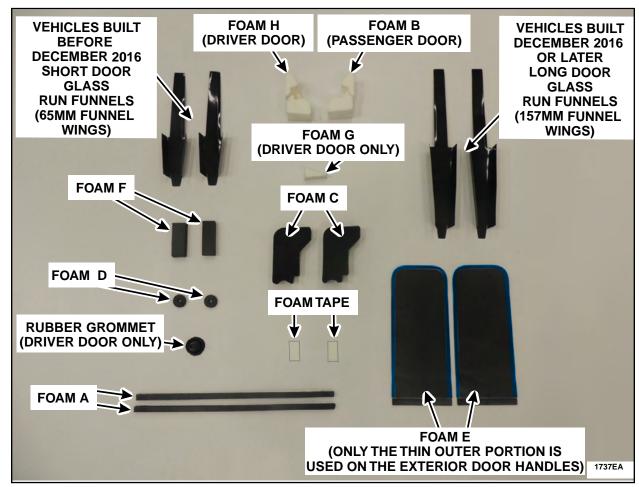
#### FIGURE 11

Complete Front Door Part Kit - Each Kit Will Include Either Long Door Glass Run Funnels Or Short **Door Glass Run Funnels**

NOTE: The parts being installed in this procedure are not labeled. Refer to Figure 11 for component identification.

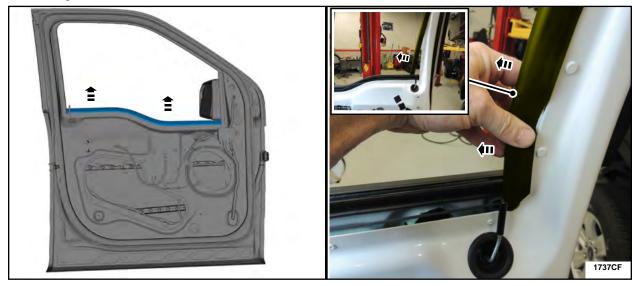
# FIGURE 13

2. Remove the inner belt moulding and position aside the latch side of the door glass top run. See Figure 13.

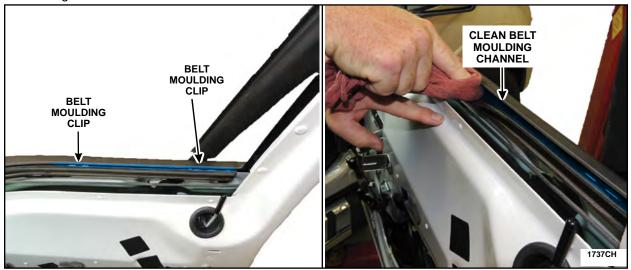
FIGURE 15

4. Clean the highlighted area of the outer belt moulding with isopropyl alcohol and a clean shop cloth. See Figure 15.

5. Apply a small bead of Motorcraft® TA-30 Silicone sealant onto the highlighted area of the outer belt moulding, ensuring the two belt moulding clips shown in Figures 15 and 16 are completely covered. Using your finger, smooth out the sealer to establish an even surface. See Figure 16.

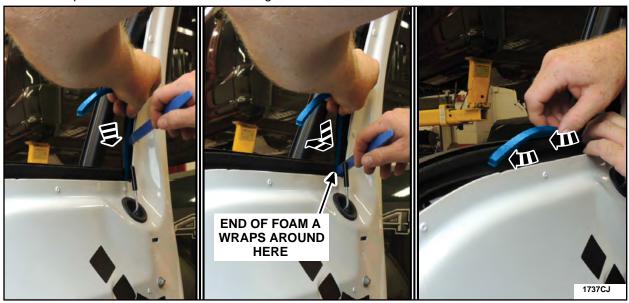
FIGURE 17

Using a small trim removal tool, install Foam A to the outer belt moulding on top of the bead of silicone that was previously applied. Both of the outer belt moulding clips need to be covered by the Foam A. See Figures 17 and 18.

**NOTE:** It is crucial that both outer belt moulding clips are covered by Foam A and that the end of Foam A wraps around the outer belt moulding as shown.

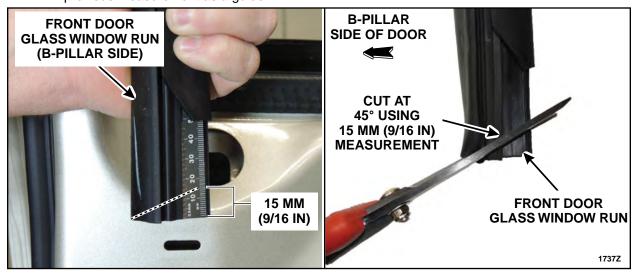
FIGURE 19

- 8. Modify the front door glass top run. See Figure 19.
  - a. Measure 15 mm (9/16 in) from the inboard bottom corner of the door glass top run.
  - b. Mark the 15 mm (9/16 in) location.
  - c. Starting at the bottom outboard corner of the door glass top run, cut a 45° notch using the previous measurement as a guide.

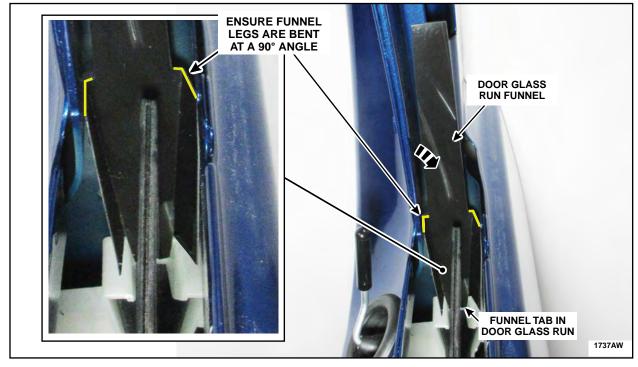
FIGURE 20

- 9. Install one of the appropriate length door glass run funnels ensuring that the lower tab is situated in the door glass run and the funnel sides sit at a 90° angle above the door glass run. See Figure 20. *Refer to Attachment V for additional information.* 
  - F-150 vehicles: Short funnels 65mm funnel wings (built before December 2016), Long funnels 157mm funnel wings (built December 2016 or later)
  - F-250-F-550 vehicles: Long funnels only 157mm funnel wings

**NOTE:** Ensure the funnel sides are at a 90° angle upon installation. It may be necessary to bend the sides of the funnel back to a 90° angle before installation.

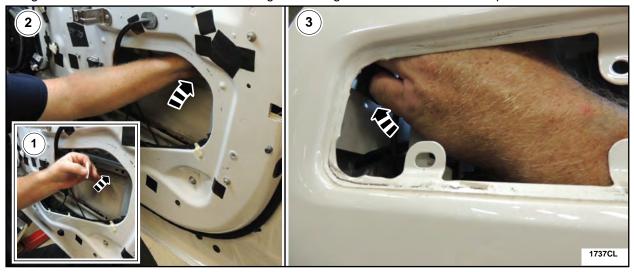
FIGURE 22

- 12. Raise the front door window to the full up position.
- 13. Using your hand install the Foam Tape on the top of the door glass run and on the back of the door glass run funnel in the order shown in Figure 22. Figure 23 shows the Foam Tape installed.

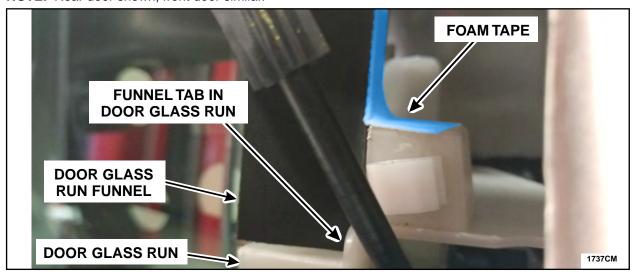
FIGURE 23

NOTE: Rear door shown, front door similar.

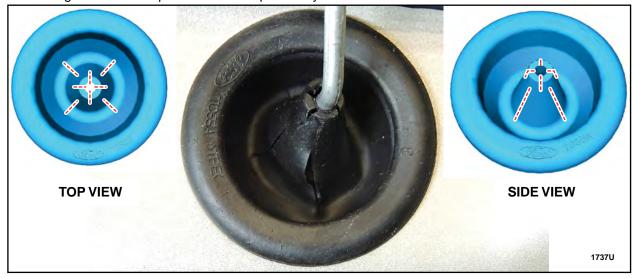
FIGURE 25

- 15. Modify the front door Lock Rod Grommet. See Figure 25.
  - a. Using a utility knife, cut four 6 mm (.25 in) long slits approximately 90° apart into the top of the front door lock rod grommet where the lock rod exits the grommet.
  - b. Cut four additional 13 mm (.5 in) long slits approximately 90° apart on the inner sides of the grommet 45° separated from the previously cut slits.

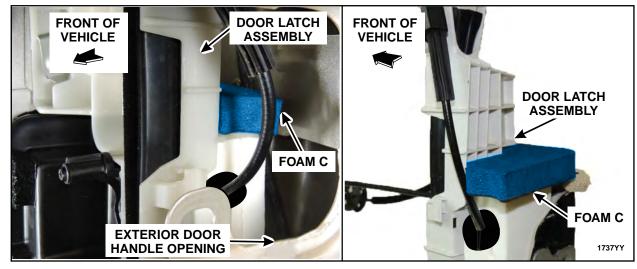
FIGURE 30

4. Using a trim tool, install Foam C onto the top of the front door latch water shield. See Figure 30.

**NOTE:** Driver door latch shown, passenger door latch similar.

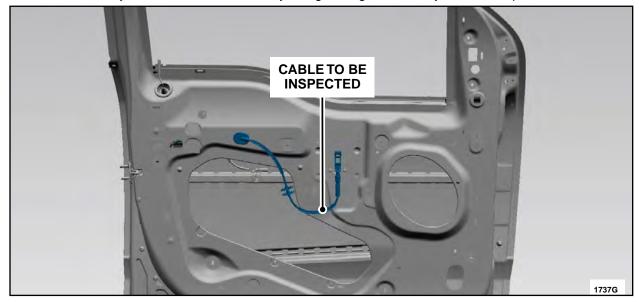
FIGURE 33

- 8. Inspect the interior door handle to latch cable for kinking. See Figure 33.
  - Correct any kinks found in the cable by straightening the cable by hand as required.

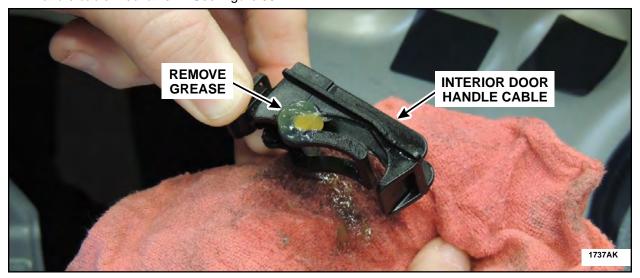
FIGURE 35

- 10. If equipped, disconnect the interior door handle cable retaining clips from the door sheet metal.
- 11. Using isopropyl alcohol and a clean shop cloth, throughly remove grease from the interior door handle cable mechanism. See Figure 35.

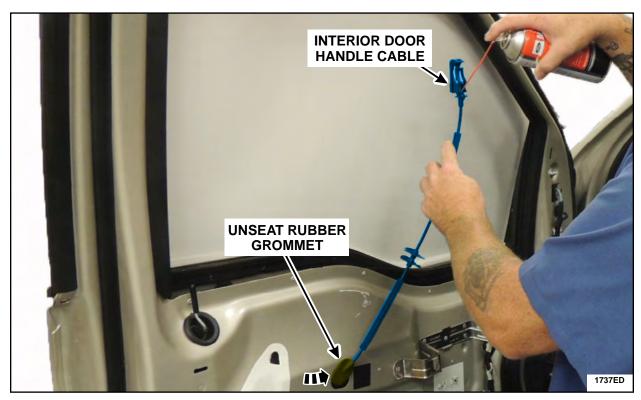
FIGURE 36

12. Unseat the interior door handle cable rubber grommet and while holding the end of the cable in an upward position, spray Motorcraft® XL-6 Lubricant down into the cable for five seconds. See Figure 36.

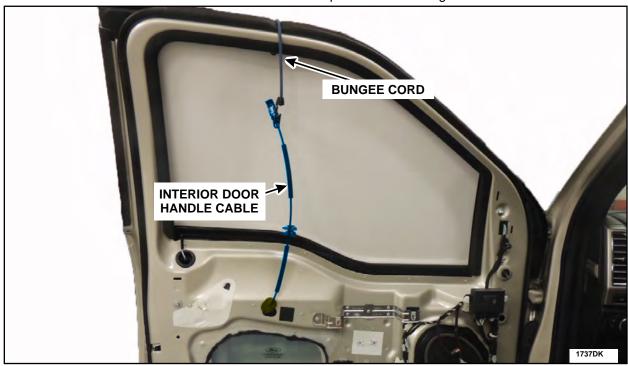
FIGURE 37

13. Using a bungee cord or other similar device, secure the interior door handle cable to the door in an upward position to allow the Motorcraft® XL-6 Lubricant time to run down into the cable, until the interior door handle cable is reinstalled later in this procedure. See Figure 37.

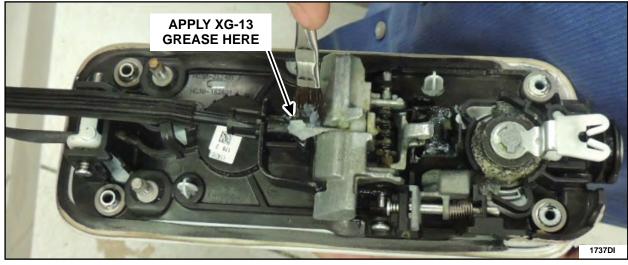
#### FIGURE 46

- 19. Remove the bungee cord used to hold the interior door handle cable up, seat the rubber grommet and if equipped, reinstall the interior door handle cable retaining clips.
- 20. Reconnect the exterior door handle cable to the door handle, then lubricate the door handle cable end with Motorcraft® XG-13 grease, as shown in Figure 46.
- 21. Reinstall the front exterior door handles. Please follow the WSM procedures in Section 501-14.

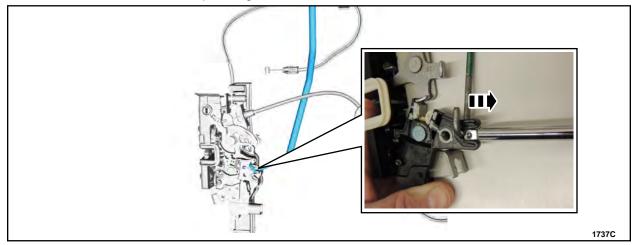
FIGURE 47

- 2. Remove the lock rod assembly from the rear door latch. See Figure 47.
  - Use the male end of a 1/4" extension to spread apart the lock rod retainer and remove the rod from the door latch.

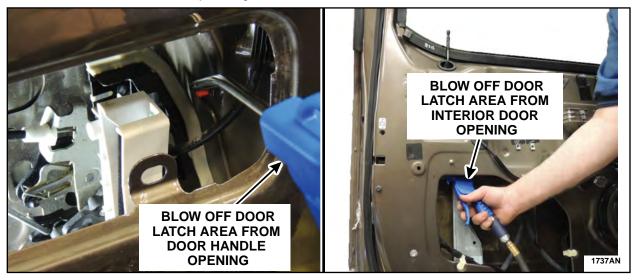
FIGURE 48

3. Using compressed air, blow out any debris or residual water from the door latch assembly, exterior door handle mechanism, and cables. See Figure 48.

NOTE: Driver door latch shown, passenger door latch similar.

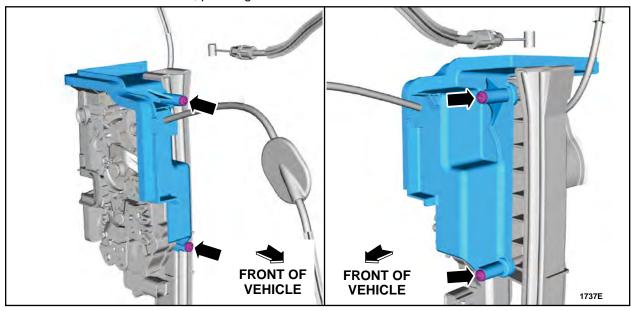
FIGURE 49

5. Install the *new* screws into the top and bottom holes of the shield. See Figure 49.

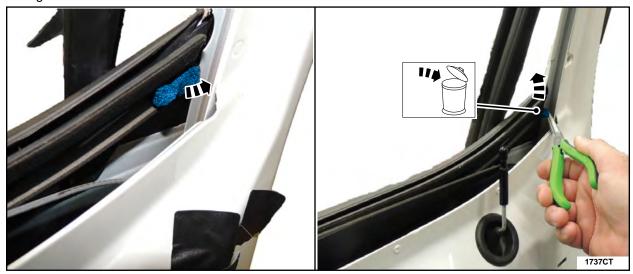
FIGURE 55

3. If present, remove and discard the foam on the door outer belt moulding at the location shown in Figure 55.

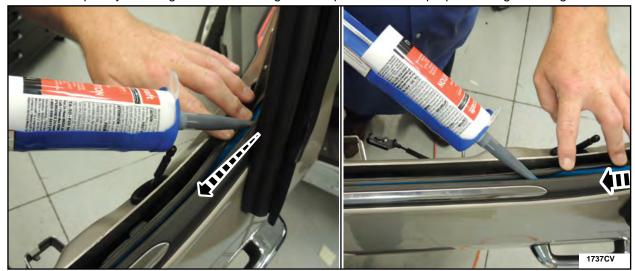
FIGURE 57

5. Apply Motorcraft® TA-30 silicone sealer to the area highlighted on the outer belt moulding. Using your finger, smooth out the sealer to establish an even surface. See Figures 57 and 58.

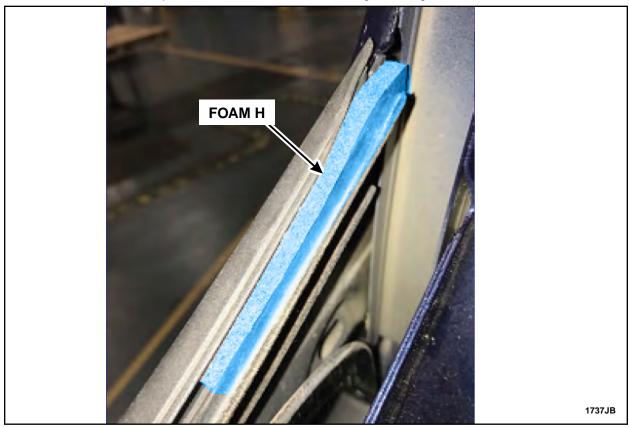
FIGURE 59

6. Install Foam H to the C-pillar end of the outer belt moulding. See Figure 59.

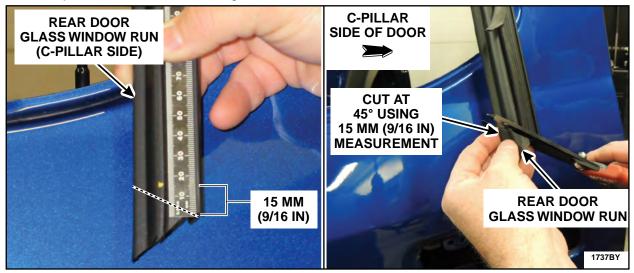
FIGURE 60

- 7. Remove any excessive silicone in visible areas on the outer belt moulding with isopropyl alcohol and a clean shop cloth.
- 8. Modify the rear door glass top run. See Figure 60.
  - a. Measure 15 mm (9/16 in) from the inboard bottom corner of the door glass top run.
  - b. Starting at the bottom outboard corner of the front door glass top run, cut a 45° notch using the previous measurement as a guide.

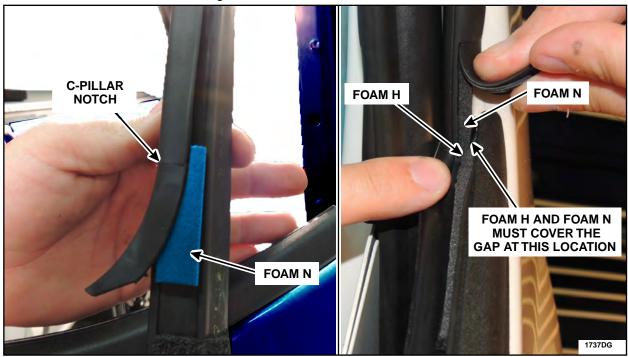
FIGURE 63

11. Install Foam N to the highlighted area of rear door glass top run making sure that the Foam N is under the C-Pillar notch. See Figure 63.

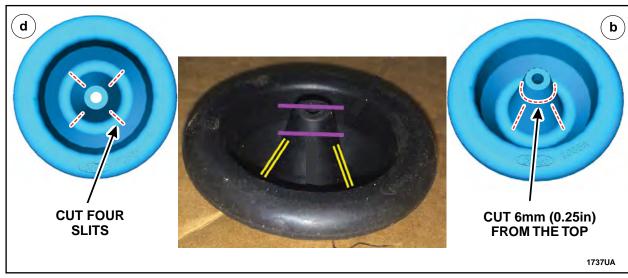
#### FIGURE 65

- 13. Modify the rear door lock rod grommet. See Figure 65.
  - a. Remove the rear door lock rod grommet from the lock rod.
  - b. Cut approximately 6 mm (0.25 in)off the top of the grommet.
  - c. Install the rear door lock rod grommet back onto the lock rod.
  - d. Using a utility knife, cut four 6 mm (0.25 in) long slits approximately 90° apart into the lower portion of the rear door lock rod grommet.

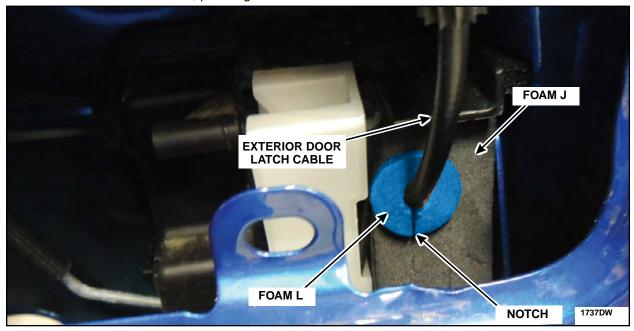
FIGURE 68

- 2. Install Foam L over the door latch cable and onto Foam J to cover the gap between the exterior door latch cable and Foam J. See Figure 68.
  - The notch of foam L must point downward when installed.

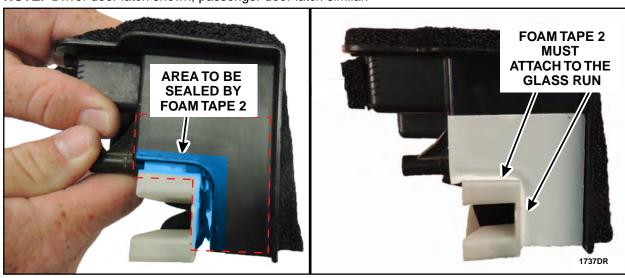
FIGURE 70

- 4. Install Foam Tape 2 on top of the rear door latch water shield. See Figures 70.
  - Make sure that Foam Tape 2 attaches to the water shield and to the door glass run.

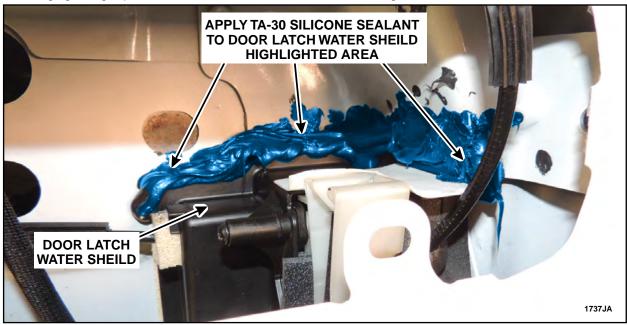
FIGURE 72

6. Apply Motorcraft® TA-30 silicone sealant in and over the mating area of the water shields to the door. Using light finger pressure smooth the bead of silicone. See Figure 72.

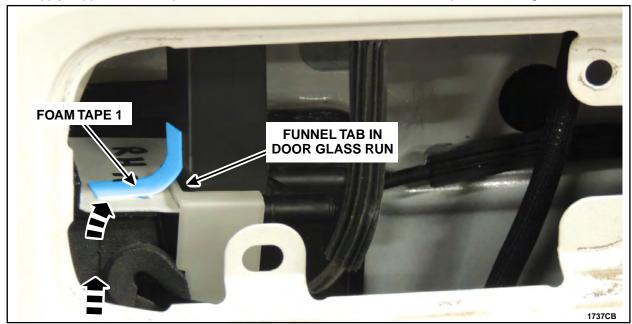
FIGURE 74

- 10. Position the rear door window glass up.
- 11. Apply supplied Foam Tape 1 in the location shown to hold the funnel in place. See Figure 74.

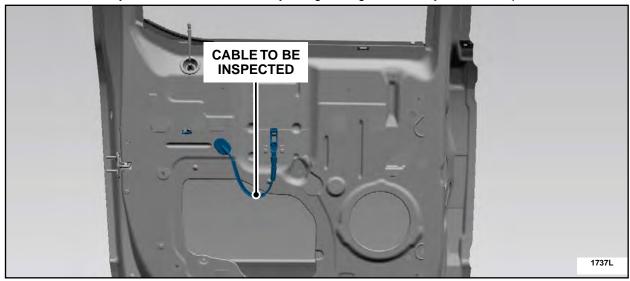
FIGURE 75

- 12. Inspect the interior door handle to latch cable for kinking. See Figure 75.
  - Correct any kinks found in the cable by straightening the cable by hand as required.

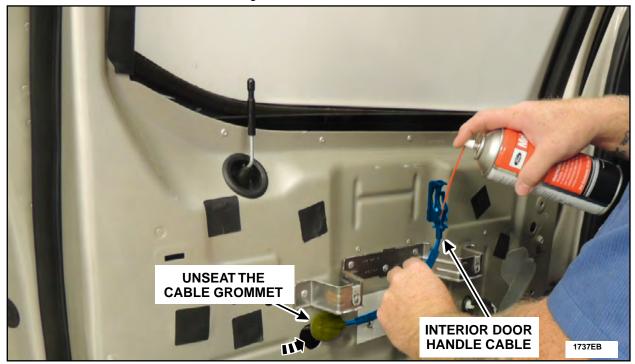
FIGURE 78

15. Unseat the interior door handle cable rubber grommet and while holding the end of the interior door handle cable in an upward position, spray Motorcraft® XL-6 Lubricant for five seconds down into the cable. See Figure 78.

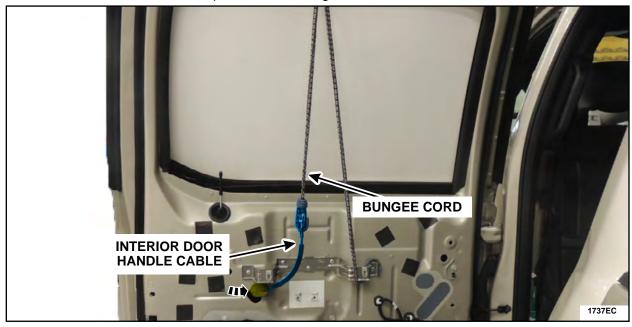
FIGURE 79

16. Using a bungee cord or other similar device, secure the interior door handle cable to the door in an upward position to allow the lubricant time to run down into the cable, until the interior door handle cable is reinstalled later in this procedure. See Figure 79.

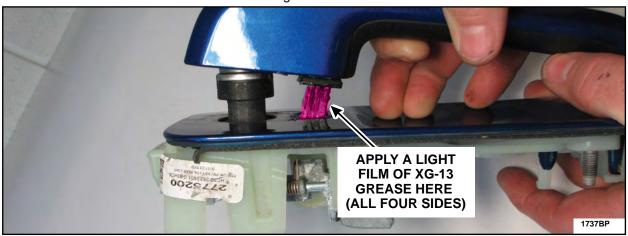
#### FIGURE 85

20. Using a clean shop cloth and isopropyl alcohol, clean the handle plunger then, using a brush, apply a light film of Motorcraft® XG-13 grease to all four sides of the exterior door handle plunger and to the mechanisms in the areas shown in Figures 85 and 86.

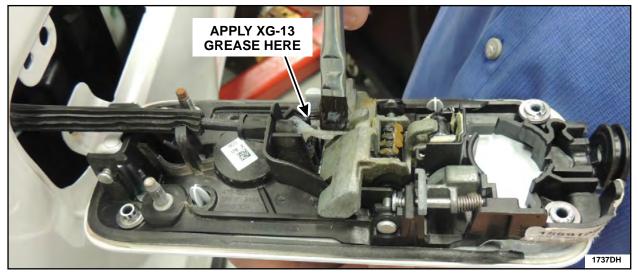
#### FIGURE 88

22. Remove the bungee cord used to hold the interior door handle cable up, seat the interior door handle cable rubber grommet and reinstall the exterior rear door handle. When connecting the exterior door handle cable to the door handle, lubricate the door handle cable end with XG-13 grease as shown in Figure 88. Please follow the WSM procedures in Section 501-14.

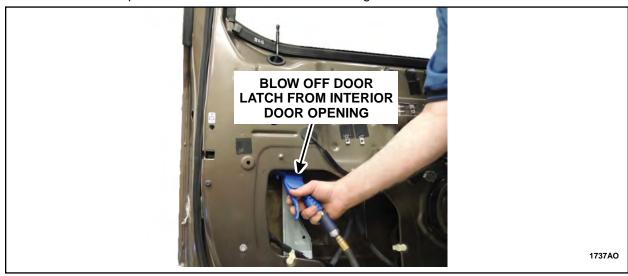
FIGURE 89

- 1. Remove the rear door interior trim panels. Please follow the WSM procedures in Section 501-05.
- 2. Remove the door panel weather shield for access. See Figure 89.

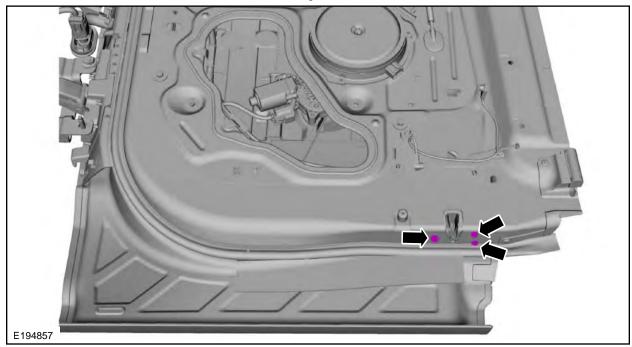
FIGURE 90

- 3. Inspect the interior door handle to latch cable for kinking. See Figure 91.
  - Correct any kinks found in the cable by straightening the cable by hand as required.
- 4. Remove the three lower door latch bolts. See Figure 90.

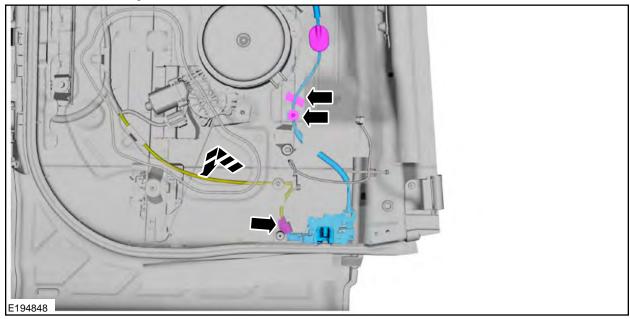
# FIGURE 91

5. Detach the cable retainers and disconnect the electrical connector. Position the rear door latch outside of the door. See Figure 91.

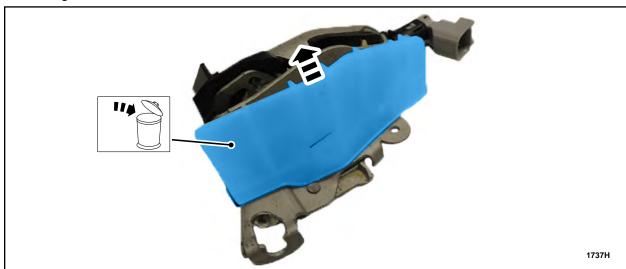
FIGURE 92

**NOTE:** Some F-150 SuperCab vehicles may be equipped with a smaller water shield than what is being installed in this program. The smaller shields must be removed and replaced. See Figure 92.

6. If equipped with small water shields, remove and discard the existing lower door latch water shields. See Figure 92.

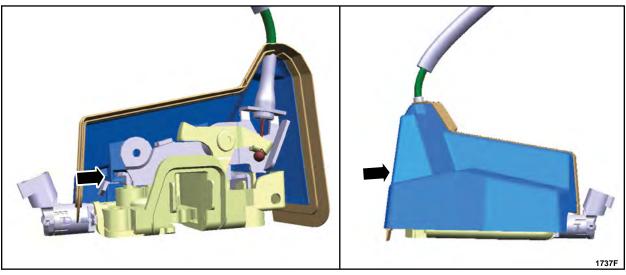
## FIGURE 93

- 7. Using compressed air, blow out any debris or residual water from the latch assembly area.
- 8. Install a new door latch water shield onto the lower rear door latch. See Figure 93.

**NOTE:** If the vehicle has previously had a rear lower door latch replaced, it may already have the latest level door latch water shield installed. If the Super Cab rear lower door latch has a large water shield installed as shown in Figure 93, then installation of a *new* water shield is not required.
