YEAR/MODEL	Date Of Issue	Bulletin Number	Service Campaign
2013-2017 Isuzu Reach	11/2/18	1002	<input type="checkbox"/> NO <input checked="" type="checkbox"/> YES

Title: Hybrid Transit front drive shaft lubrication

Applies To: All XL Hybrid 130" wheel base Transits.

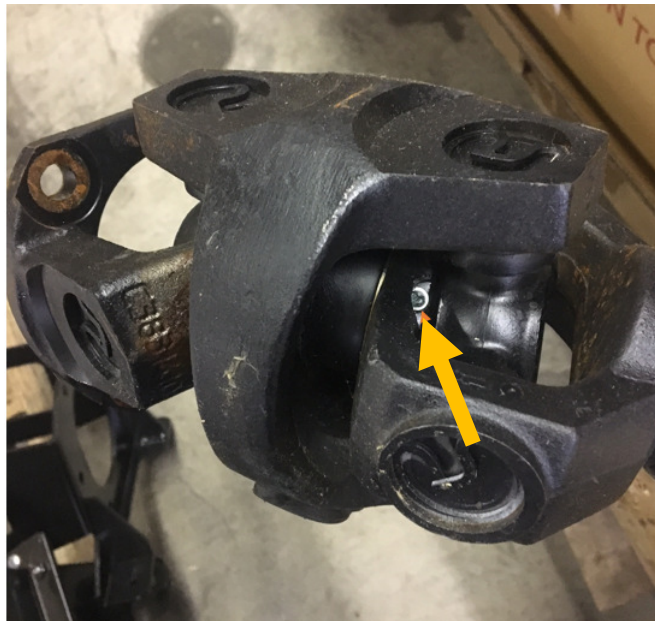
Figure 1

1. Raise vehicle on suitable hoist, or jack vehicle and place on stands. Place vehicle in neutral.
2. Rotate drive shaft to locate and gain access to flush mount grease fittings. Using needle style grease tip, lubricate ball and socket joint. (See figure 1)

3. Repeat for rear joint.
