## CR172 – DQS sensor check and replacement (if required)

Panigale V4 (all model versions)

Technical Service Bulletin SRV-TSB-19-002

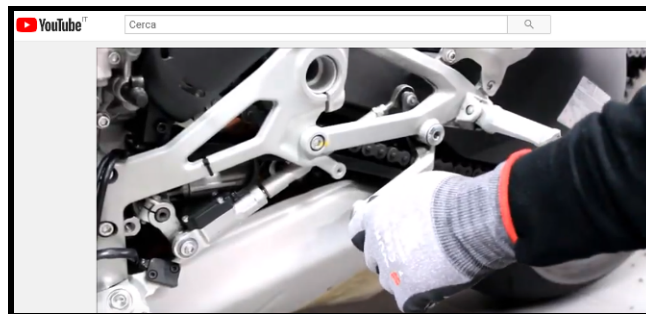
### Part 1: Checking the DQS (Ducati Quick Shift) operation

1. Connect the DDS 2.0 to the motorcycle through the relevant diagnosis socket
2. Enter section “ECU self-diagnosis” and select “Activations”
3. Select “DQS operation test” and press “Start”

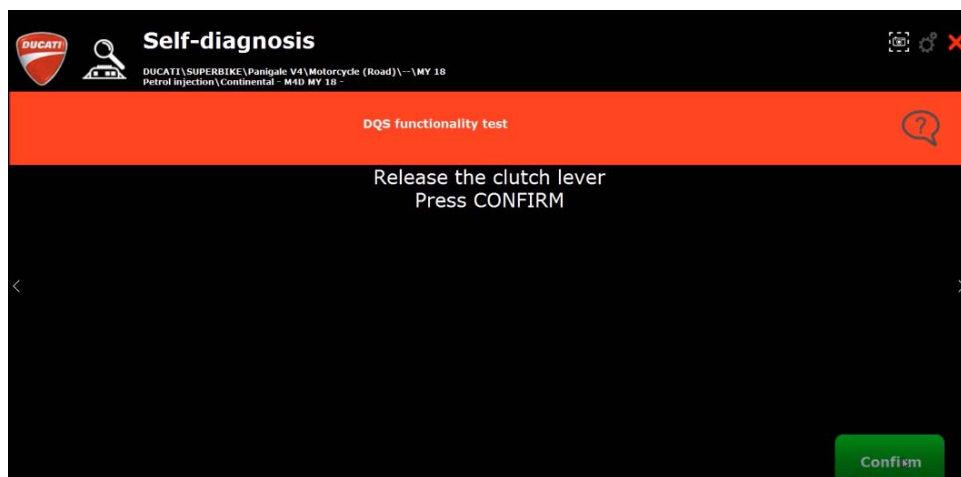
2. Release the clutch lever and confirm

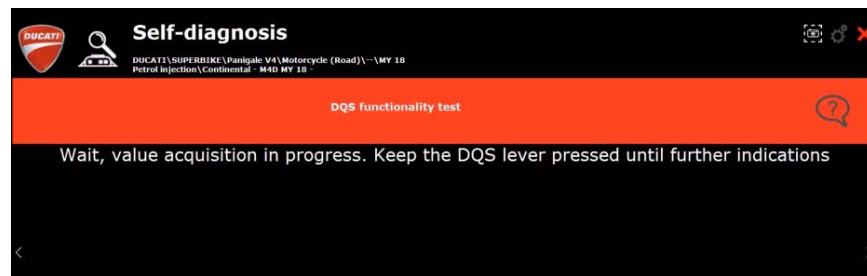
Keep the gear shift lever "pulled" ("pressed" in case of reversed shift) until the next indication appears on the display.

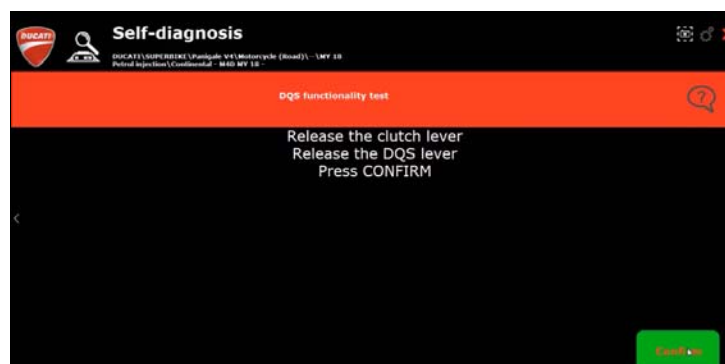
2. Release the clutch and gear shift lever and confirm

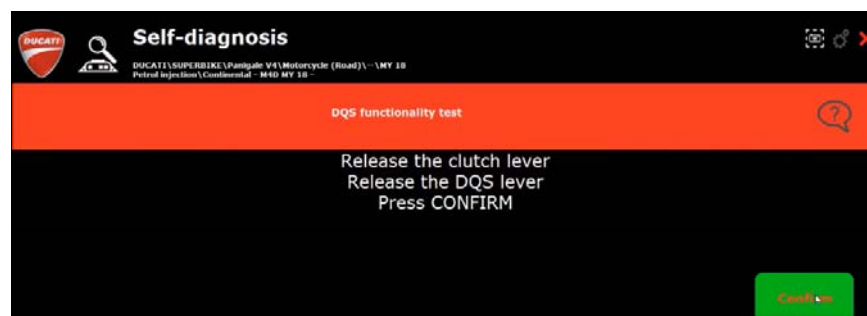
2. Release the clutch and gear shift lever and confirm.

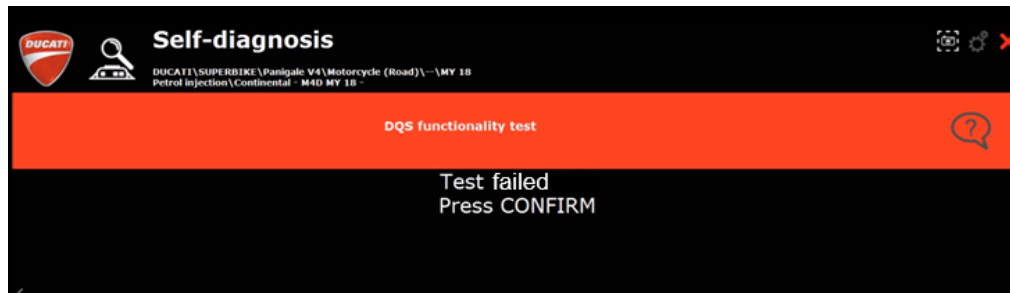
**Type 2:** If the test result is **Failed**, there is a malfunction in the DQS sensor and it is necessary to replace it
