# Technical Service Bulletin

GROUP <b>BODY</b>	NUMBER <b>19-BD-001H</b>
DATE <b>FEBRUARY, 2019</b>	MODEL(S) <b>GENESIS (DH)</b>

**SUBJECT:** GENESIS (DH) PANORAMIC SUNROOF NOISE REPAIR

**Description:** This bulletin provides the procedure to repair the panoramic sunroof creaking noise originating from the panoramic moving glass assembly.

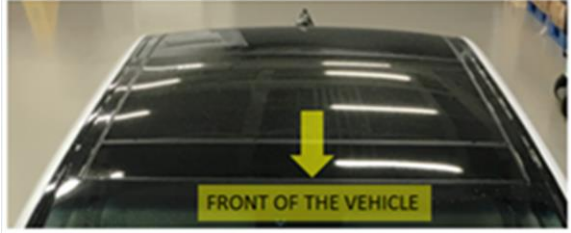
<p>1.</p>	<p><b>Condition:</b> Noise from panoramic sunroof area while driving. (“ticking” or “popping” noise)</p>

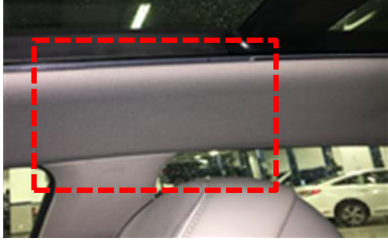
<p>2.</p>	<p><b>Location:</b> Noise can be heard at the center or rear of the panoramic sunroof glass.</p>

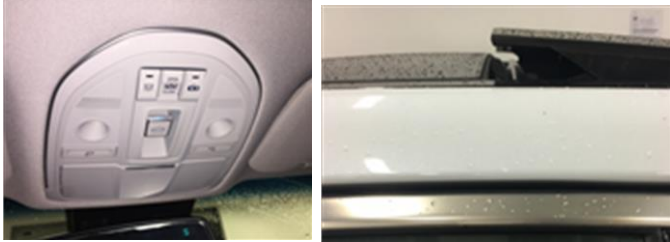
<p>3.</p>	<p><b>Confirmation:</b> Noise can be confirmed by tilting the sunroof glass up while driving. -&gt;If noise does not occur when moving glass is tilted up, the TSB does not apply.</p>

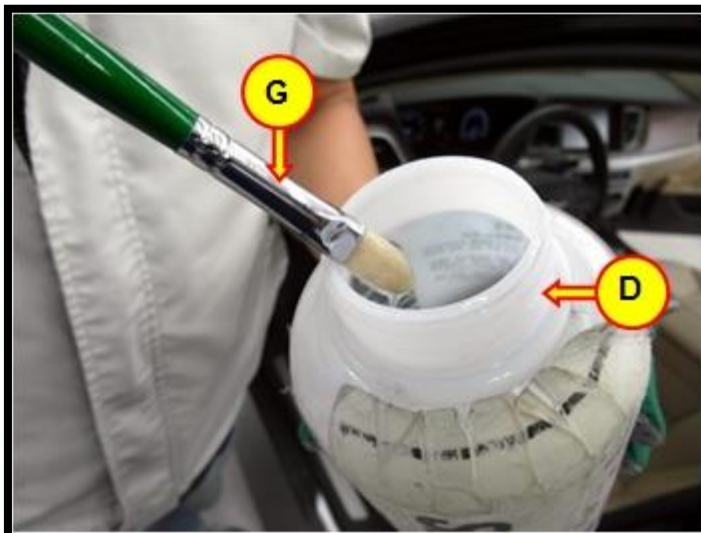
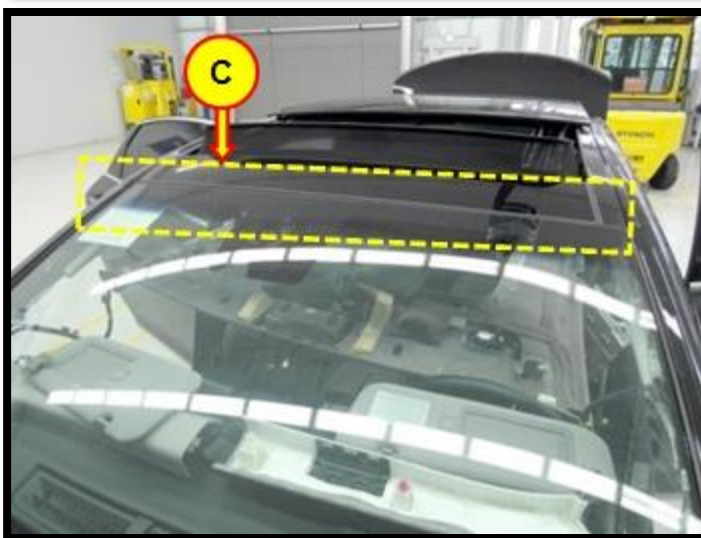
2. Apply the silicone oil (D) using a brush (G) to the front sunroof glass molding (C).

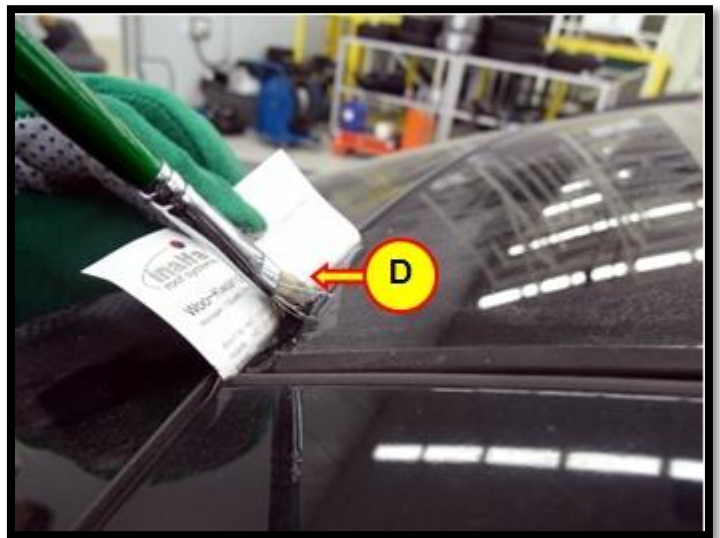
5. Apply the silicone oil (D) to the rear moving glass side similar to the front side procedure.

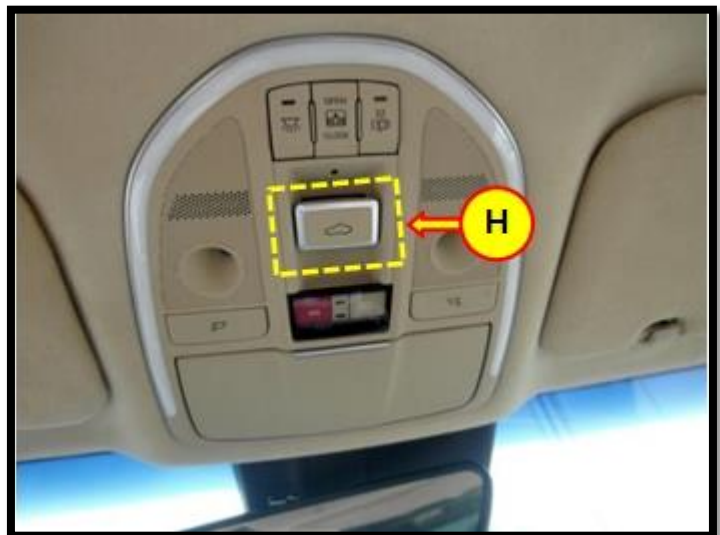
6. Push the sunroof switch (H) and open the panorama sunroof.

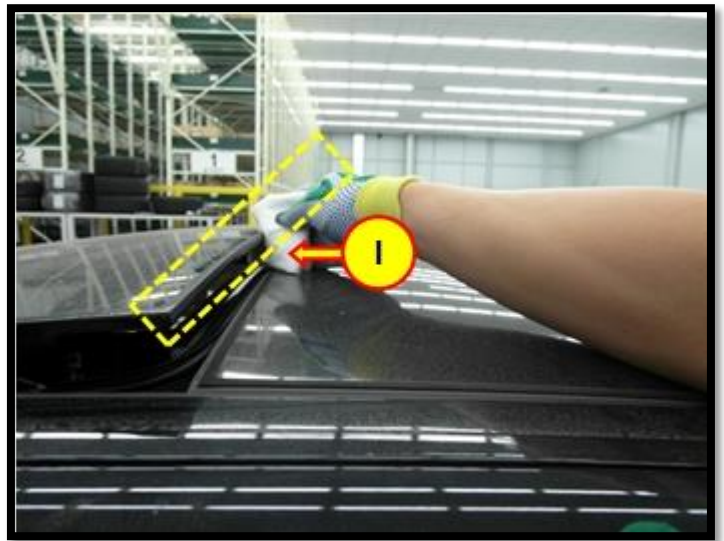
11. Clean the moving glass (I) side after tilting the front glass back side.

Wipe using wet towel and then use the dry towel.

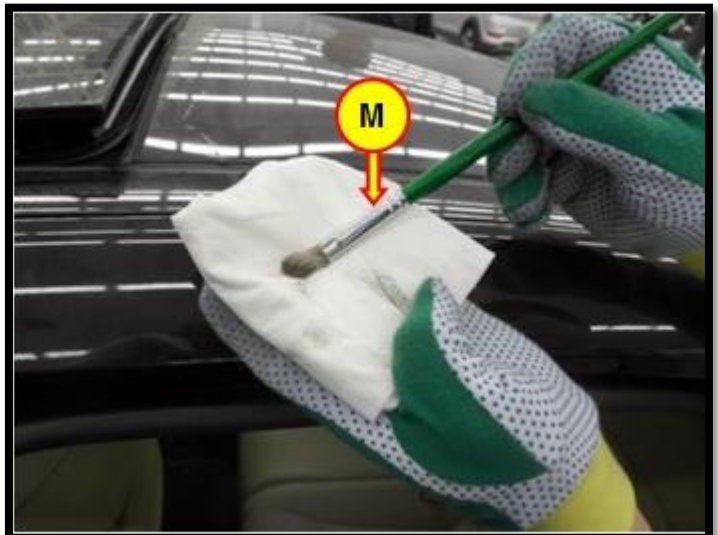
17. Prepare a clean brush (M).

**NOTE:**  
If the brush is contaminated, wipe it using a clean towel.

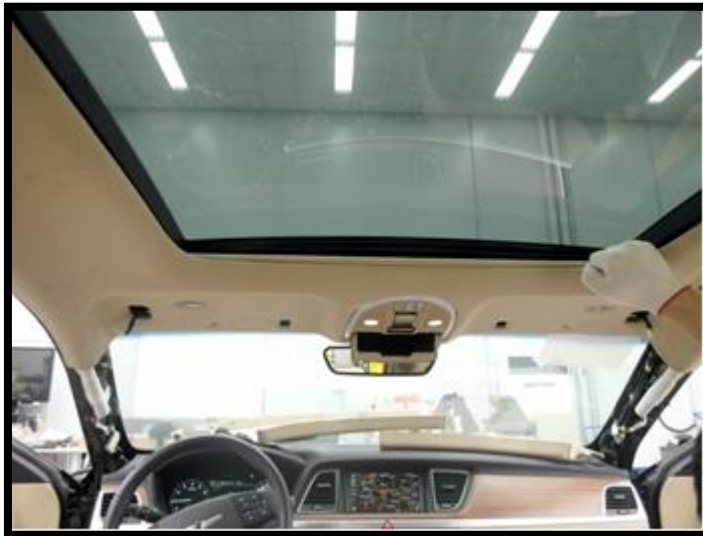
2. Check the position of LH/RH sunroof front mounting side (S).

Check the tightening torque of bolts (S).

5.5 ~ 6.5 Nm (0.5 ~0.6 kgf.m, 4.0 ~ 4.7 lb-ft)

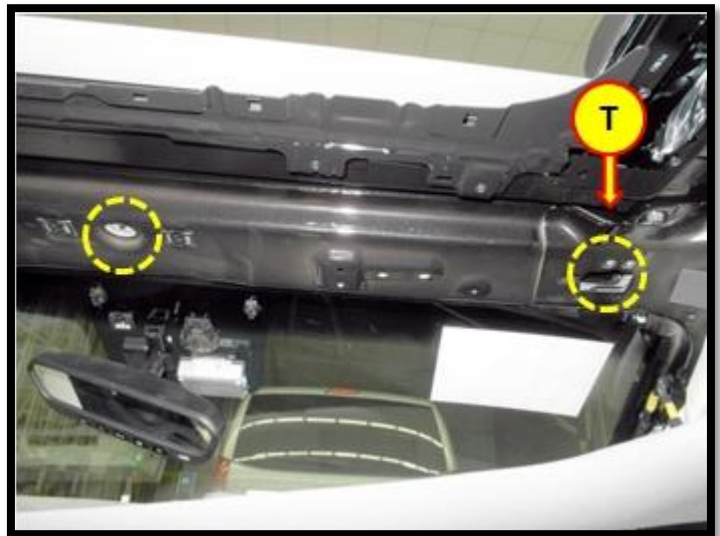
3. Loosen the front sunroof mounting nuts (T).

Front mounting nut : Total 3 EA (LH/RH, Center)

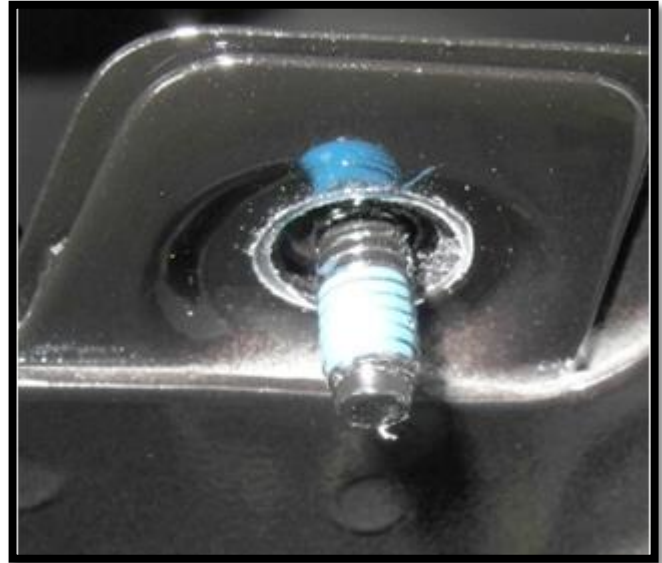
4. Apply the Loctite to the front sunroof mounting bolts (U).

Apply the Loctite to the 3 bolts (LH/RH, Center).

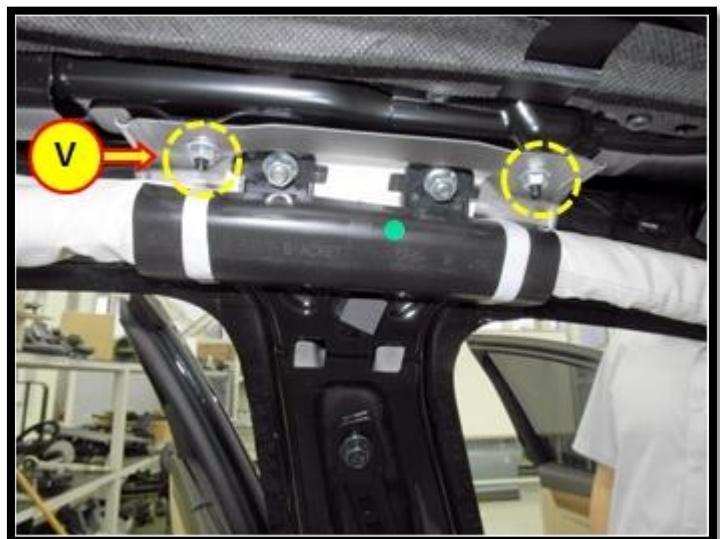
6. Remove the mounting nuts (V) of 'B' pillar side LH/RH bracket.

Apply Loctite to the mounting bolts and retighten mounting nuts to specification.

7.8 ~11.8 Nm (0.7 ~ 1.2 kgf.m, 5.7 ~ 8.7 lb-ft)

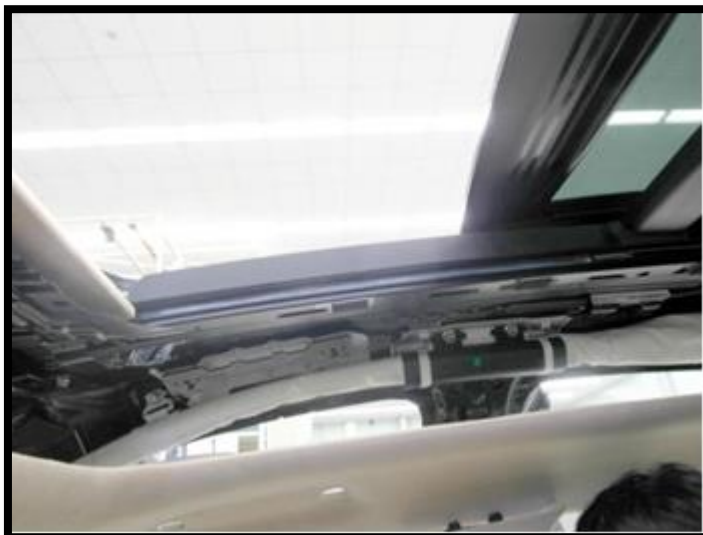
8. Open sunroof completely.

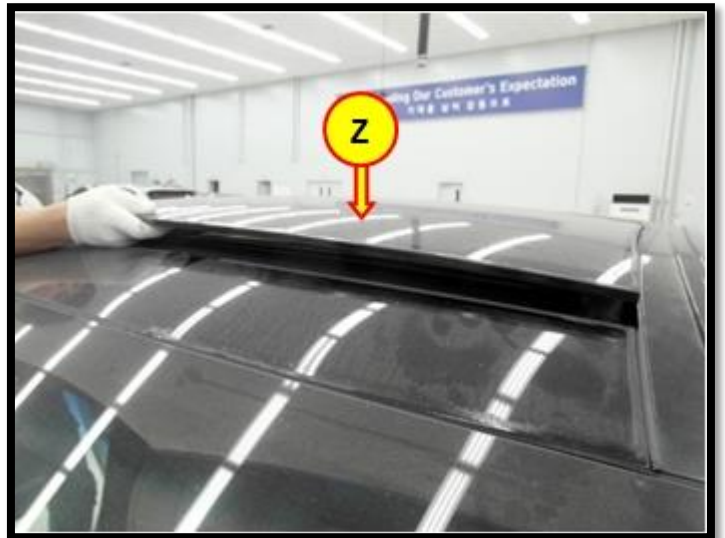
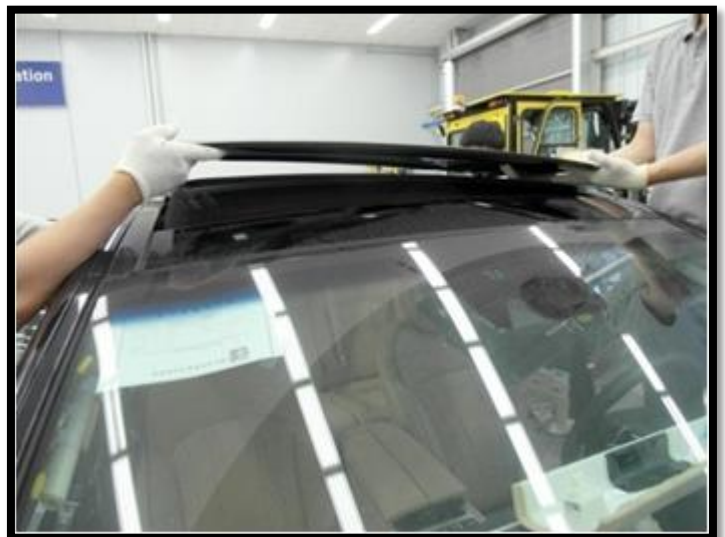
11. Remove the moving glass (Z).

When removing/installing the moving glass, be careful not to damage or scratch it.

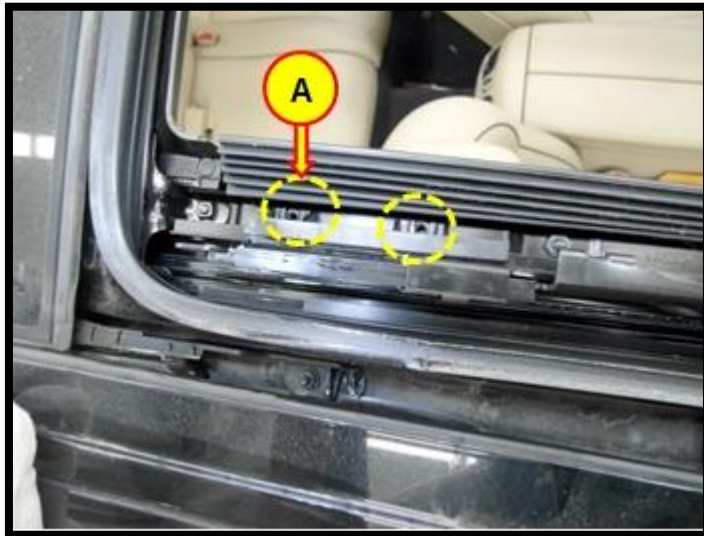
12. Remove the rear locator mounting bolts (A).

**4.5 ~ 5.5 Nm (0.4 ~ 0.5 kgf.m, 3.3 ~ 4.0 lb-ft)**

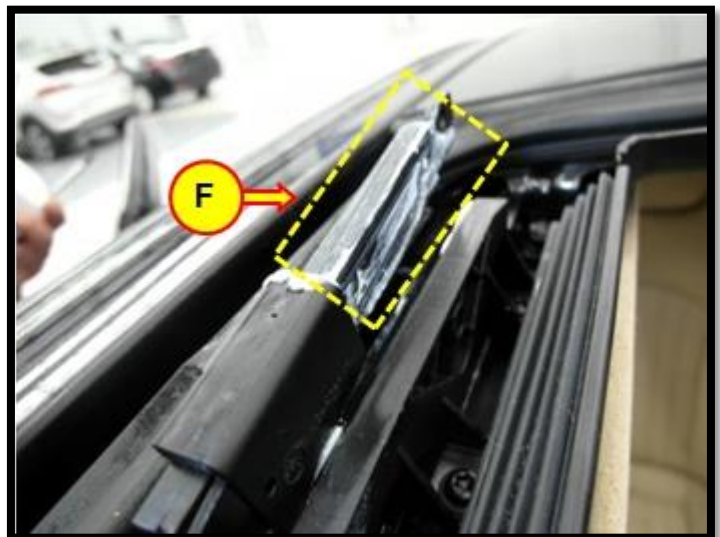
19. Apply grease to the 4 surfaces (F) of curve on panel.

**NOTE:**  
Complete procedure on both LH/RH sides.
