# Service Bulletin

Bulletin No.: 12-06-01-003C

**Subject:** Information for Repairing Engine Front Cover Oil Leak, Sealing Surface Preparation and Applying RTV Sealant

**Models:** 2006-2019 GM Passenger Cars and Trucks (Including Export Vehicles) Equipped with V6 Engine – RPO LAU, LF1, LFW, LFX, LFY, LLT, LP1, LY7, LF3 or LF4

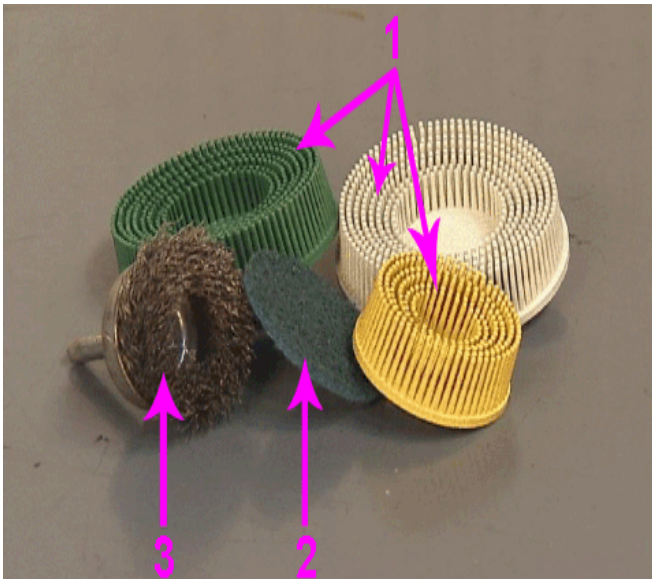
2833722

**Notice:** DO NOT use bristle discs (1), abrasive pads (2), wire wheels (3) or surface conditioning discs to clean the sealing surfaces of engine components.

Abrasive pads and bristle discs are embedded with abrasive material. The bristle discs wear down as they clean, continually exposing fresh abrasive to the surface of the component. These types of devices should not be used because they produce

a very fine grit that the oil filter is unable to remove from the oil. **THIS GRIT IS ABRASIVE AND IS KNOWN TO CAUSE INTERNAL ENGINE DAMAGE.**

- Abrasive pads, wire wheels and bristle discs can remove enough metal to affect the engine front cover, cylinder head, engine block, oil pan rail, and intake manifold runner surface flatness, which can then result in engine coolant leaks, engine oil leaks and air leaks. It takes about 15 seconds to remove 0.203mm (0.008in) of metal with an abrasive pad.

General Motors strongly recommends using a plastic razor blade, plastic gasket scraper, a wood scraper or a non-metallic scraper to remove all sealer/gasket material on the surface of engine components that are to be reused. Do not use any other method or technique to remove the sealant or the gasket material from a part.

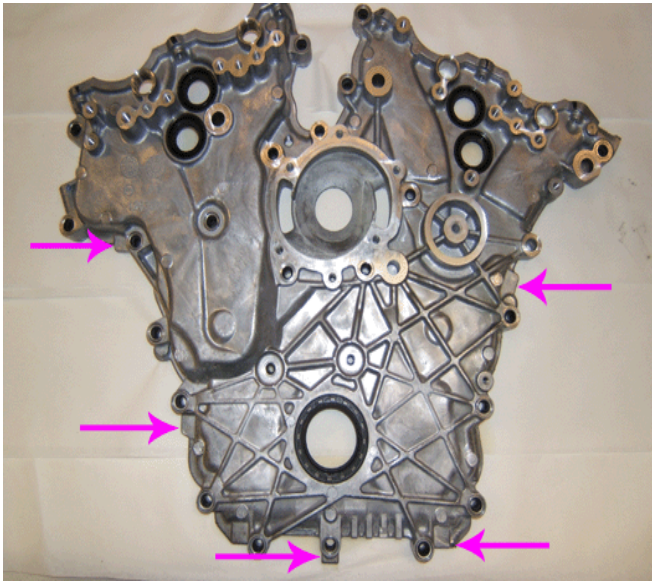
2834479

- Use the incorporated pry points to separate the engine front cover from the engine block.
- The pry points are positioned so that other vital engine components are not damaged when the pry points are used.
- Do not try to separate RTV sealed components by prying against other engine components.

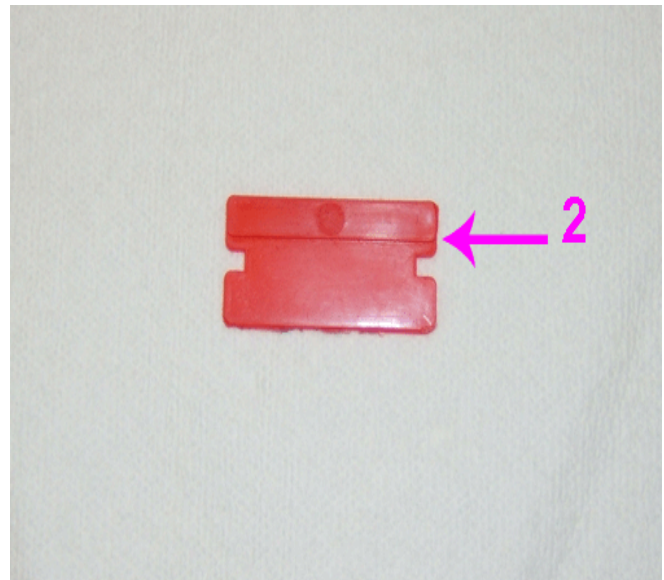
2833177

- Use a plastic razor blade (1), that mounts in a scraper device or a hand held plastic razor blade (2), to remove old RTV sealant from a sealing surface. Use a new blade for each corresponding engine component surface. Hold the blade as parallel to the flat surface as possible.

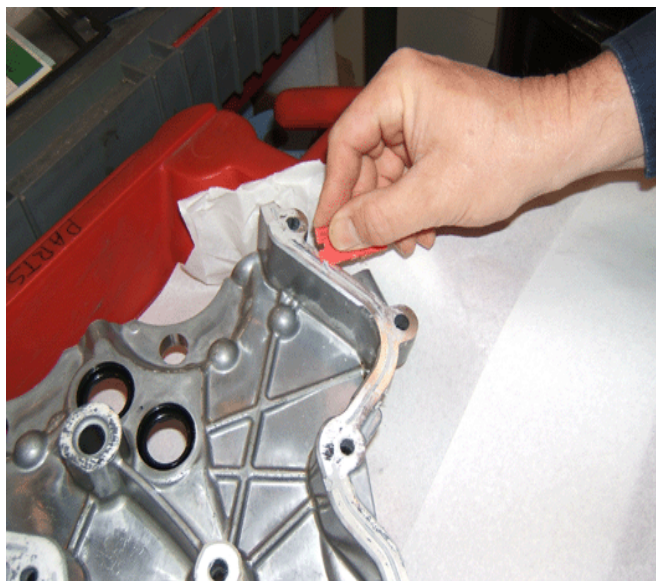
2834507

- Position and work the blade back and forth in the grooved areas of the component to loosen and remove the old RTV.

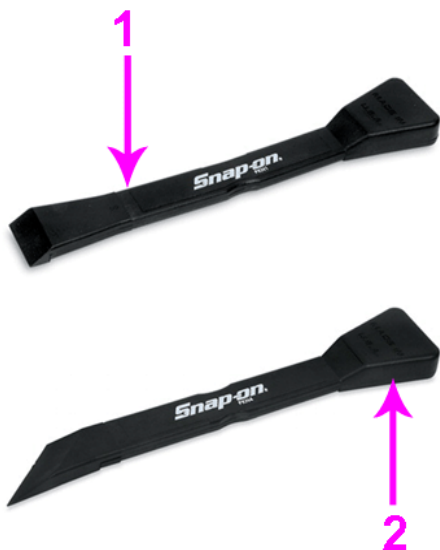
2832527

- When using a plastic gasket scraper with a straight blade (1) to remove old RTV sealant from a sealing surface, hold the scraper as parallel to the flat surface as possible.
- Use a plastic gasket scraper with an angle blade (2) and work the blade back and forth in the grooved areas of the component to loosen and remove the old RTV.
- Clean the engine front cover in solvent.
- Dry the engine front cover with compressed air.

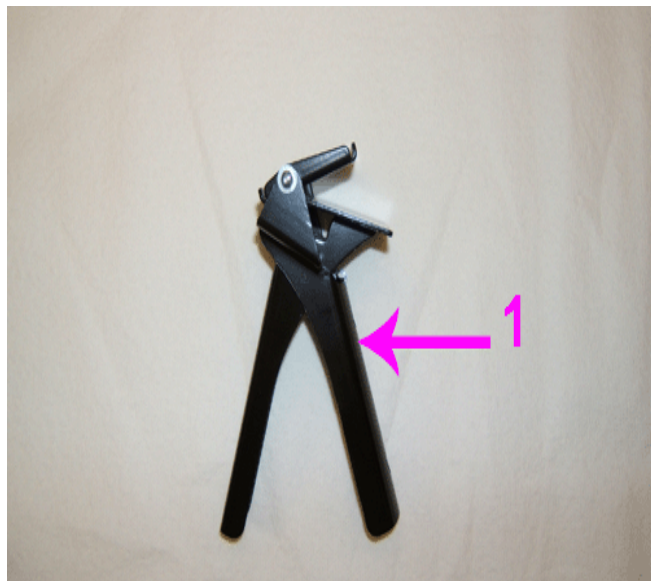
2833110

- Use a Tube Grip® dispensing device (1) or an equivalent to apply the new RTV sealant for the following reasons:
  - A precise application of the RTV sealant bead to the component, in the specified amount.
  - The dispensing device will squeeze 35 % more material out of the tube, reducing waste.
  - Using the device will eliminate most cleanup.

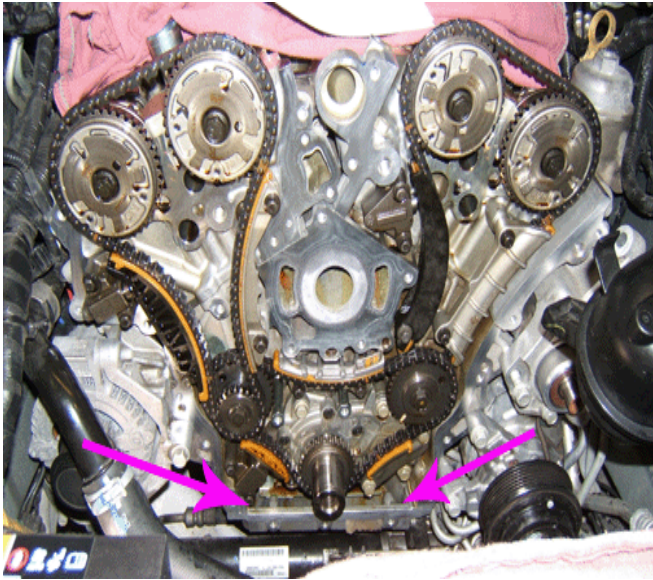
2833996

4. Insert a piece of cardboard at the front of the oil pan in the area shown to prevent any contaminants and debris from falling into the oil pan.

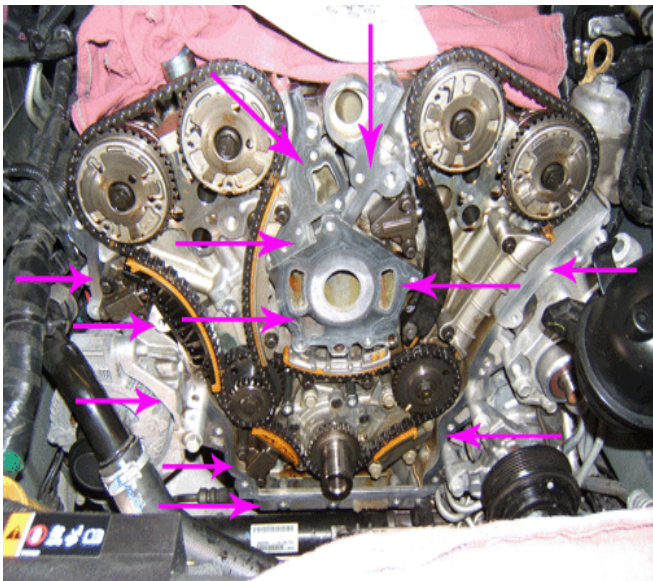
2834020

5. Using the tool or tools as outlined in this bulletin, carefully clean the front cover sealing surfaces on the **engine**.
6. Clean out any debris from the bolt holes for the front cover fasteners in the **engine**.

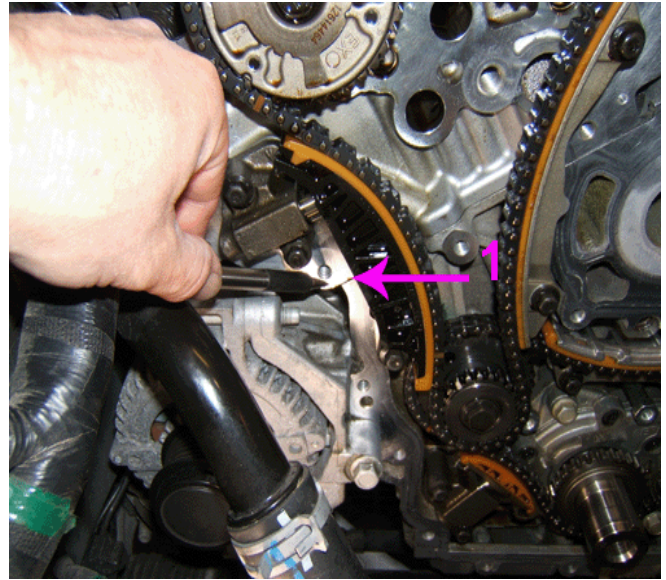
2834570

7. Clean out any debris from the T-joint (1) where the left side of the cylinder head meets the engine block.

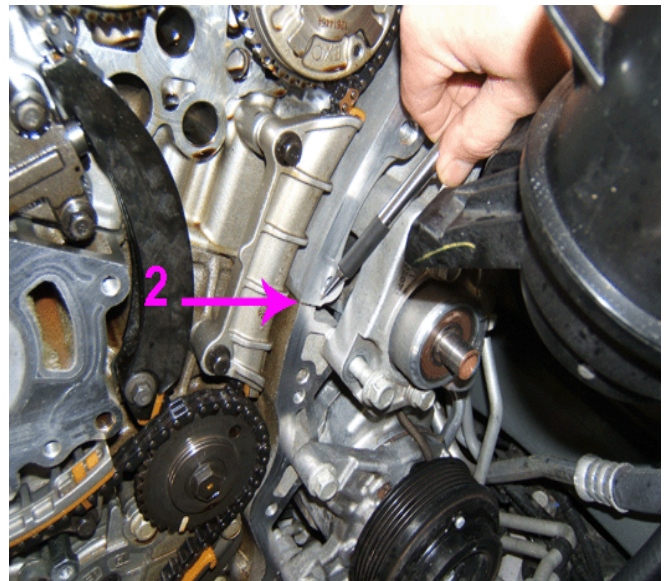
2834612

8. Clean out any debris from the T-joint (2) where the right side of the cylinder head meets the engine block.

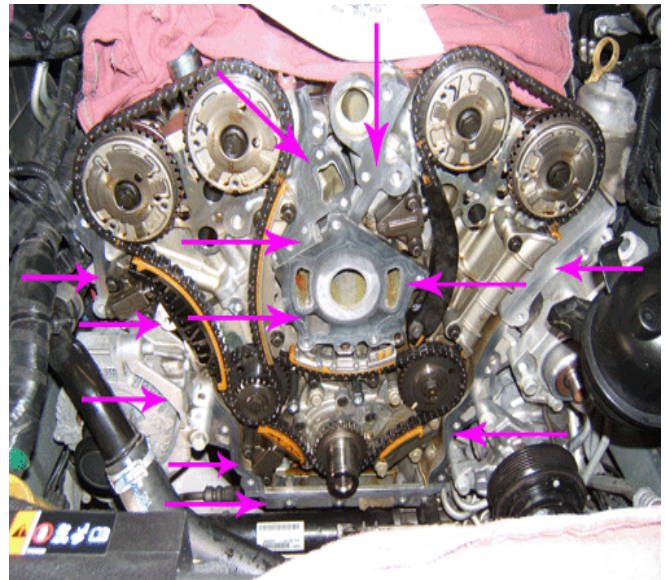
2834020

12. Wipe the front cover mating surfaces on the **engine** with a folded lint free shop cloth. Rotate the shop cloth until there are no more visible signs of contamination on the cloth.
13. Spray GM Low VOC Cleaner, or an equivalent, on the mating surfaces of the front cover and allow it to soak in for 5 minutes.

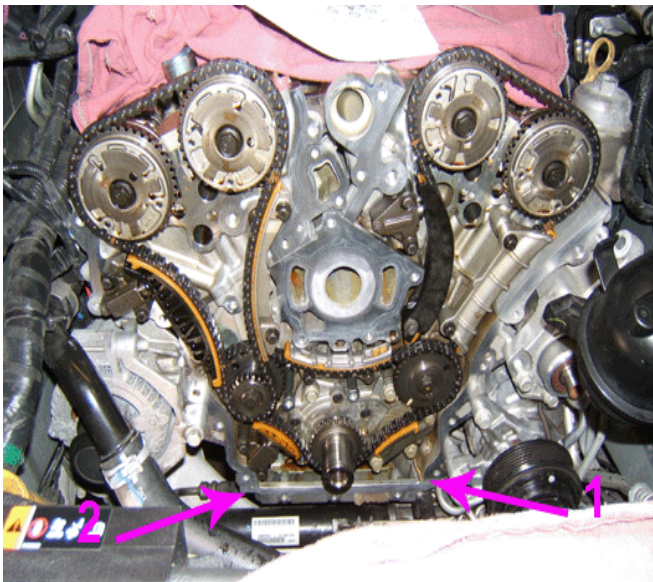
2834622

10. Clean out any debris from the T-joint (1) where the right side of the oil pan meets the engine block.
11. Spray GM Low VOC Cleaner, P/N◆19287401 (in Canada, P/N 88901247) or an equivalent, on the mating surfaces of the **engine** side for the front cover and allow it to soak in for 5 minutes.

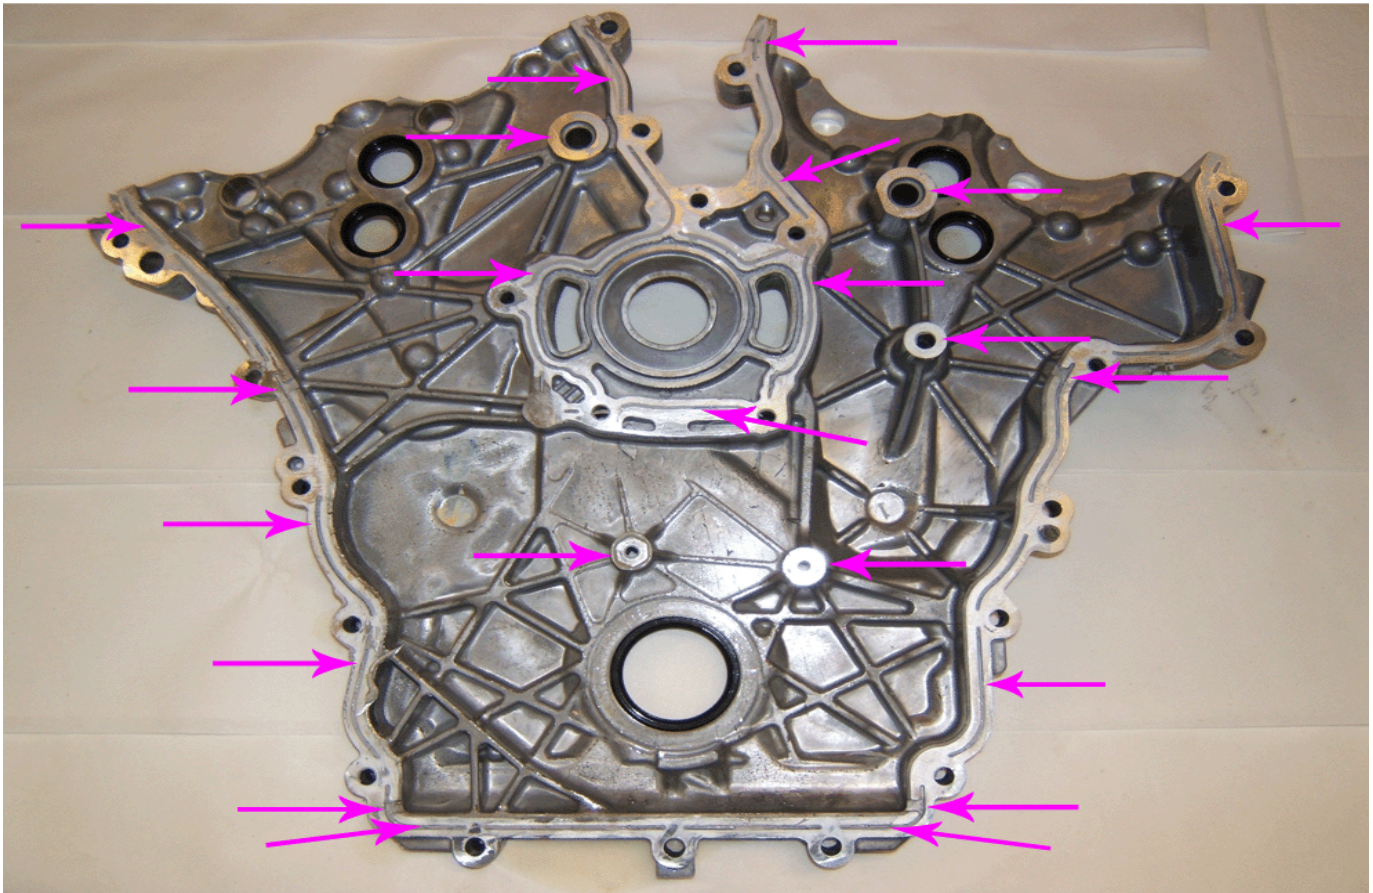
2834958

14. Carefully clean the front cover sealing surfaces and grooves.
  15. Clean out any debris from the bolt holes for the front cover fasteners.
  16. Drain and wipe the remaining oil from the front cover.
  17. Dry the front cover with compressed air.
  18. Inspect the exterior of the front cover for the following conditions:
    - Damage to the camshaft position actuator valve oil seal bores (1).
    - Damage to any bolt holes (2).
    - Damage and/or corrosion to the engine coolant passage (3).
    - Dents or damage to the exterior (4).
    - Damage to the crankshaft front oil seal bore (5).
    - Gouges or damage to the water pump sealing surfaces (6).
    - Damage to the water pump bolt hole threads (7).
- ⇒ If any of the above conditions are found, repair or replace the front cover as necessary.

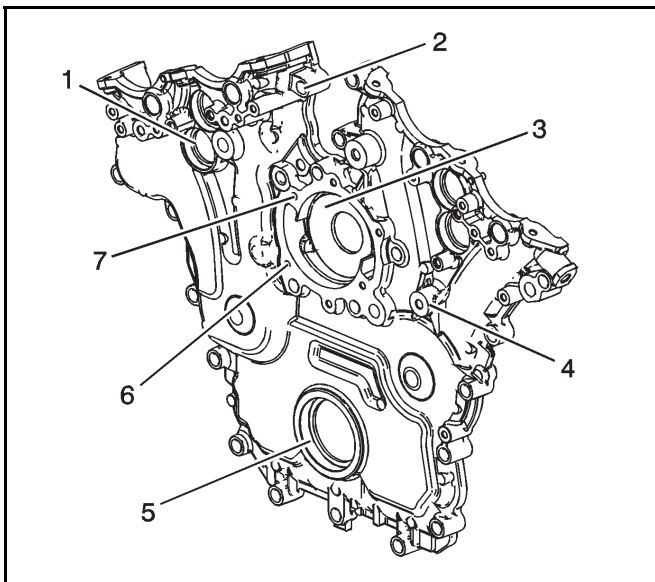
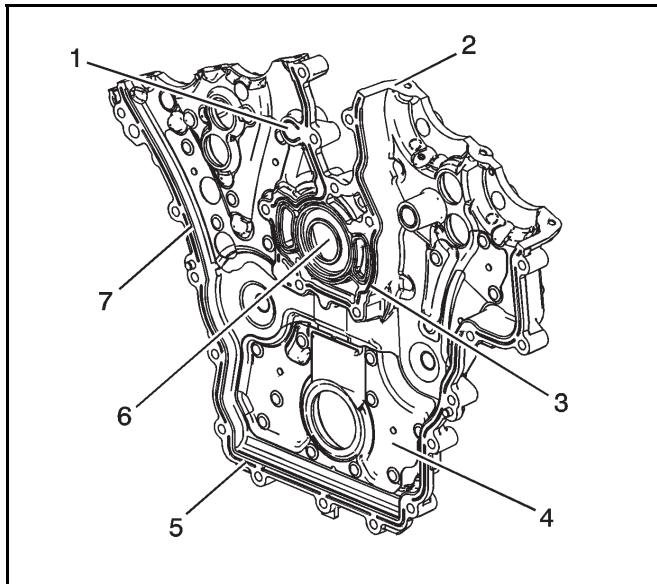
19. Inspect the interior of the front cover for the following conditions:
- Damage to any bolt holes (1).
  - Gouges or damage to the cover sealing surfaces to the engine block (7), oil pan (5) and camshaft covers (2).
  - Gouges or damage to the water pump seal area (3).
  - Loose or damaged deadener plates (4).
  - Damage and/or corrosion to the engine coolant passage (6).
  - Damage to the crankshaft front oil seal bore.
  - Gouges or damage to the O-ring sealing areas.
- ⇒ If any of the above conditions are found, repair or replace the front cover as necessary.

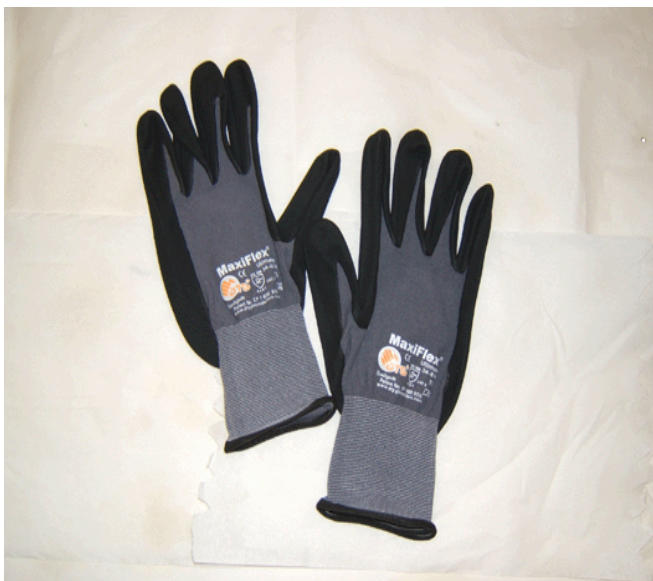
2835832

**Notice:** Wear Gloves. After the final cleaning with GM Low VOC Cleaner and before reassembly, DO NOT touch the cleaned surfaces with your bare hand. The oils from your skin WILL CONTAMINATE the surfaces and prevent proper bonding of the new RTV sealant.

20. Clean the sealing surface prior to reassembly by spraying GM Low VOC Cleaner, on a folded lint free shop cloth. Wipe the mating surfaces and rotate the shop cloth until there are no more visible signs of contamination on the cloth.
21. After the final cleaning of the parts, allow 5 minutes for the components to dry before applying new RTV sealant.
22. Remove the cardboard from the front of the oil pan.

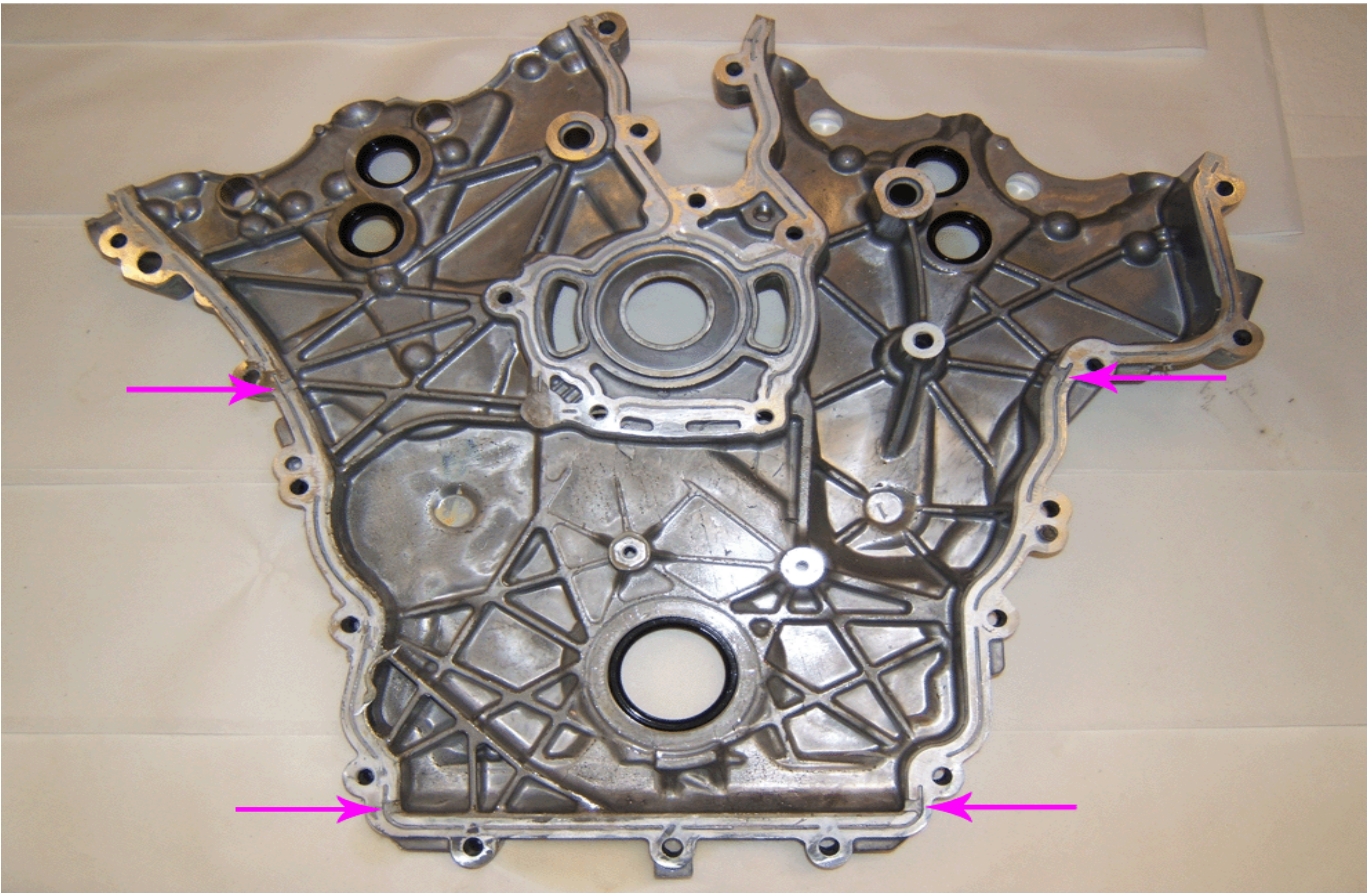
2834933

**Notice:** THIS STEP IS ESSENTIAL.

Oil leaks at the T-joints are one of the most common conditions encountered.

23. Apply a 5 mm bead of RTV sealant to the **T-joints** on the front cover in order to ensure that there is enough sealant to extend into the joint.

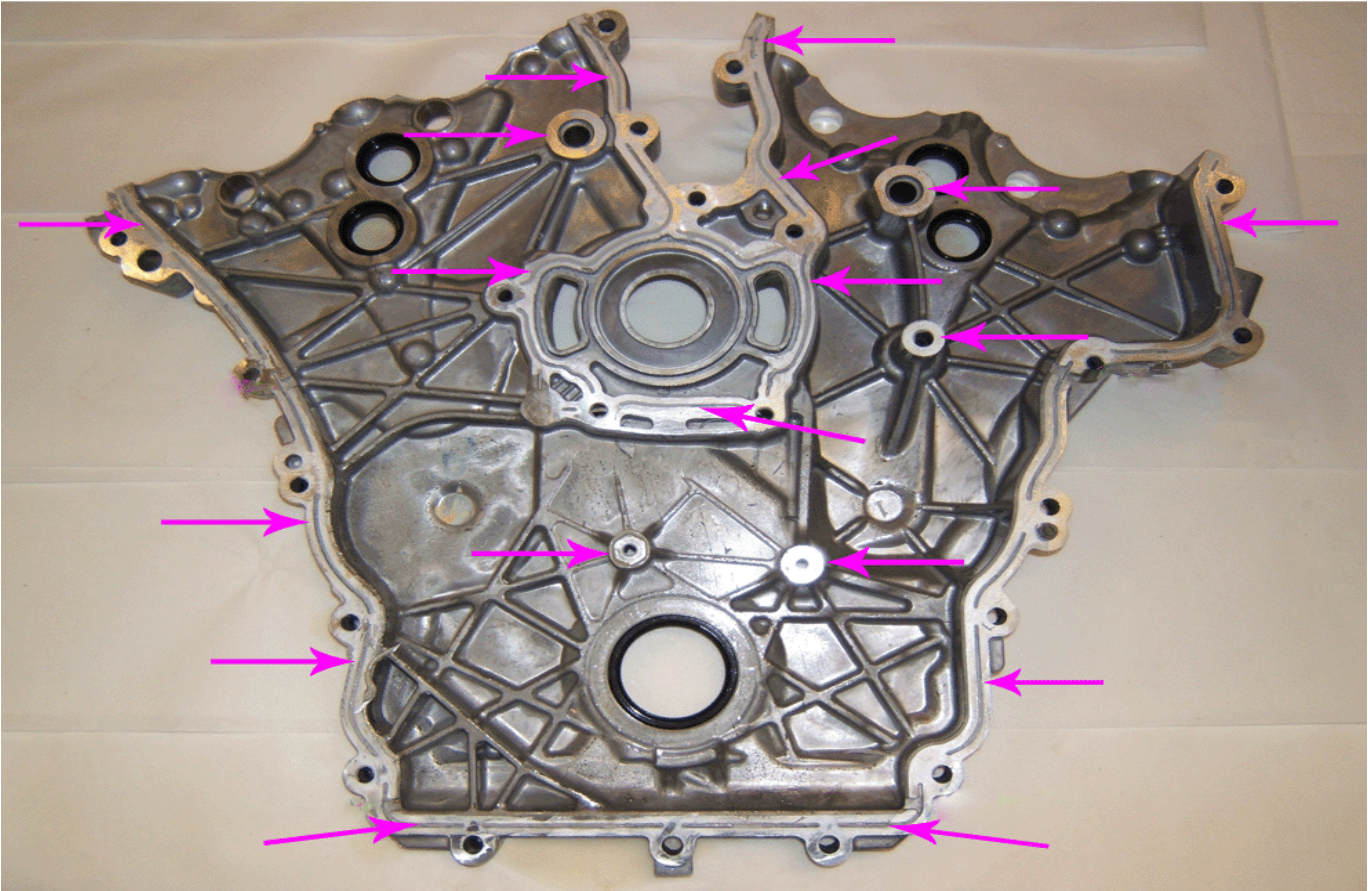
2835399

24. Apply a 3 mm bead of RTV sealant to the remaining front cover sealing surfaces.

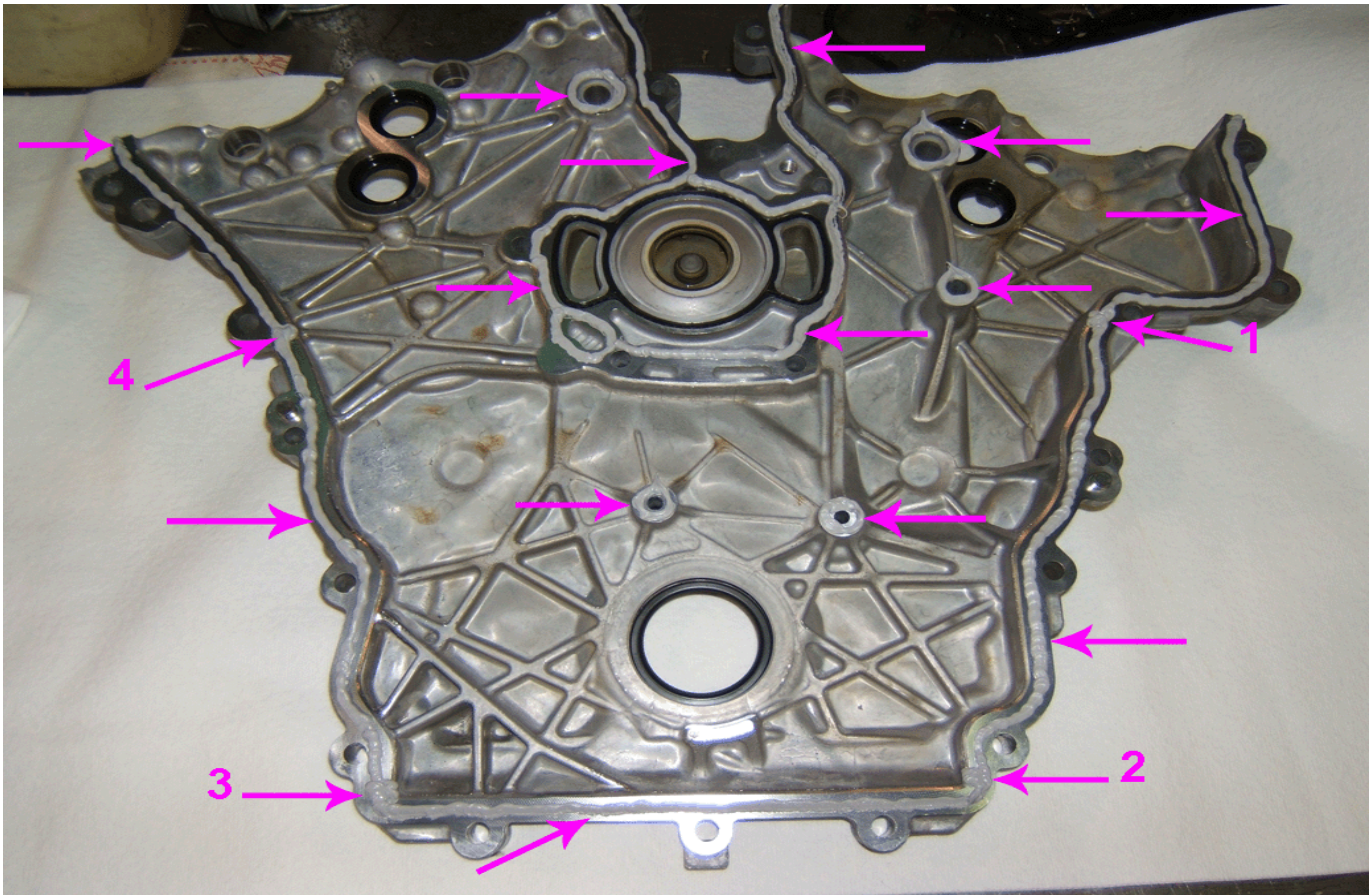
2835122

25. This is a typical view of the proper application of the RTV sealant to the front cover, with a 5 mm bead of RTV sealant to the T-joints (1, 2, 3, 4) and a 3 mm bead of RTV sealant to the rest of the sealing surfaces.

**Notice:** The front cover must be installed BEFORE the RTV sealant is allowed to “skin over” or the sealant will not adhere.
