Belt catch, squeak against upholstery

REF NO: TJ 33616.1.1	ISSUING DEPARTMENT: Technical Service	CAR MARKET: United States and Canada	
PARTNER: 3 US 7510 Volvo Car USA		ISSUE DATE: 2018-08-20	STATUS DATE: 2018-08-23
FUNC GROUP: 8843	FUNC DESC: Catch for safety belt	Page 1 of 5

Title	Front safety belt buckle	Page	1 (3)
Action	Product fix	Operation number:	98711-2

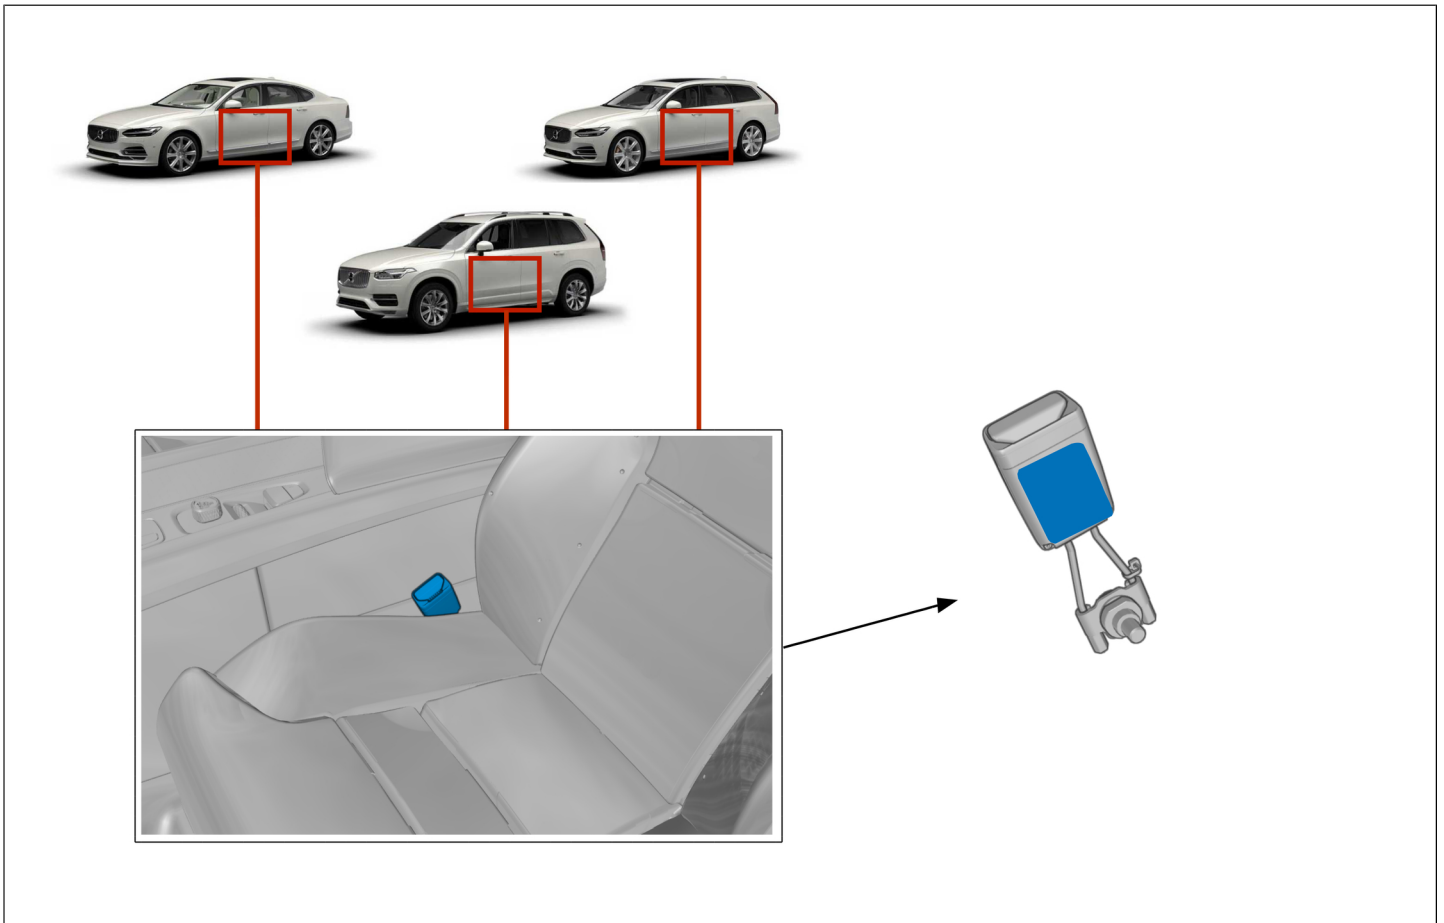
Adjustment

If the front seat belt catch makes noise when moving against the seat upholstery, follow instruction under Service.

On both sides.

Apply anti squeak tape 1161842 according to instruction TJ 33616_en-US.pdf.

Use: Anti-squeak tape , 1161842

Cut

Round the corners.

Install the marked component.
