## TECHNICAL SERVICE BULLETIN

### Various Drivability Concerns And/Or Illuminated Malfunction Indicator Lamp (MIL) - Built On Or Before 24-Jul-2018

**19-2091**  
22 March  
2019

<b>Ford</b> 2015-2018 Transit
----------------------------------

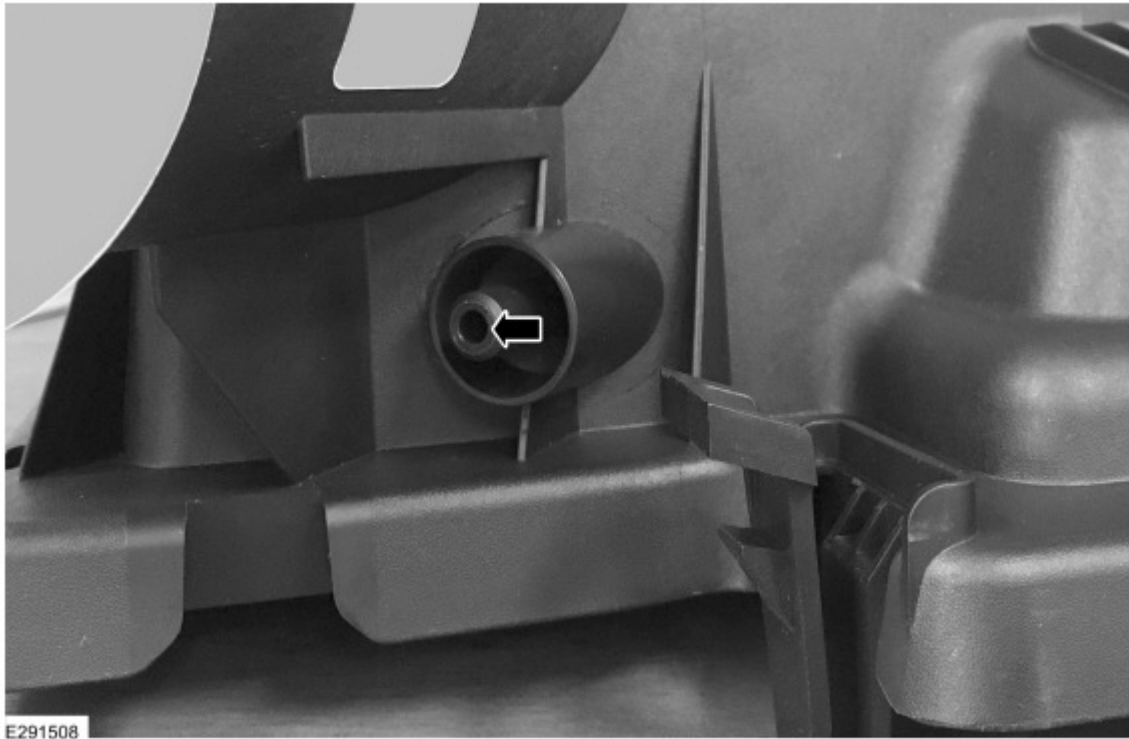
Figure 1

1. Check the vehicle build date and repair history. Was the vehicle previously repaired under FSA 15B39, TSB 15-0118, TSB 17-0014 or built on 30-Mar-2015 and through 24-Jul-2018?
  - (1). Yes - proceed to Step 2.
  - (2). No - proceed to Step 5.
2. Is the vehicle a 2015 equipped with a 3.5L EcoBoost engine?
  - (1). Yes - this article does not apply. Refer to the Powertrain Control/Emissions Diagnosis (PC/ED) Manual.
  - (2). No - proceed to Step 3.
3. Is the vehicle a 2015 equipped with a 3.7L engine?
  - (1). Yes - fill the vacuum port below the outlet on the new air cleaner cover with Motorcraft® Silicone Gasket And Sealant or equivalent. (Figure 1) Proceed to Step 4.
  - (2). No - proceed to Step 4.

- 15.** Secure the wire harness to the fastener.
- 16.** Is the vehicle a 2015 equipped with a 3.7L engine?
- (1). Yes - fill the vacuum port below the outlet on the new air cleaner cover with Motorcraft® Silicone Gasket And Sealant or equivalent. (Figure 1) Proceed to Step 17.

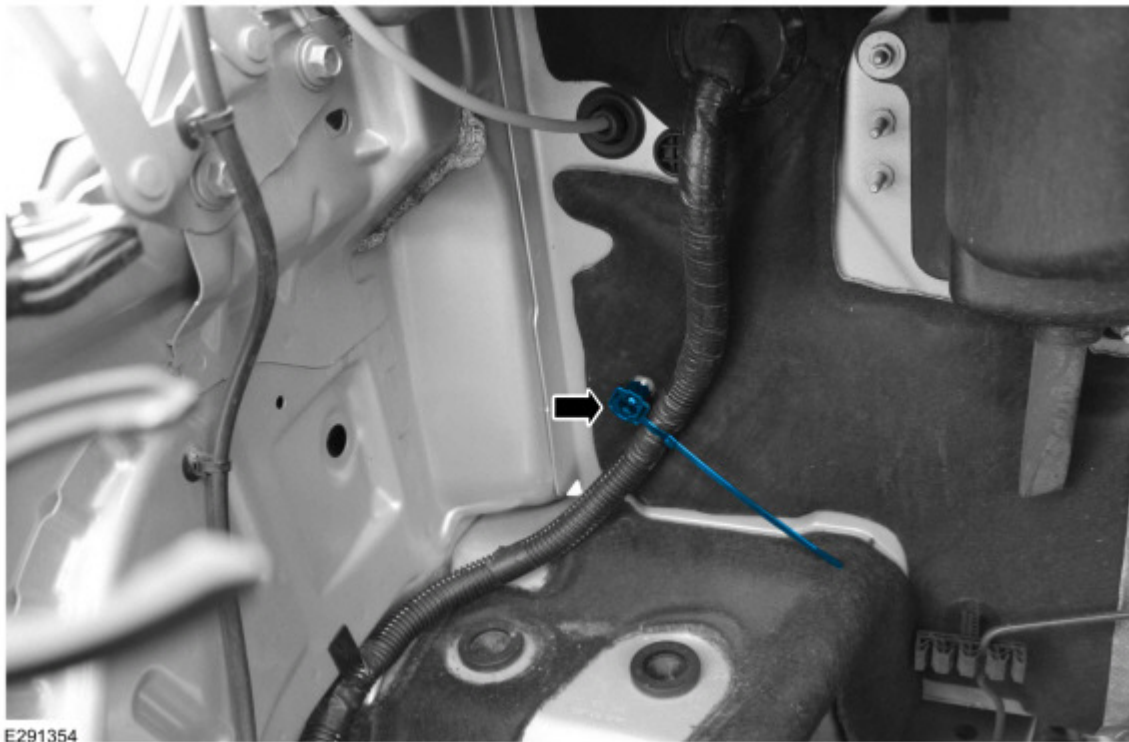
Figure 2

4. Replace the engine air cleaner cover. Refer to Workshop Manual (WSM) Section 303-12. While the air filter cover is off, remove the existing top mount wire harness retainer and replace with the side mount wire harness retainer (Figure 2). Repair is complete.

- (1). Yes - reinstall air cleaner cover. Refer to WSM Section 303-12. Proceed to Step 18.
  - (2). No - remove the existing top mount wire harness retainer and replace with the side mount wire harness retainer. (Figure 2)

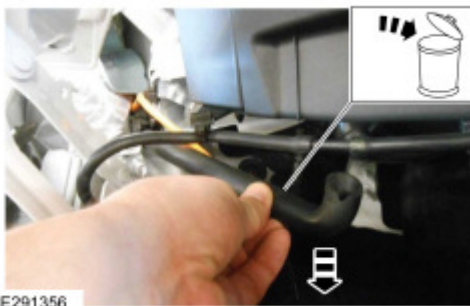
Figure 4

**9.** Remove and discard the drain hose from the right side of the cowl panel grille. (Figure 4)

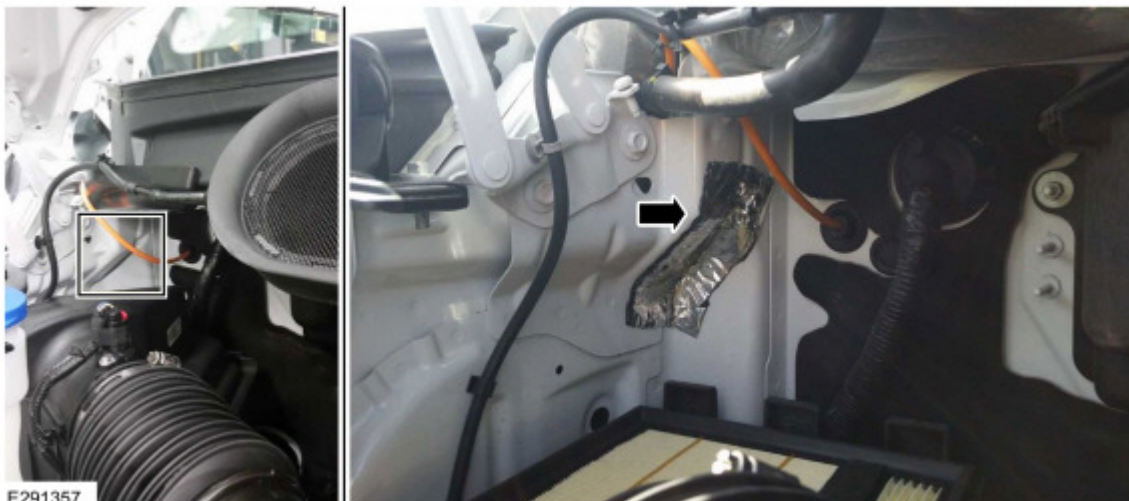
Figure 5

**11.** Clean the body joint between the right inner fender and dash panel with a Motorcraft® Metal Surface Prep Wipe or equivalent. (Figure 5)

**12.** Cut the mastic patch to 8 cm x 13 cm (3 in x 5 in) and apply the patch to the body joint. (Figure 5)

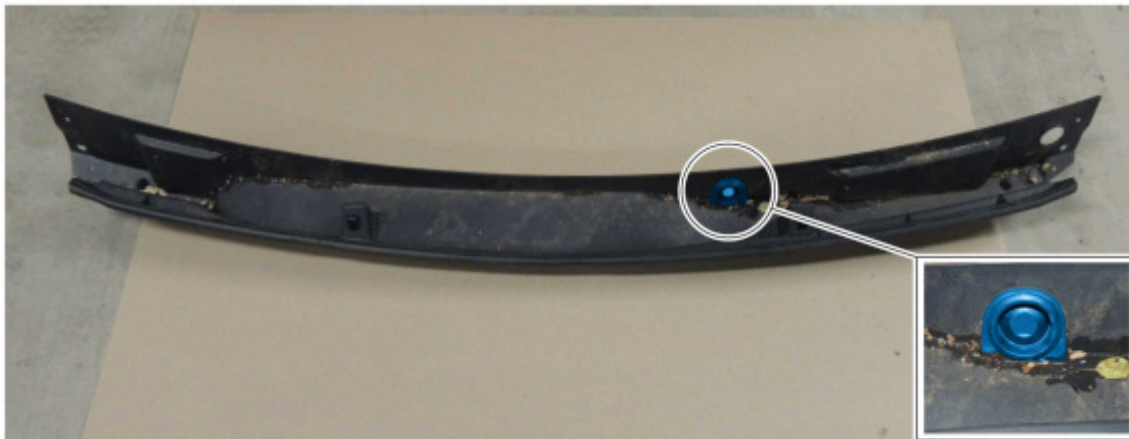
Figure 6

- (2). No - proceed to Step 17.
- 17.** Install a new engine air cleaner cover. Refer to WSM Section 303-12.
- 18.** Is the vehicle a low roof model?
- (1). Yes - replace the right side windshield wiper arm grommet on the cowl panel grille. Proceed to Step 19. (Figure 6)

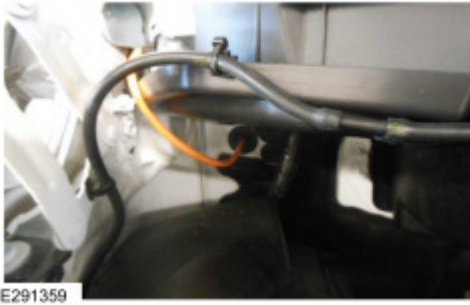
Figure 7

- 19.** Reinstall the cowl panel grille. Refer to WSM Section 501-02.
- 20.** Install a new deflector on the right side of the vehicle. (Figure 7)
- (1). Install the outboard end of the deflector into the sheet metal tab behind the hood hinge.
  - (2). Snap the deflector onto the cowl panel grille.

**21.** Route the orange antenna wire in front of the deflector and route the washer hose under the inboard end of the deflector. Attach the washer hose clip to the front edge of the deflector. (Figure 7)
