Technical Bulletin

| Model(s) | Year | Eng. Code | Trans. Code | VIN Range From | VIN Range To |
|---|---|---|---|---|---|
| Passat | 2011-2012 | All | All | A3_BC000001 | A3_CC025567 |

40 13 03 October 1, 2013 **2028353** Supersedes V401302 dated June 25, 2013 to include replacement part numbers necessary to complete the repair.

Front Suspension Creaking Noise

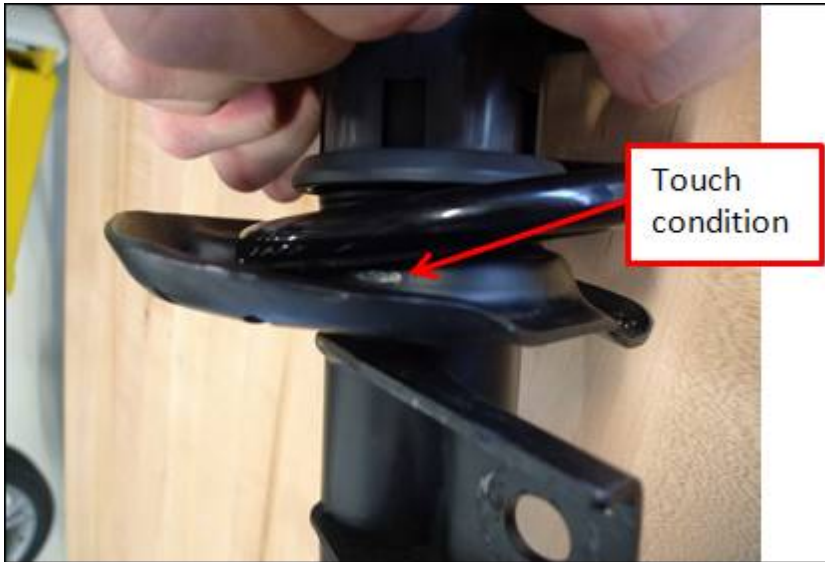
Figure 1

Front suspension creaking noise during suspension cycles (going over speed bumps or entering on an inclined surface).

Coil Spring is not formed correctly and rubs against the perch of the strut.

- Verify if a car with the creaking noise has the contact mark (on one side or on both sides) as shown in figure 1.

- Remove affected suspension strut and disassemble, see Repair Group 40 in ElsaWeb.
- Apply touch up paint to the contact area of the strut perch and allow required drying time.

Use Rustoleum Cold Galvanizing Compound # V2185838 (or similar obtained locally), 2 coats.
Cover with Rustoleum Flat Black Spray Paint # V2178838 (or similar obtained locally), 1 coat.

- Install new spring on suspension strut (**per vehicle PR-codes**).
- Install suspension strut, see Repair Group 40 in ElsaWeb.
