Noise from deco door panel when playing music

REF NO: TJ 33228.1.0	ISSUING DEPARTMENT: Technical Service	CAR MARKET: United States and Canada	
PARTNER: 3 US 7510 Volvo Car USA		ISSUE DATE: 2018-03-08	STATUS DATE: 2018-03-13
FUNC GROUP: 8511	FUNC DESC: Door upholstery	Page 1 of 11

Title	Decor panel, door	Page	1 (9)
Action	Product fix	Operation number:	98703-2

Model year	Model
2018	XC60 (18-)

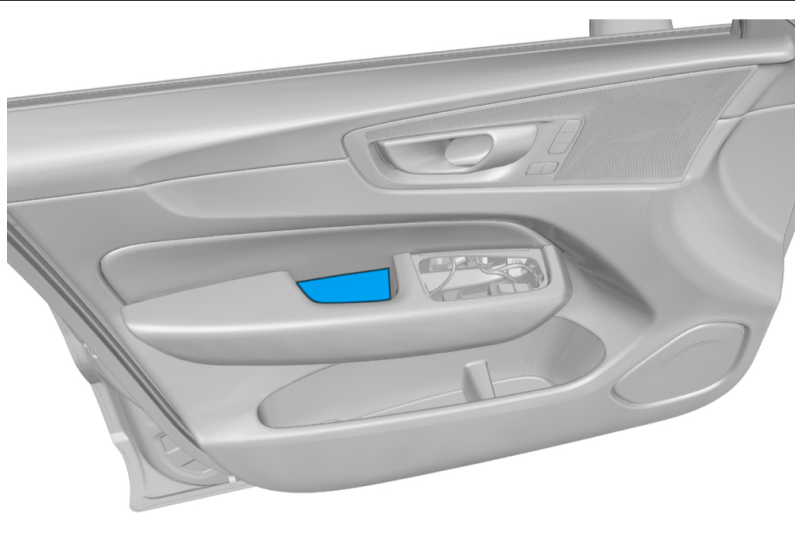
Remove the marked part.
Interior trim remover

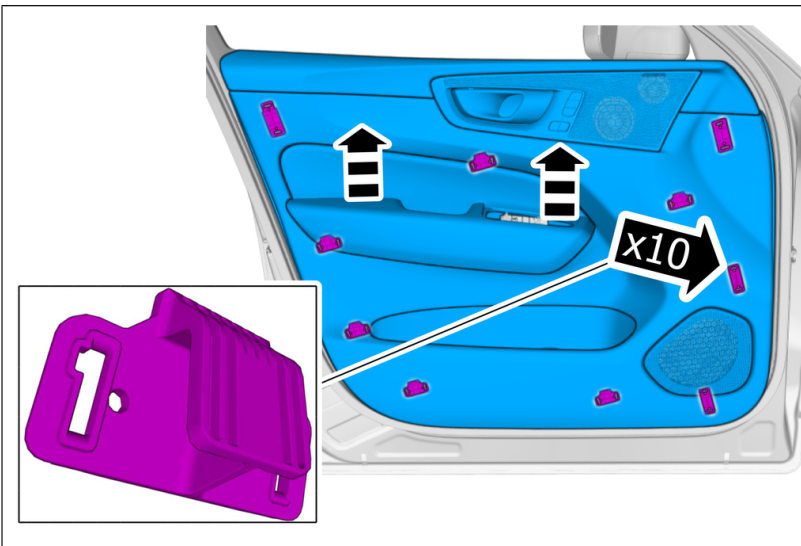
Remove the marked part.

Disconnect the connector.
