## Ball joint check on front axle

Topic number	LI33.00-N-066643
Version	1
Design group	33.00 General
Date	06-30-2017
Validity	Model 901.###, 902.###, 903.###, 904.###, 905.###
Reason for change	Distribution revised
Reason for block

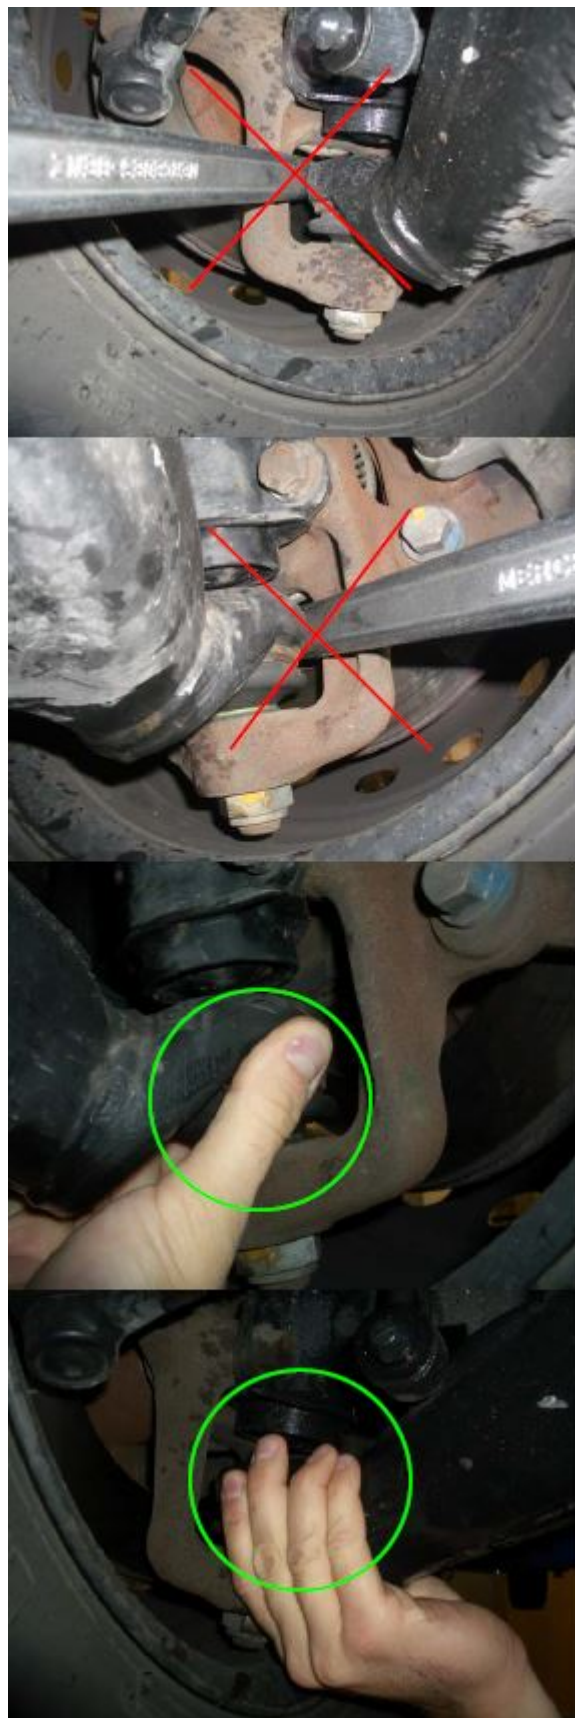
01.jpg:

Attachments	
File	Description
01.jpg	Supporting ball joint check

- Raise the vehicle at the front axle at the center of the crossmember at the level of the leaf spring using a floor jack until the wheels are no longer in contact with the ground.
- When raising the vehicle, monitor whether there is lateral misalignment (radial play) in the supporting joint.
- Misalignment of more than 3 mm is rated as a serious defect by the technical inspection associations.

Due to the fact that supporting ball joints are frequently replaced unnecessarily, we would once again like to point out that checking the supporting ball joints for axial play is not required and is not possible.

The supporting ball joints of the front axle must be checked for unacceptably high wear and to establish whether the dust boot is seated correctly and is undamaged. The stabilizer bar, shock-absorber struts, springs and their attachments must be checked to establish whether they are the cause of the noise.

- Visual inspection for correct seating and possible damage.
- Squeeze the boot together (using your fingers, not tools) to check the concealed parts and to establish whether moisture has penetrated the joint.
- Damage to the dust boot must be rated as a serious defect (if such damage exists, the supporting joint can be expected to fail soon).

Checking for wear by means of an pry bar or comparable tool is not envisaged by the manufacturer. If this is performed there is a risk of the ball joint bearing shell being damaged due to excessive test forces and / or the rubber boot being damaged as a result of being trapped.
