Sliding door in partition wall cannot be locked in open position

Topic number	LI68.74-N-057463
Version	2
Design group	68.74 Partition wall
Date	06-09-2017
Validity	Model 906.6## with code (D64) Partition wall with sliding door
Reason for change	Remedy completely revised and method revised.
Reason for block

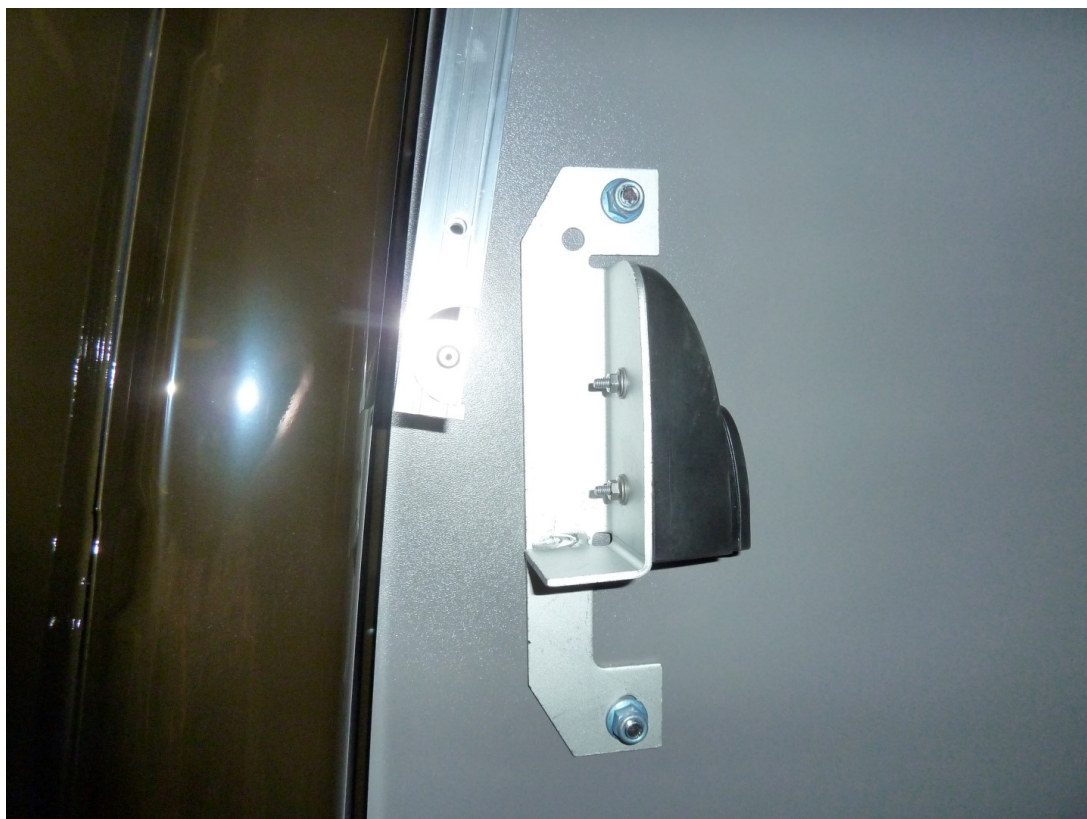
02.JPG:

- 1.3 Remove upper strut in area of roof paneling.
2. Close sliding door in partition wall.
3. Remove left partition wall and replace old door holder with door holder with magnet. Work procedure as described in AR68.74-D-0001H, but reinstall the partition wall at a later stage. The new door holder (see picture: 02.jpg) must be assembled prior to installation. (AR68. 74-D-0001-01H)

6. Remove locking pin (4) of sliding door in partition wall (see picture: 01.jpg).
7. Attach steel plate (see picture: 04.jpg) to sliding door. Depending on the variant of the previously installed locking pin, either the steel plate is bolted on to the existing points (see picture: 02.jpg), or appropriate holes must be drilled for it (in the case of ball studs with central bolt). With the latter variant, the steel plate is then fastened to the sliding door with blind rivet nuts.

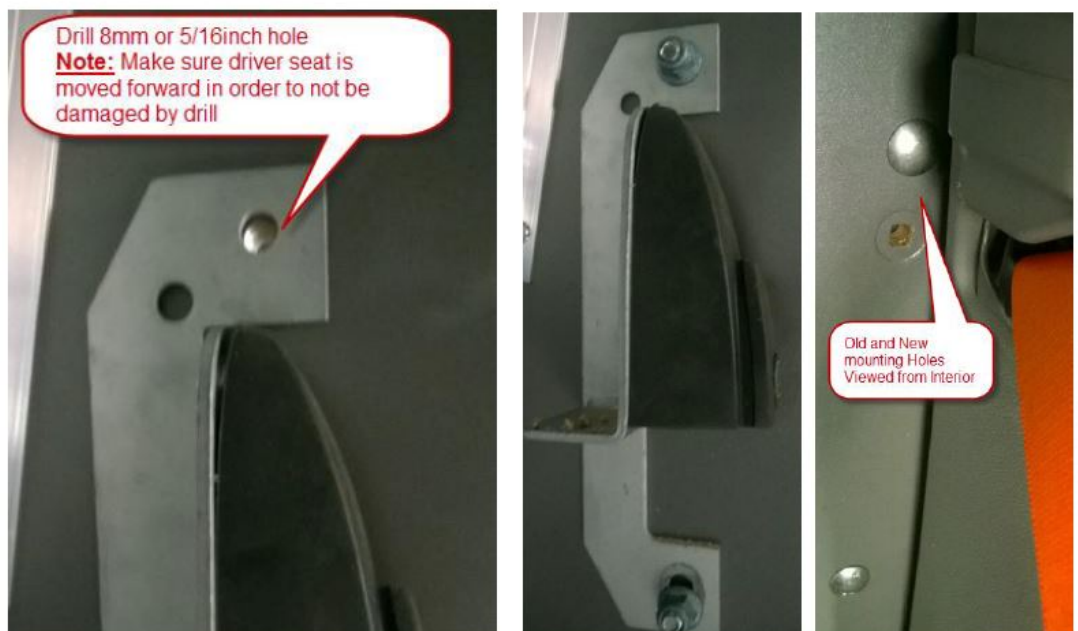
07.JPG:

Drill new hole for Upper mounting hole Reuse old Carriage Bolt and tighten and Reinstall Partition Wall

4. Mount Updated Bracket using only the lower mounting hole (see picture: 05.jpg) and center magnet with door plate. (See picture: 06.jpg).
5. Drill new hole for upper mounting hole (see picture: 07.jpg). Reuse old carriage bolt and tighten then reinstall partition wall.
