## Engine power output is reduced, engine diagnosis indicator lamp lights up, fault codes P15FF00 and P245411

Topic number	LI07.08-N-065219
Version	2
Design group	07.08 Governor
Date	07-20-2017
Validity	MODEL 906 with OM642 (from 906.### N574794) MODEL 906 with OM642 (to 906.### N605428) MODEL 906 with OM642 (from 906.### S874134) MODEL 906 with OM642 (to 906.### S977452)
Reason for change	Added Step 7 and pictures 8 & 9
Reason for block

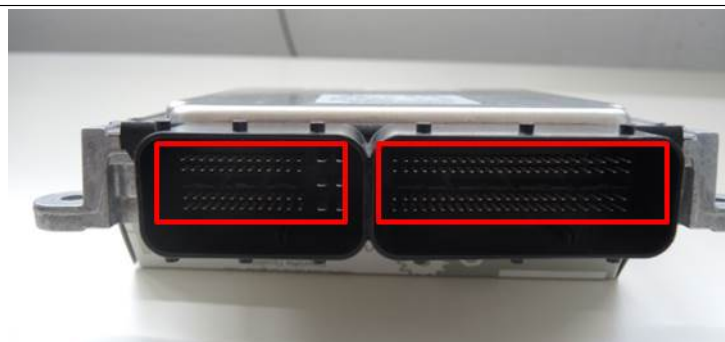
1.jpg:

4.1 A total of 154 contact pins have to be cleaned on the engine control unit (see 1.jpg).

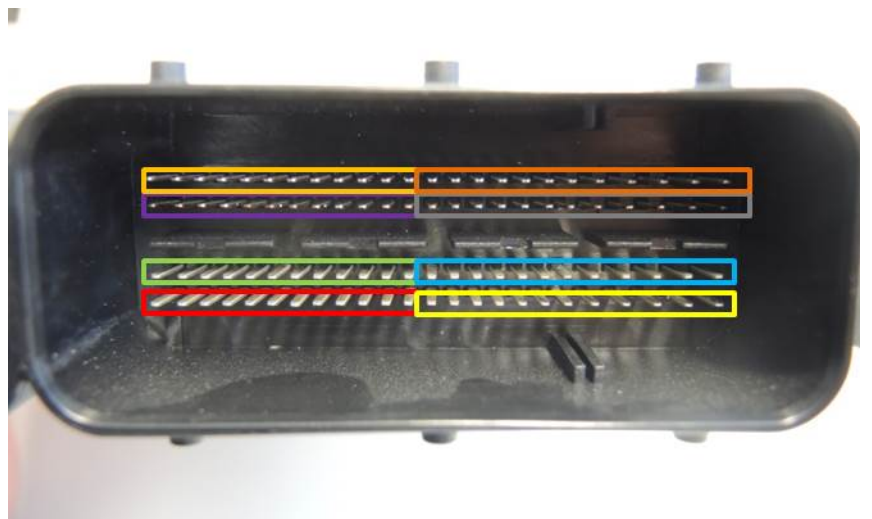
2.jpg:

Important: One cleaning contact is sufficient to clean all the contact pins in a color-marked area (see 2.jpg and 3.jpg).

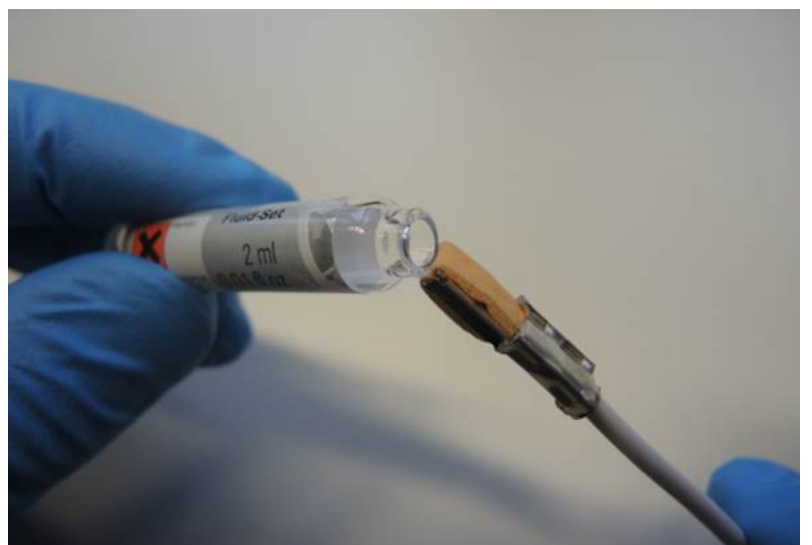
4.jpg:

4.2. Apply cleaning fluid to cleaning contact. Avoid forming droplets! It need only be applied once to clean the specified number of pins per cleaning contact (see 4.jpg).

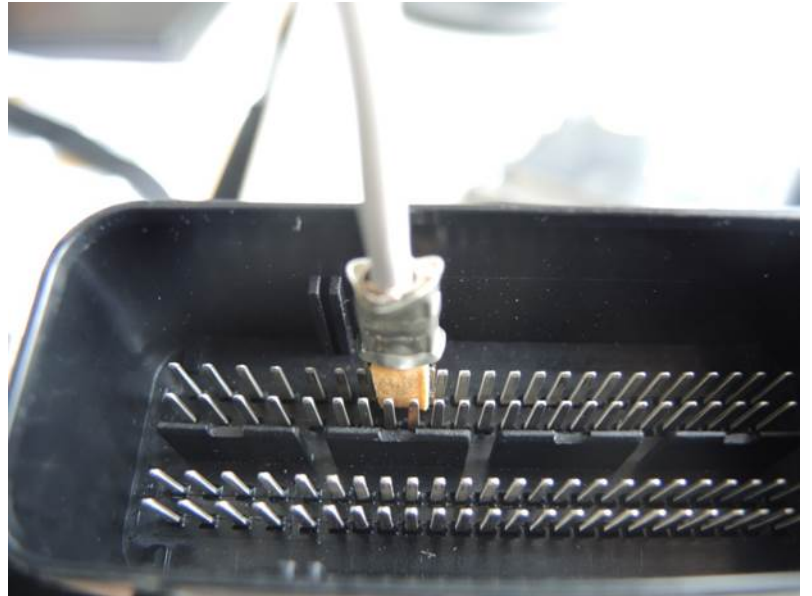
5.jpg:

4.3 The cleaning contact is used for 2 contacts at the same time on the small contact pins. Clean pins by moving up and down 2 times in succession. Slide cleaning contact onto pins until the cleaning contact impacts with the multipoint connector housing (see 5.jpg, 6.jpg and 7.jpg).
