# RECALL CAMPAIGN BULLETIN

## VOLUNTARY EMISSIONS RECALL CAMPAIGN 2019 ALTIMA; FRONT EXHAUST TUBE

**CAMPAIGN ID #:** PC689  
**APPLIED VEHICLE:** 2019 Altima (L34) front wheel drive only  
**APPLIED ENGINE:** PR25DD only

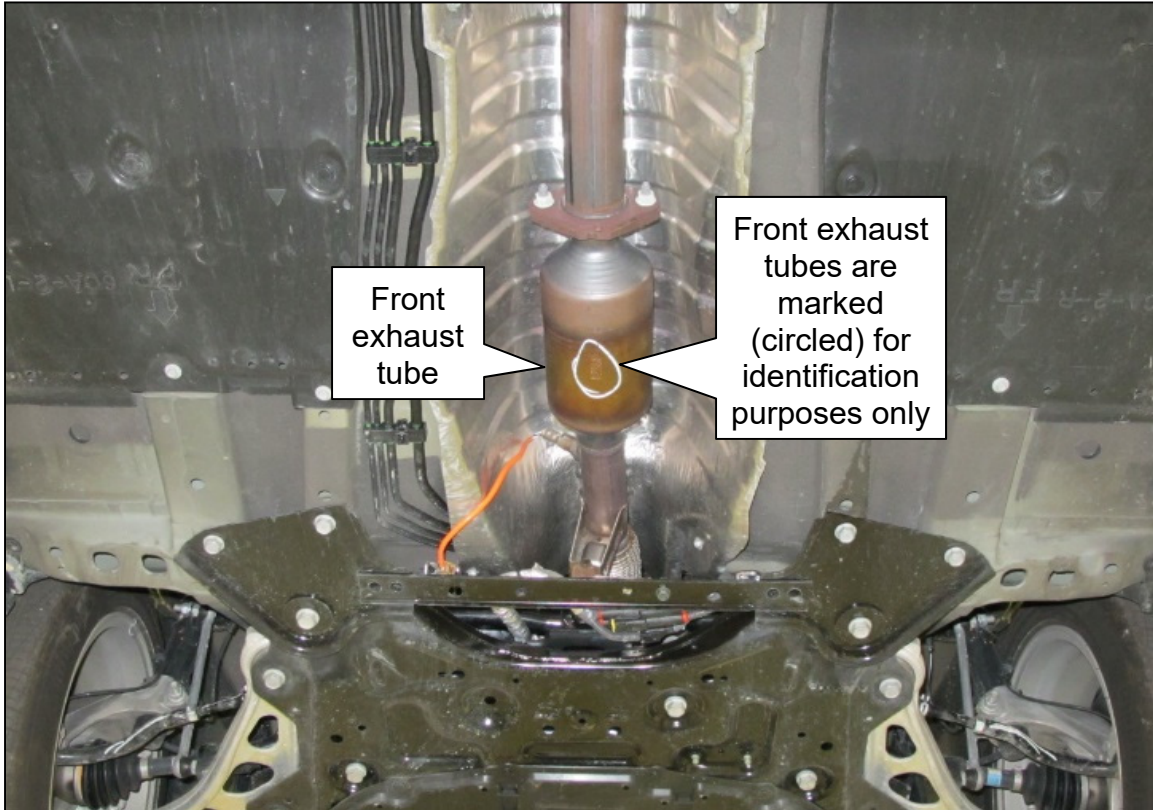
Figure 1

1. Raise the vehicle on a lift.
2. Locate the area of the front exhaust tube shown in Figure 1.

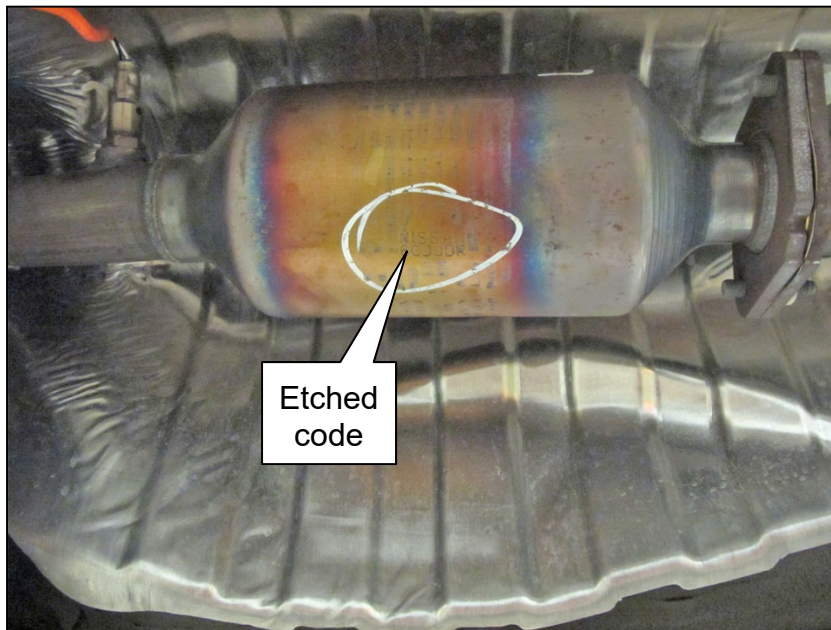
Figure 2

3. Find the etched code in the center rear of the exhaust tube.

- If the first three alphanumeric characters of the code under “NISSAN” are “6CJ”, STOP HERE. No further inspection or repairs are needed.
- If the first three alphanumeric characters of the code under “NISSAN” are “6CL”, replace the front exhaust tube.
