# LATEST VEHICLE CONCERN FIXES

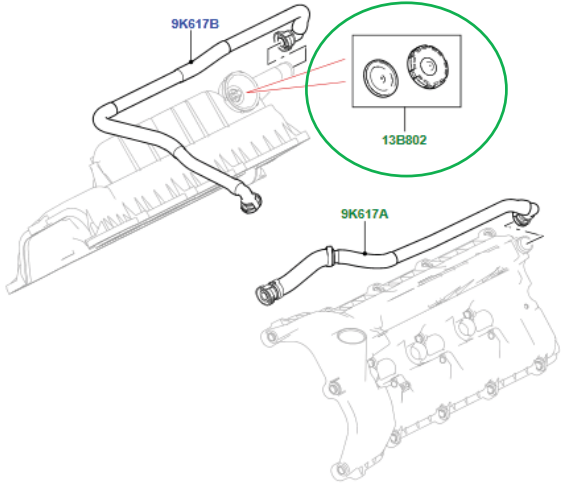
PCV Diaphragm Torn	All models equipped with AJ126 or AJ133
<p><b>Customer Voice:</b></p> <ul style="list-style-type: none"><li>- The Check Engine Lamp is illuminated.</li></ul> <p><b>Technical Description:</b></p> <ul style="list-style-type: none"><li>- There is an unmetered air leak from the PCV valve diaphragm.</li></ul> <p><b>Status:</b></p> <ul style="list-style-type: none"><li>- A lower level repair kit has been developed and can be ordered through parts.</li><li>- Part number is LR133579 / C2D60163.</li><li>- Part will be delivered to the UK warehouses this week.</li><li>- Local sample parts stock has been exhausted, so please do not raise a TA to obtain parts.</li></ul>

<p>The diagram illustrates the PCV valve assembly. It shows a side view of the valve (labeled 9K617B) and a top view of the valve housing (labeled 9K617A). A circular inset highlights the diaphragm components, with a callout box showing two diaphragm parts (labeled 13B802) and red lines indicating their location within the valve assembly.</p>
