## SERVICE BULLETIN

EL19-009
 NTB19-029
 April 4, 2019

# INTELLIGENT KEY DOES NOT WORK AFTER BATTERY REPLACEMENT

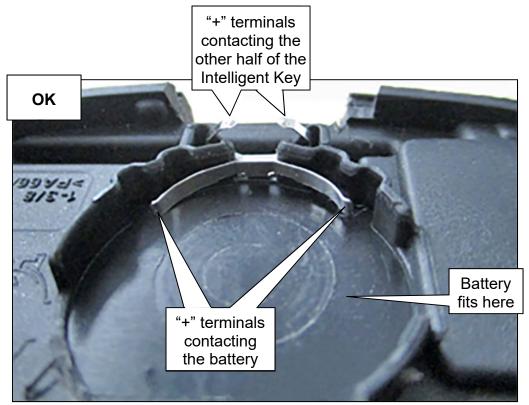
Figure 1

If the battery side of the Intelligent Key is held by pinching down on the terminals while removing the battery, it is possible to bend the terminals down far enough that they will not touch the contacts on the other half of the Intelligent Key.

If the terminals are found to be bent down, pry them back up so that they will come in contact with the other half of the Intelligent Key's contacts.
