Title Volvo Chassis - Automated Manual Transmission (AMT, I-Shift) Repair Strategy; Component Inspection And Reuse Guidelines And Instructions; Required Tasks When Disassembling An AMT For Repair - **For use with Service News SNV19-020e**

Volvo Model VNL , VNM , VNR , VNX , VAH , VHD

Transmission AMT-C , AMT-D , AMT-F With Crawler Gears , AMT-F Without Crawler Gears

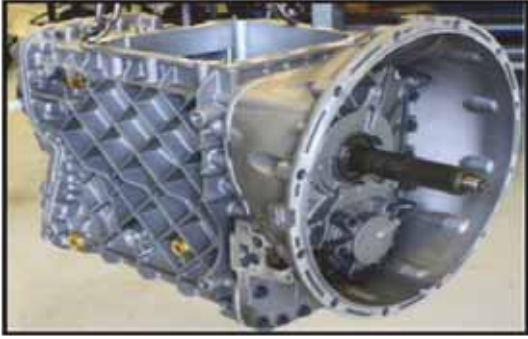
<u>Basic Transmission</u>
--	---------------------------

<p>- Same as complete, but does not include the CCA, TECU, or Top Cover Assembly & Solenoid</p>

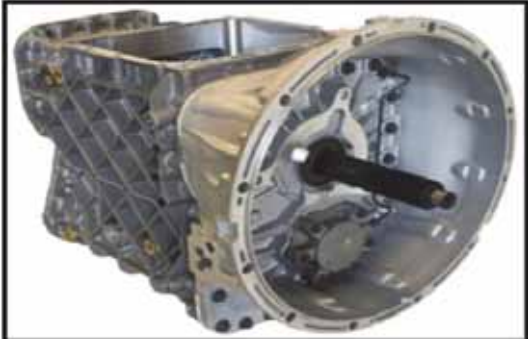
<p><u>Short Transmission</u></p> <p>Same as Basic, but without Range Shift Assembly</p>
