# Service Bulletin

Bulletin No.: 19-NA-080

**Subject:** Information on Positive Crankcase Ventilation (PCV) Drain Tube Deletion

**Attention:** This Bulletin only applies to Small Gas Engines (SGE) that are in for lower engine repairs.

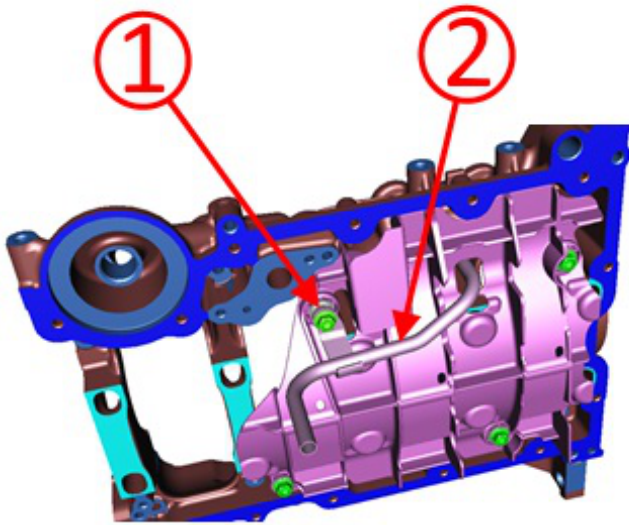
5314689

<b>Involved Region or Country</b>	North America and N.A. Export Regions
<b>Condition</b>	Some technicians may find the PCV drain tube installed during an engine repair. ⇒ General Motors has determined that the PCV drain tube is not needed and it will be deleted mid-year 2019 and forward. Please be advised you will no longer see this tube when doing an engine service on these engines.
<b>Information</b>	If the PCV drain tube on any SGE engine needs to be replaced, the tube is no longer available and replacement of the tube is no longer required. ⇒ Discard the old tube and replace the drain tube bolt with a shorter bolt to retain the crankcase oil deflector.

1. Remove the bolt (1) that secures the PCV drain tube (2) to the crankshaft deflector and bedplate.

**Note:** It is very important that you use the shorter bolt if you discard the PCV drain tube.

2. Using care, remove the PCV drain tube assembly from the bedplate and discard.
3. Install the new shorter bolt.

Tighten the bolt to 15 N•m (11 lb ft).
