GROUP Electrical	MODEL 2016-2019MY Optima (JFa), Sorento (UMa)
	NUMBER PS600	DATE May 2019

SUBJECT: OUTSIDE MIRROR GLASS CONTROL INOPERATIVE

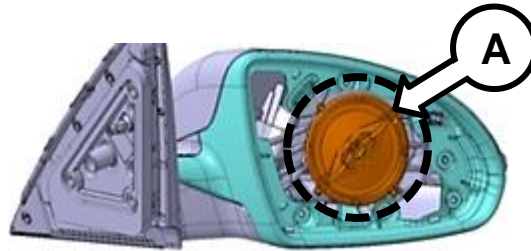
If the mirror glass cannot be adjusted, and the resulting diagnosis confirms the mirror actuator (A) is at fault, replace only the mirror actuator. DO NOT replace the complete mirror assembly. Below are the part numbers and Labor Op Code for only the actuator replacements, used on both 2016-2019MY Optima (JFa) and Sorento (UMa) vehicles.
