# Technical Service Bulletin

## 20 MIL on, DTC P045600 stored in the ECM

20 19 16 2035073/14 May 24, 2019. Supersedes Technical Service Bulletin Group 20 number 19-13 dated April 11, 2019 for reasons listed below.

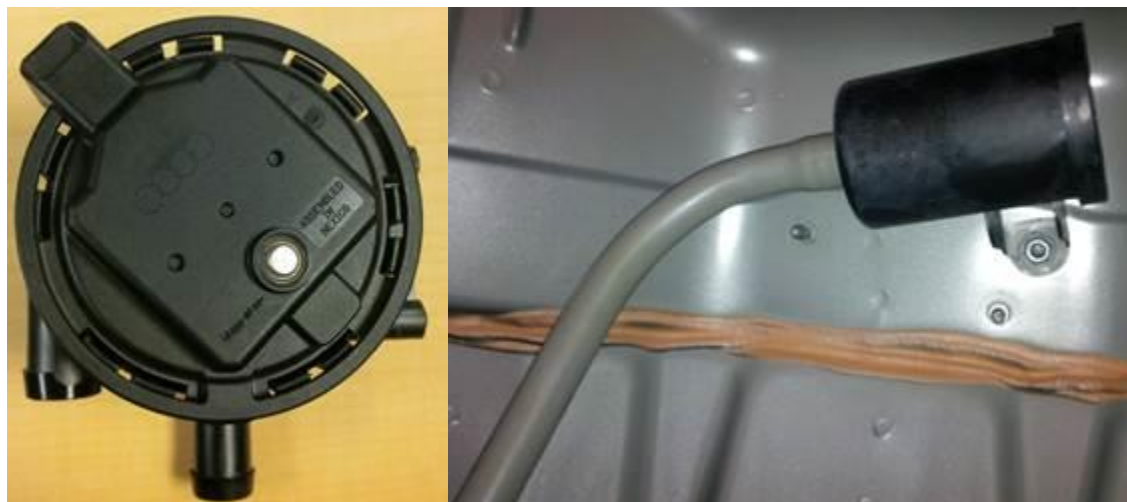
*Figure 1. NVLD pressure sensor (left) and NVLD filter (right).*

1. Ensure that **DTC P045600** (EVAP System Leak Detected NVLD (very small leak)) is stored in the engine control module (ECM), J623 (address word 0001). If **DTC P045600** is not present, this bulletin does not apply.
2. Replace the NVLD pressure sensor G400 and the NVLD filter with the latest part number available (Figure 1).

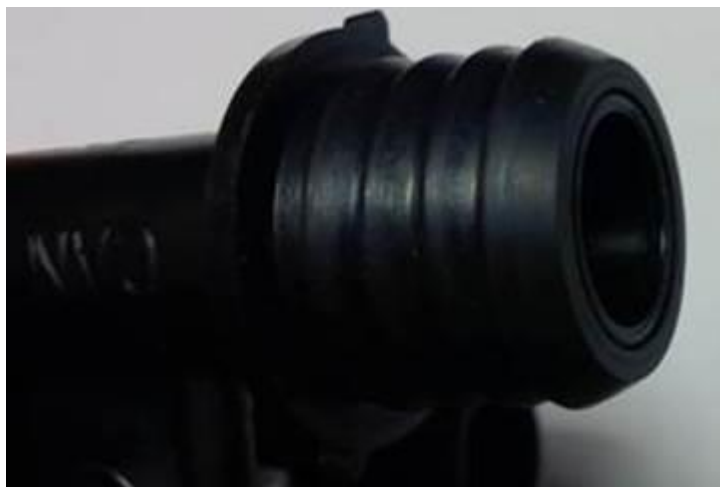
*Figure 2. Align the grommet and sensor outer edges.*

3. Align the grommet and sensor outer edges (Figure 2).

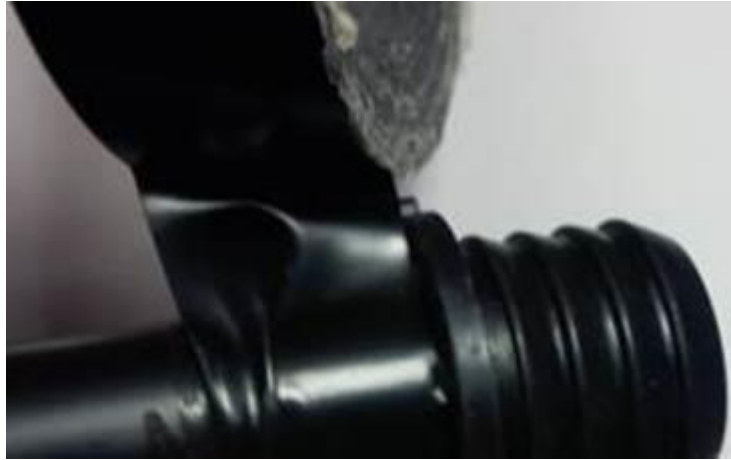
*Figure 3. Wrapping vinyl tape behind the grommet.*

4. To aid installation, wrap several (~10) layers of vinyl tape behind the grommet to ensure that it does not slip during installation (Figure 3 and Figure 4).

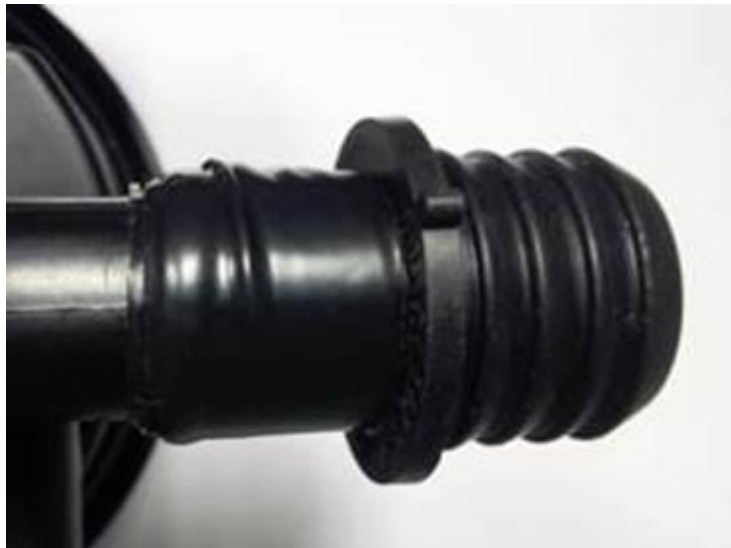
*Figure 4. Vinyl layer supporting grommet.*

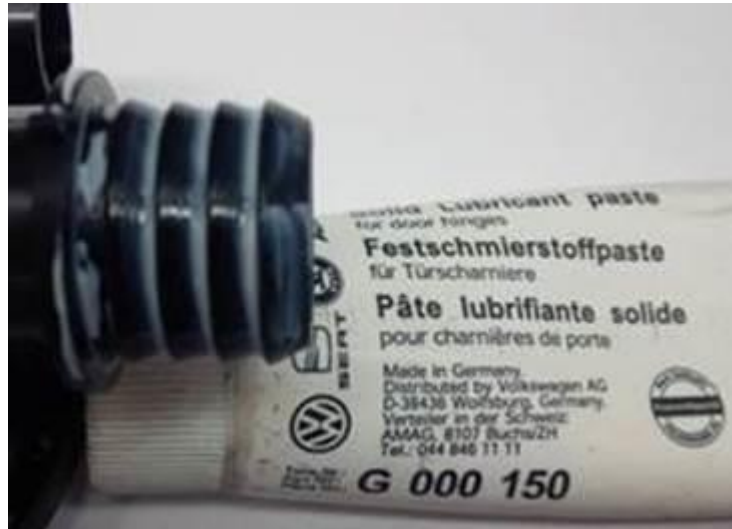
**Figure 5.** Grease film on the outer surface of the grommet.

5. Apply a small amount of grease to create a film on the outer surface of the grommet before installing the sensor (Figure 5).

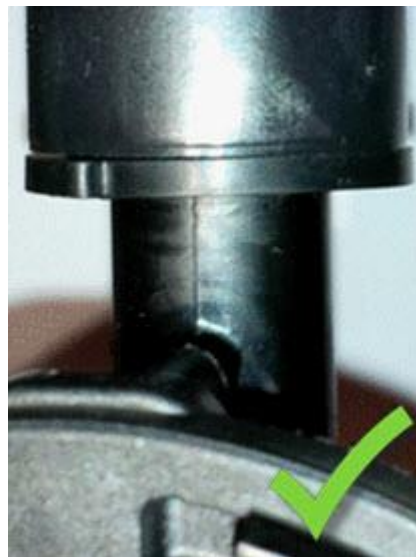
**Figure 6.** Correctly-installed sensor and grommet.

6. When the sensor and grommet have been correctly installed, the grommet and canister will be flush (Figure 6). At this point, the vinyl tape can be removed (or it can be left in place).

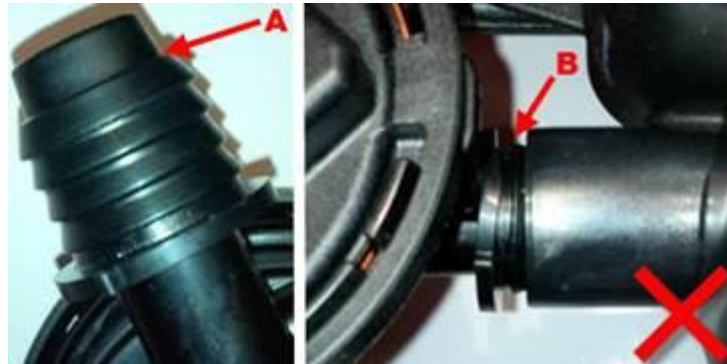
7. An incorrectly-installed sensor and grommet (Figure 7) can cause an EVAP leak and repeat failures. Issues can occur when the NVLD switch is pressed too far into the canister, then pulled back out in an attempt to align the NVLD switch with the mounting holes.

**Figure 7.** Plastic port extending past the grommet (A) causing installation issues (B).

Do not apply any lubricant between the sensor and the grommet.
