87-18-08 - Air Conditioning, Cleaning of the R1234yf Refrigerant Circuit (U.S. Only)

Release date: 5/28/2019

Debris can be dispersed throughout the refrigerant circuit after A/C component damage. In order to maintain A/C operating efficiency, it is important to flush the refrigerant circuit after A/C component repairs.

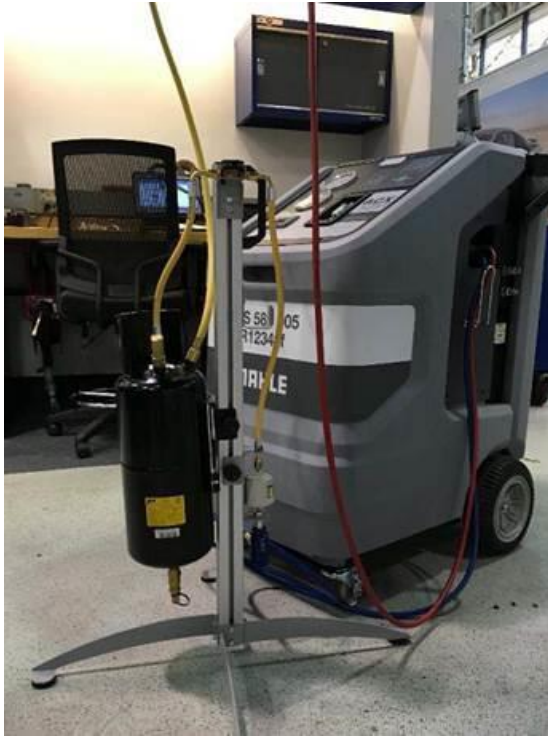
Use the MAHLE R1234yf A/C Service Unit VAS581005 and the R1234yf Flush Kit RTI360831040 (Figure 1).

Used for effective refrigerant handling and air conditioning circuit flushing after air conditioning component failure.

Figure 1. The VAS581005 Air Conditioning Service System with Flushing Device.

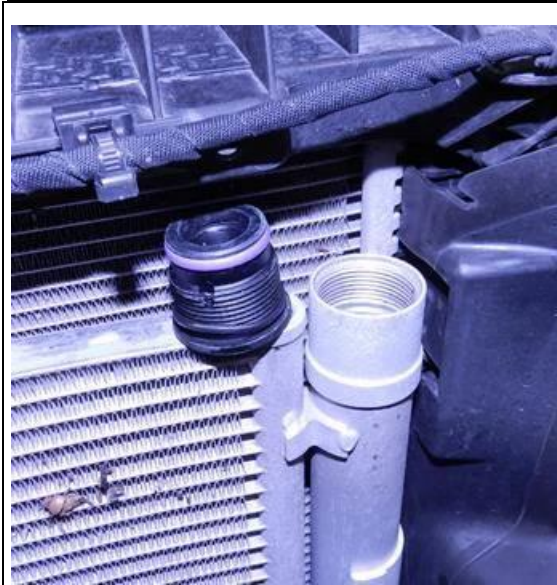
Figure 2. Location of the Receiver Drier

6. Remove receiver drier cartridge.
Reinstall cartridge cap with O-ring. (Figure 2)

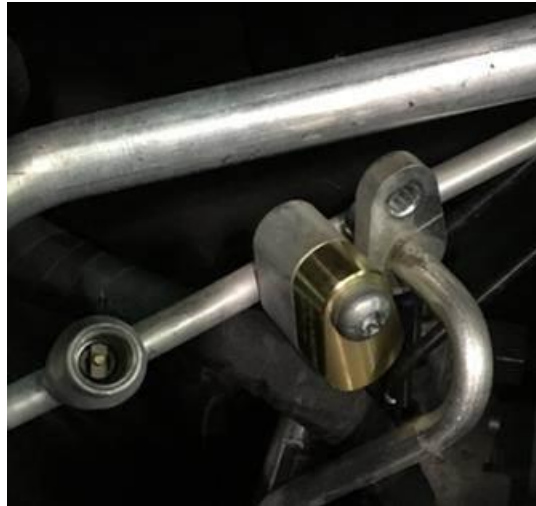
Figure 4a. Installation of high side rear A/C Line connection block adaptor VAS 6338/63

(Atlas Only) The rear A/C unit refrigerant lines must be disconnected and replaced with block off adaptors VAS 6338/5 and VAS 6338/63 before performing the front A/C unit flush procedure.

8. (Atlas Only) Disconnect rear refrigerant lines and install adaptors VAS 6338/5 and VAS 6338/63 as shown. (Figure 4a, 4b)

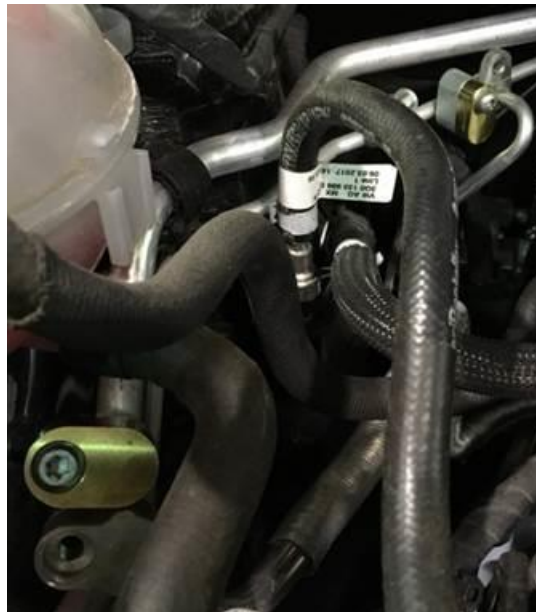
Figure 4b. Installation of Low side rear A/C Line connection block adaptor VAS 6338/5

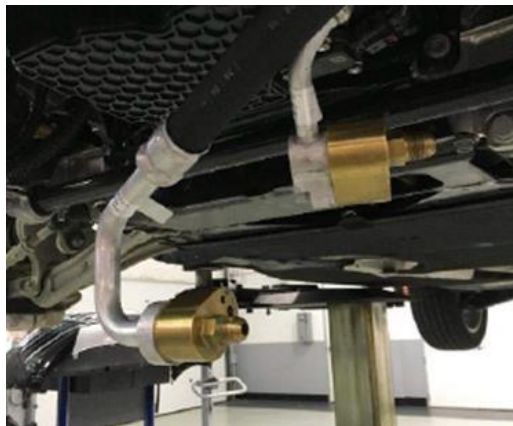
**Figure 6.** Installation of VAS 6338/3 and 6338/12.

10. Disconnect AC compressor hoses from the compressor.

Install flush adaptor VAS 6338/3 on the high side compressor hose.

Install flush adaptor VAS 6338/12 on low side compressor hose. (Figure 6)

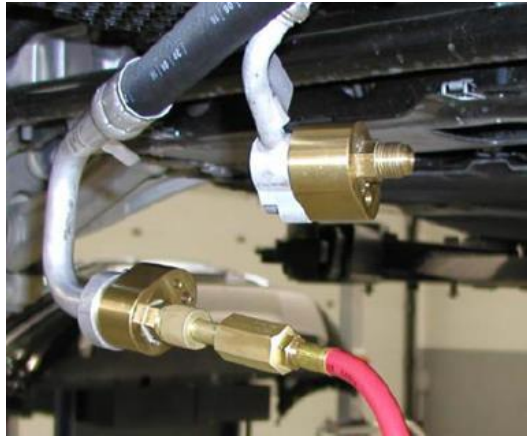
Figure 7.

This connection strategy allows for a system flush *in the opposite* direction of the normal refrigerant flow.

11. Attach high side A/C Recovery machine hose with VAS 6338/48 fitting to low side compressor hose adaptor VAS 6338/12. (Figure 7)

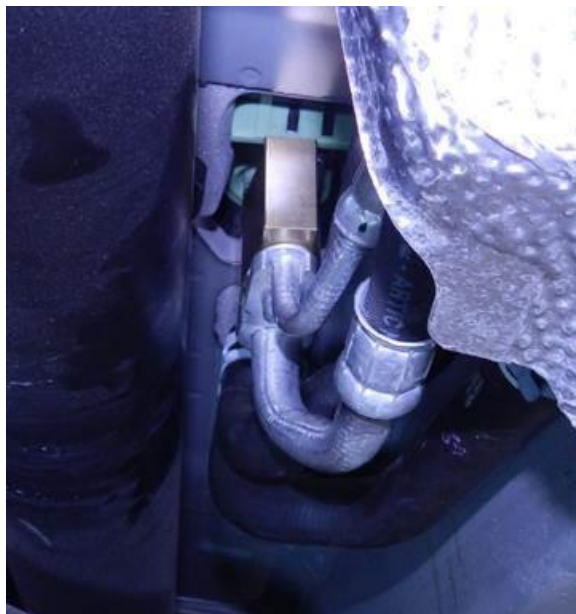
**Figure 13.** Location of rear air conditioning unit expansion valve.

23. Remove rear expansion valve and install VAS6338/38 as shown. (Figure 13)

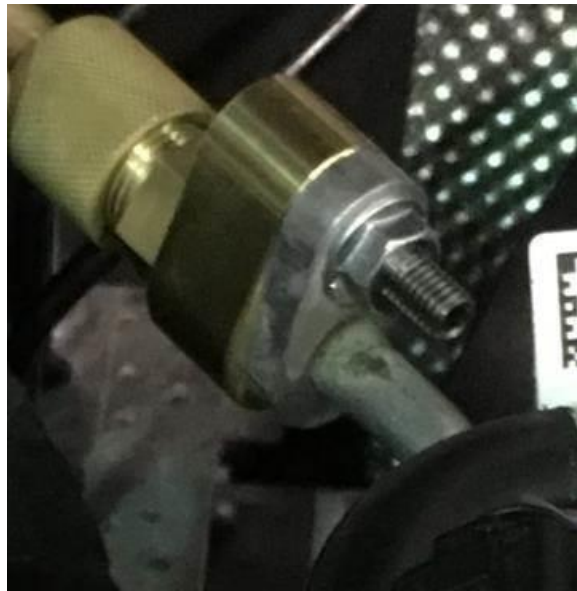
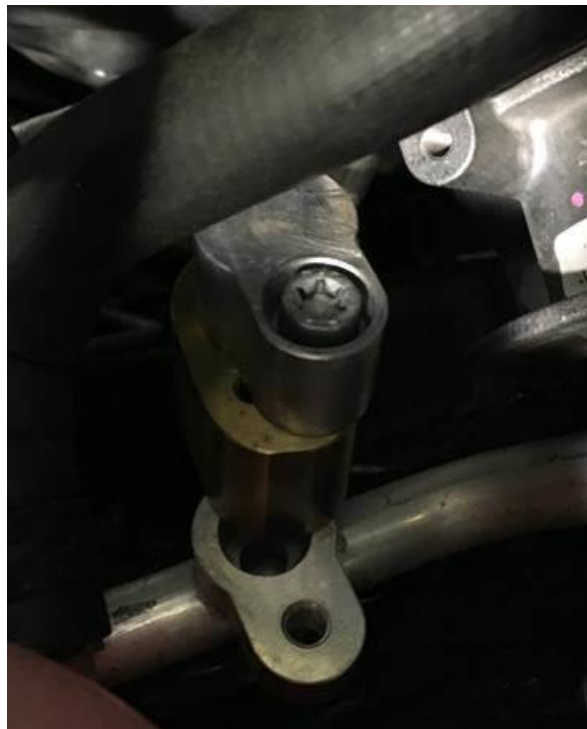
Figure 14. Location and connection of the adaptors for the rear unit A/C lines

24. Connect the VAS 6338/3 and VAS 6338/60 to the rear refrigerant A/C lines previous disconnected in step 12. (Figure 14)

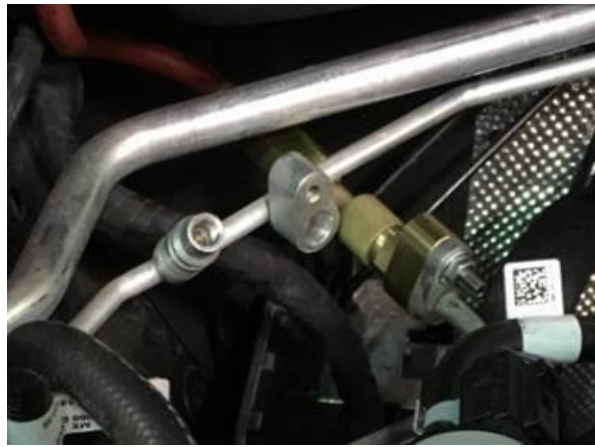
Figure 15. Attaching service station and flush hoses to rear A/C lines.

25. Connect the VAS 6338/3 and VAS 6338/60 to the rear refrigerant A/C lines.

26. Connect the VAS 6338/48 to adaptor VAS 6338/60

27. Connect flush tank hose (Yellow) to the high side compressor hose adaptor VAS 6338/3. (Figure15)

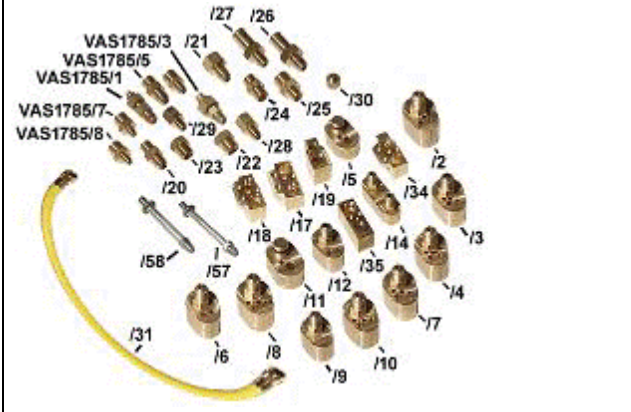
<p>Adapter set for refrigerant circuits</p>

<p>VAS 6338/1</p>
<p>Refrigerant circuit adapter for MAHLE A/C Service Unit and R1234yf Flush Kit</p>

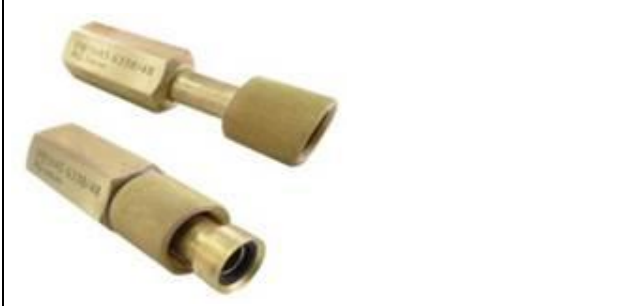
<p>VAS6338/48</p>
<p>Refrigerant circuit adapter for expansion valve bypass</p>
