Subject: TIB 43-060 – Greenhouse Gas (GHG) Vehicle Compliance Door Label Replacement
EXPIRATION DATE: NONE
The VINs are listed on the back of this page

Technical Information Bulletin

43-060

Green House Gas (GHG) Door Label Goodyear Tire Classification Issue

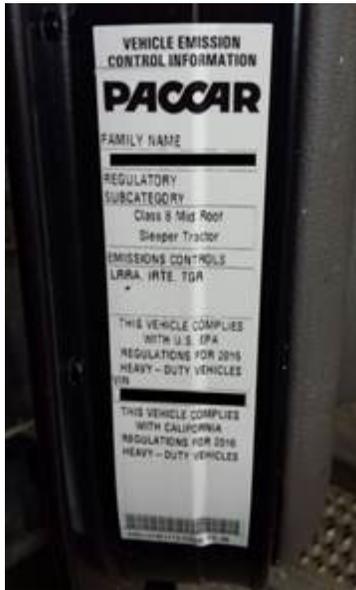
Kenworth has determined that certain chassis equipped with certain Goodyear tires received a Greenhouse Gas label that does not reference the correct tire emissions identifier related to new rolling resistance data.

1. Locate the GHG Label on the Driver Side door.

2. Peel off the old label.
3. Clean the surface of residue.
4. Install the new label in the same location. Ensure the label is free of wrinkles or air bubbles.
5. Include with your claim a clear and in-focus photo of the installed new label.
