BT19-007

ITB19-011

DEAD PEDAL REPLACEMENT

APPLIED VEHICLES:
 2013 JX35 (L50)
 2014 – 2019 QX60 (L50)
 2014 – 2018 QX60 Hybrid (L50)

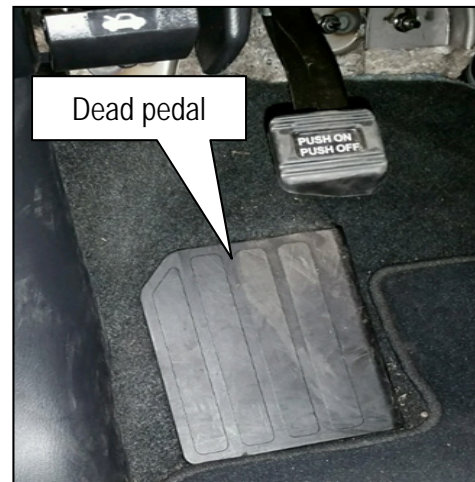
Figure 1

If the dead pedal needs to be replaced for any reason, it is no longer necessary to replace the front floor trim (carpet).

The dead pedal is now available as a service part.

NOTE: Do not replace the carpet if only the dead pedal is needed.
