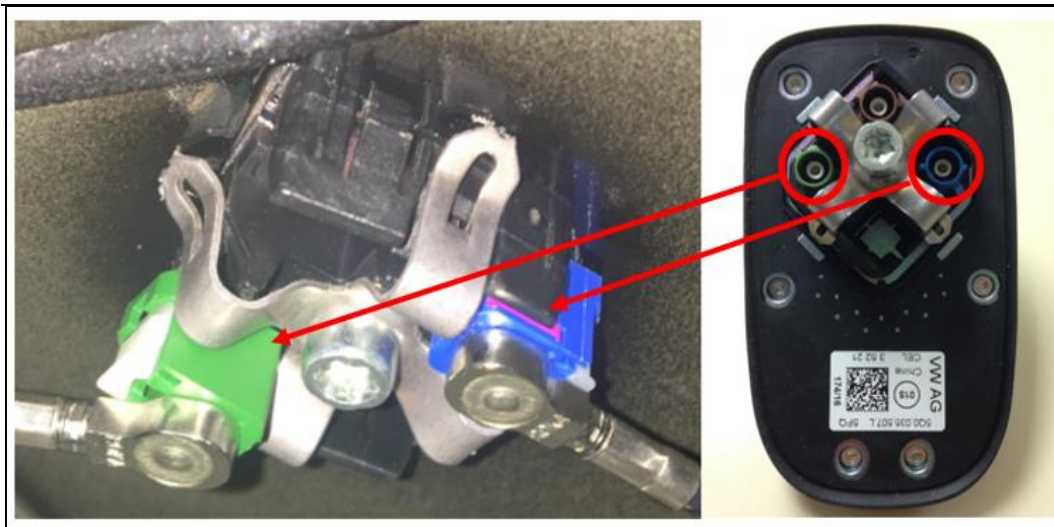
Figure 1.

If during diagnosis of complaints related to malfunctions of the satellite radio or GPS navigation, the testing leads toward replacement of the antenna, first ensure there are no electrical connector issues at the antenna itself (see Figure 1).

If any connection issues exist at the antenna, repair the connection issue and retest before proceeding to antenna replacement. DO NOT replace the antenna before ruling out connection issues.
