Topic	12MY,13MY and 14MY Power Boot Campaign RoW (SC16/24)
Market area	Hongkong-Macau (5HK),Russische Föderation (5RU),Australia E04 Bentley rest Asia and Australia (6E04),China 796 VW Import Comp. Ltd (Vico), Beijing (6796),Germany E02 Bentley rest Europe (6E02),Japan E03 Bentley Japan (6E03),Russian Federation 935 Volkswagen Group RUS (6935),United Arab Emirates E06 Bentley Middle East and Africa (6E06),United States E05 Bentley USA and rest America (6E05)
Brand	Bentley
Transaction No.	2045092/5
Campaign number	EA62
Note	
Type	Service Campaign
US code

New Continental

Bentley has developed a boot system update pack to resolve customer issues.

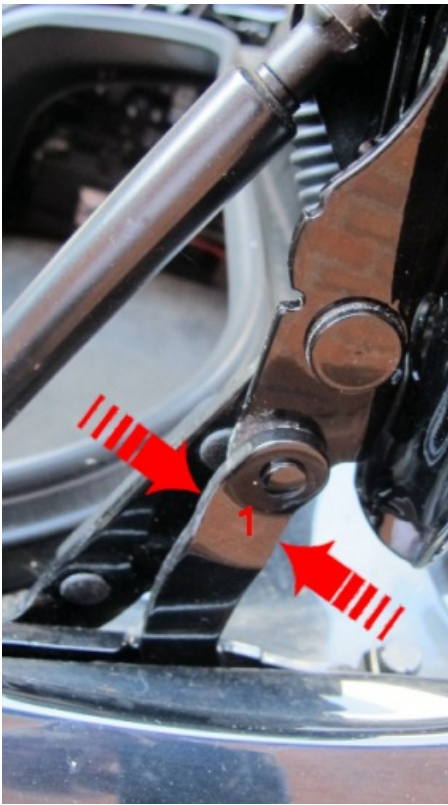
Figure 1a

Prior to performing software update on Continental models ensure the motor driven, right hand, hinge (1) is serviceable, check for excessive play in hinge pivots, manipulate the open hinge manually whilst checking for excessive play. Ensure the hinge function is uncompromised and no misalignment exists in the hinge elements, replace individual driven hinge where necessary (see Figure 1a)

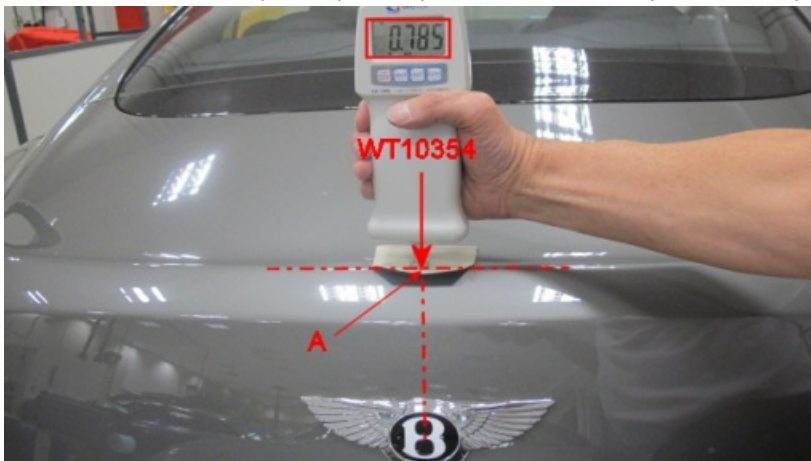
Figure 4

2. Carry out closing force gauge test – to perform this test the boot lid is operated to close and stopped short of closing on the power close cycle by pressing the close button again and manually catching the boot lid in the final centimetres of the close cycle, just before it engages with the striker pin. At this point the boot lid is resting on the boot lid seal, once in this state the force gauge (WT10354) set to display Kg should be set in position *A on the boot lid. Apply load to the boot lid via the force gauge recording the load in Kg at which the boot lid power latched (see Figure 4).
3. Record results

***Note: Position A for the force gauge is the intersection on the centre line of the boot lid and the rear lip of the boot lid. Place protection between the boot lid painted surface and the gauge foot at position A to avoid paint damage. An offcut of leather will suffice (see Figure 4)**

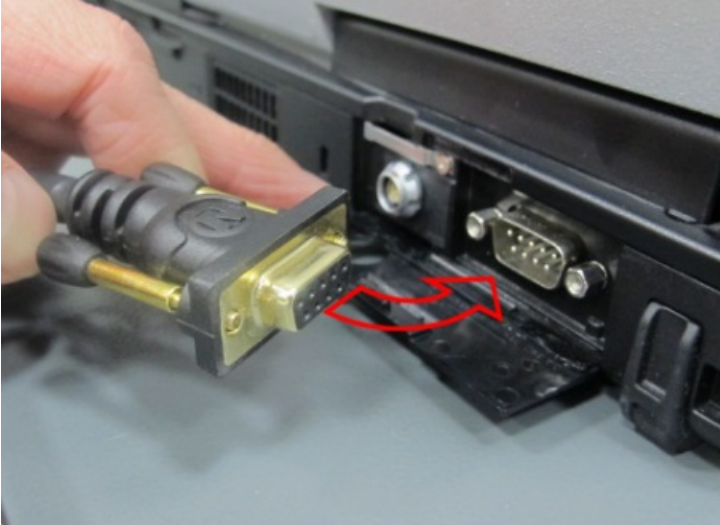
Figure 1

4. Connect boot control module update cable (part number WT10370) to the Bentley diagnostic tool VAS 5052A or later approved equipment (see Figure 1)

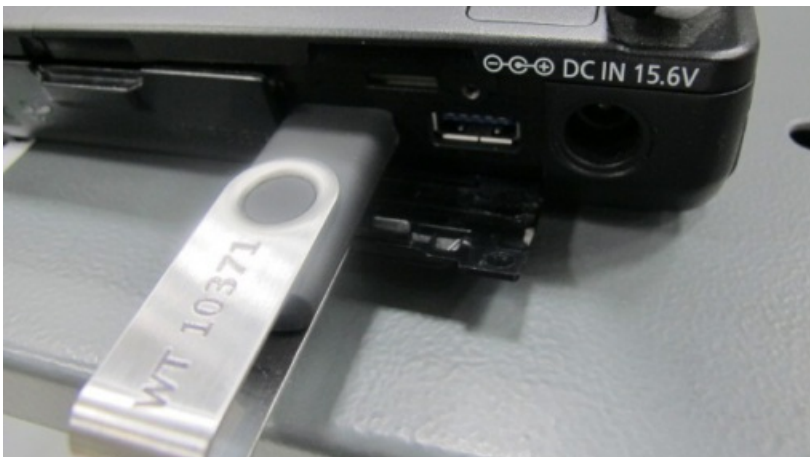
Figure 2

5. Insert USB memory stick boot CM SW (part number WT10371) into USB port of Bentley diagnostic tool (see Figure 2)

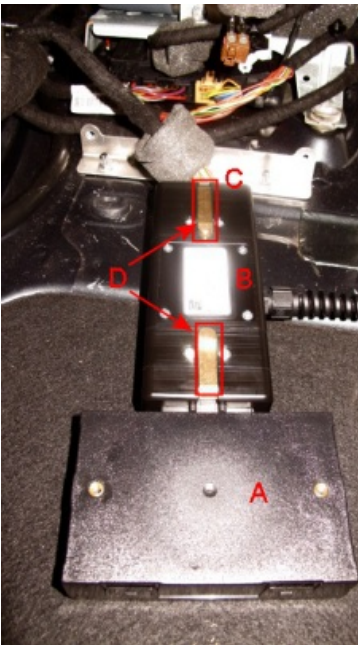
Figure 3

6. Insert boot control module 'A' and its associated plug 'C' into each end of connector 'B' of the boot control module update cable, ensure the connector release mechanism of the boot control module update cable (D) is facing up to avoid unexpected release of the module during software update (see Figure 3)
7. Switch on the ignition using the ignition key

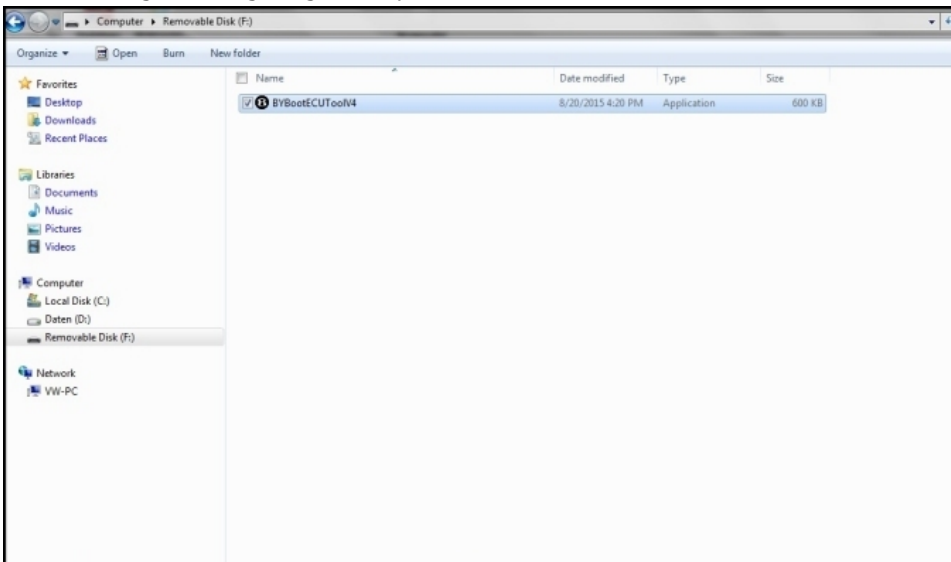
Figure 4a

8. From the diagnostic tool main desktop open USB memory stick (removable disc BYBootCUTTool) (see Figure 4a)
9. Select open application BYBootCUTTool

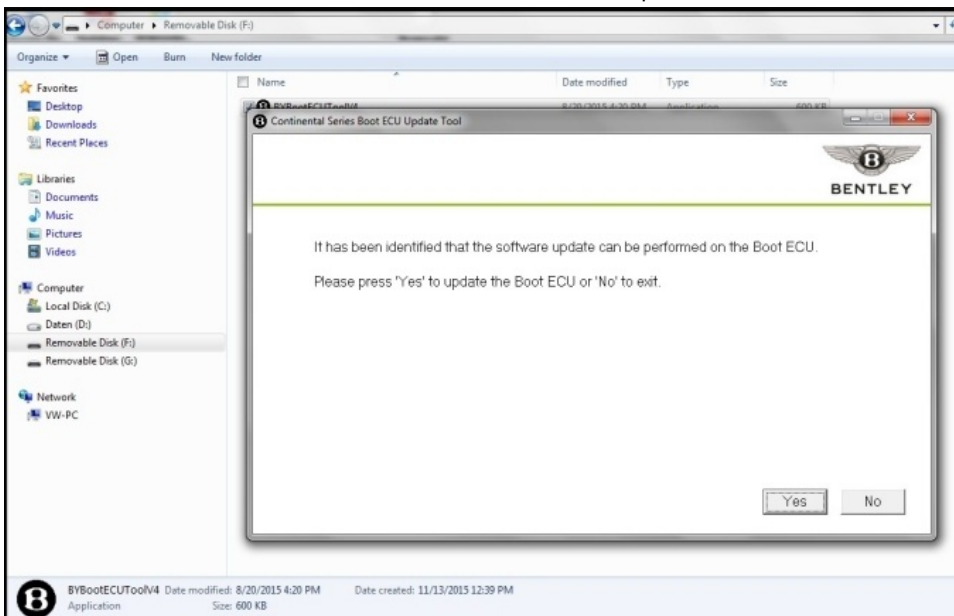
Figure 6

12. Select Yes to update (see Figure 6)

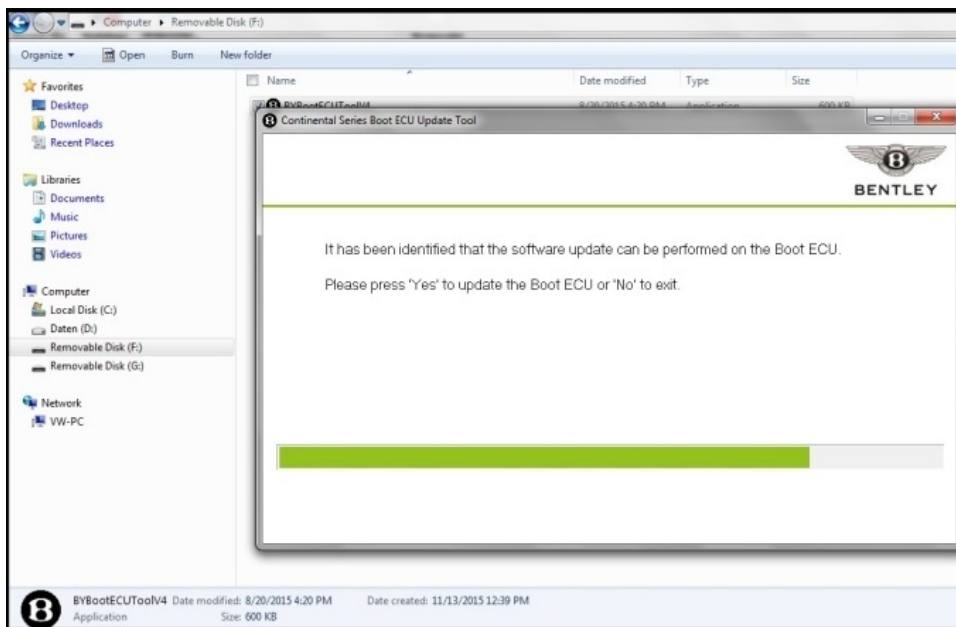
Figure 7

13. A progress bar will be displayed during update (see Figure 7)

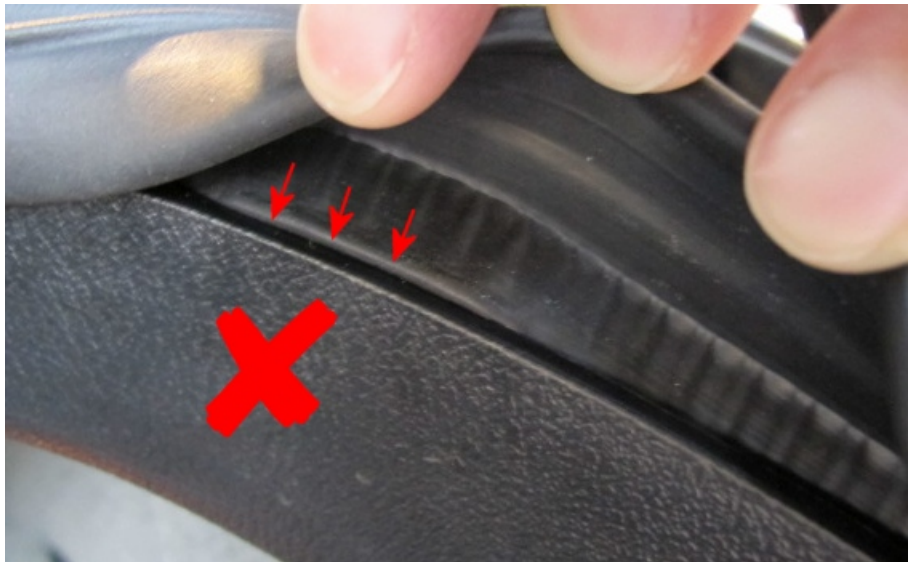
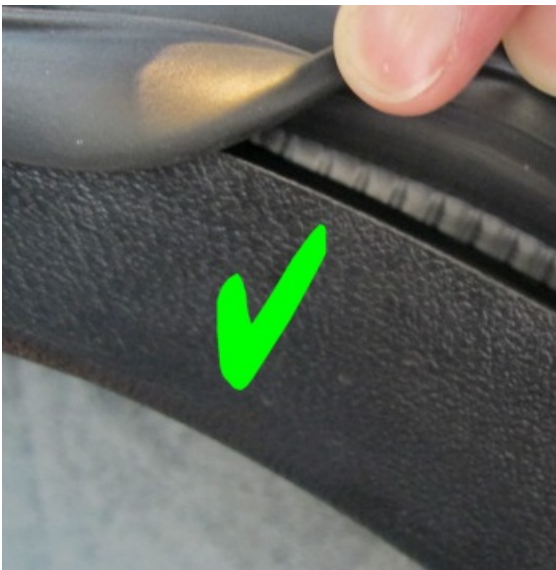
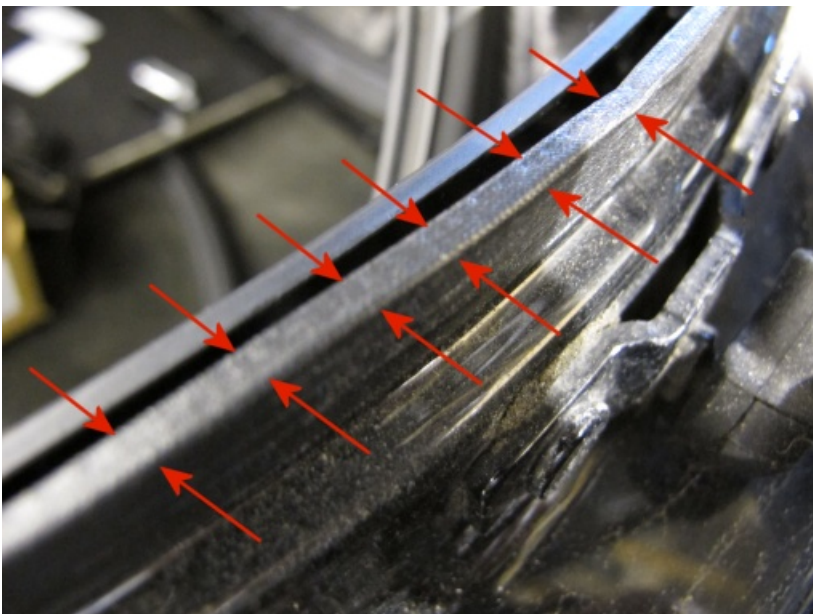
Figure 1a

Ensure the boot lid seal is correctly fitted

1. Ensure the boot lid seal is correctly fitted (see Figure 1a) specifically the knock-on strip element of the seal must be fully engaged on the lip of the boot aperture and not as shown in figure 1 where it is displaced by the boot trim. Ensure the obscuration tape fitted to the boot aperture flange is not restricting seal fitment (see Figure 1b). Check seal is correctly orientated, the vulcanised joint -1- should be to the centre line (+/- 10mm) of the ball joint -2- on the boot lid gas strut (see Figure 2 and 2a)

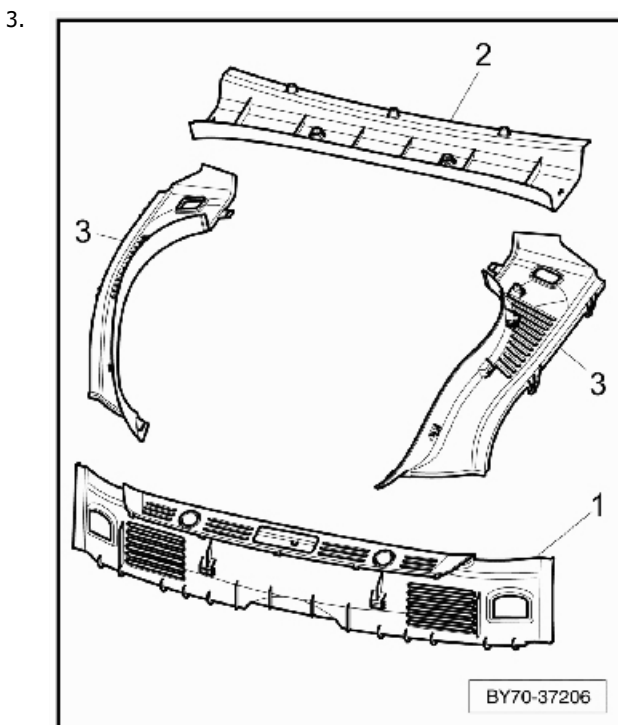
Figure 3

4. Ensure the boot aperture finishers (see Figure 3) are secure, correctly fitted and not compromising the boot lid seal fitment, rectify and replace damaged clips where necessary

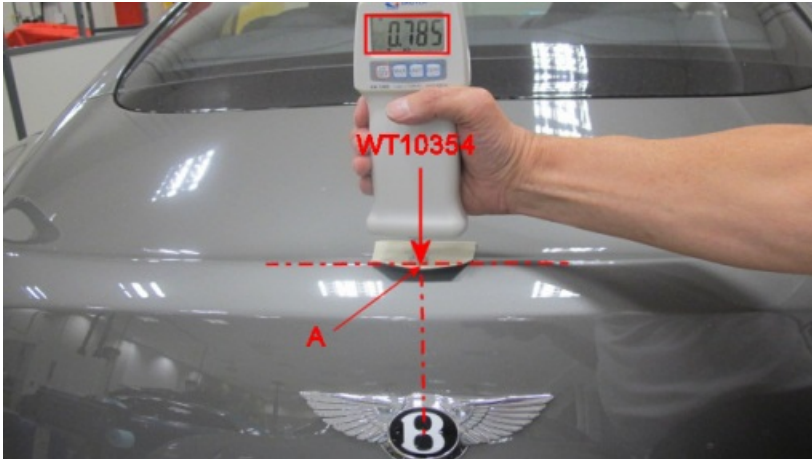
Figure 4

2. Carry out closing force gauge test – to perform this test the boot lid is operated to close and stopped short of closing on the power close cycle by pressing the close button again and manually catching the boot lid in the final centimetres of the close cycle, just before it engages with the striker pin. At this point the boot lid is resting on the boot lid seal, once in this state the force gauge (WT10354) should be set in position *A on the boot lid. Apply load to the boot lid via the force gauge recording the load at which the boot lid power latched (see Figure 4)
3. Record results

***Note: Position A for the force gauge is the intersection on the centre line of the boot lid and the rear lip of the boot lid. Place protection between the boot lid painted surface and the gauge foot at position A to avoid paint damage. An offcut of leather will suffice (see Figure 4)**

The load measured should be less than 1Kg. If the load measured to initiate the close cycle is less than 1Kg or the boot latches under its own weight and the boot completed three consecutive power open and close cycles then the campaign is complete, apply a white campaign identification mark to the boot striker plate (see Figure 25).

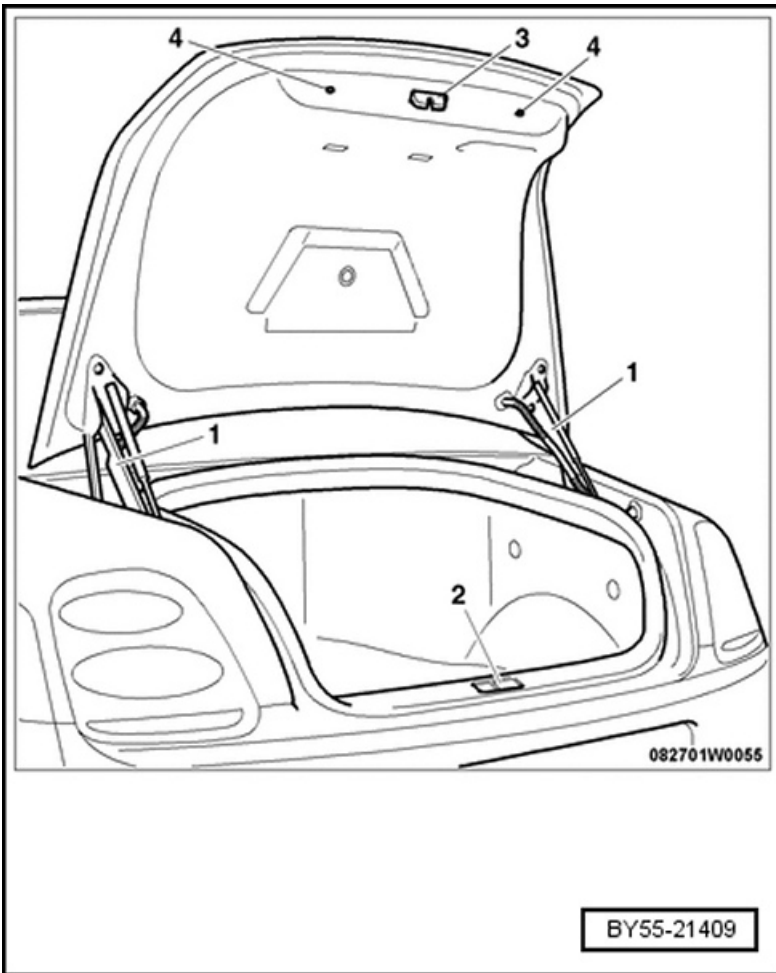
Figure 5

Prior to adjusting the boot lid hinge ensure the hinge (1) is serviceable, check for excessive play in pivots ensure the hinge function is uncompromised and no misalignment exists in the hinge elements, replace individual hinges where necessary.

Check the striker pin (2) is serviceable the pin should be undamaged and pin should rotate freely by hand, free off and lubricate where necessary, in extreme cases a replacement may be required

The position of the boot lid can be set by adjusting the hinges (1) or the striker (2). The locking latch (3) is attached directly to the boot lid. It does not have slotted holes and therefore has no means of adjustment. Before any adjustments are made the car must be resting on its wheels and on level ground. Ensure the socket used to release the fasteners is 'as new' and that it is fully engaged with the fastener. Tapping the socket with small dead blow hammer to assist the tool in cutting into the paint to aid engagement is recommended. Releasing the harness conduit clips from the each hinge will assist in access. When applying specific torque to fasteners ensure any adaptors or extensions used on the torque wrench are accounted for in your calculation for applied torque

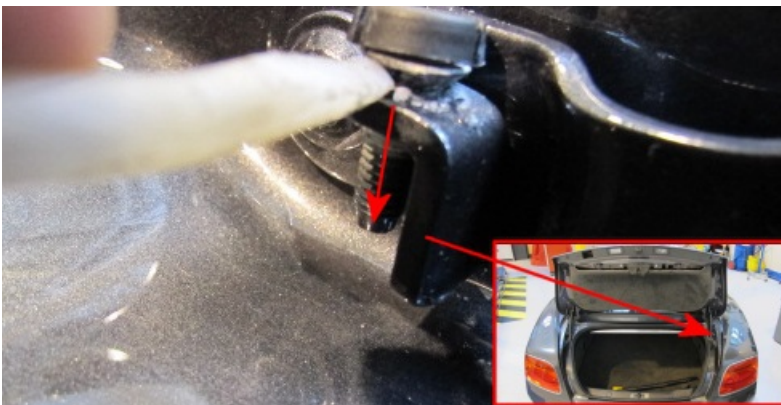
Figure 6

Remove the plastic cap and wind down the boot lid hinge bump stops located on each hinge assembly, these are adjusted back after the setting procedure (see Figure 6)

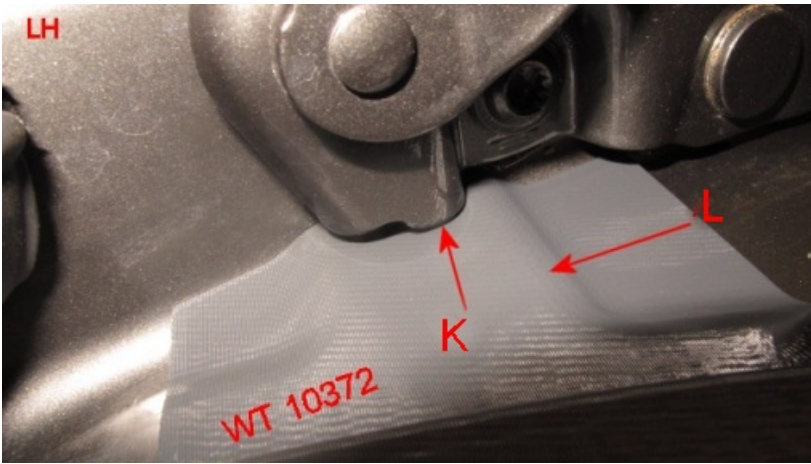
Figure 7

For New GT – use gauge part number WT10372 left hand or WT10373 right hand

Gauge setting hinge. Clean the drain channel to ensure the gauge will be fully engaged with the channel surface.

The gauge is loaded into the drain channel from the front of the hinge in direction L. With the gauge correctly positioned the full length of the gauge will be in contact with both vertical sides of the drain channel whilst sitting on the channel bottom

In this position the rearward section of hinge should be touching the gauge at point K (see Figure 7). If the gauge is tight or loose, not touching, at K then slacken both fasteners and adjust hinges to achieve the base setting at K. The gauge adjustment at K is achieved at the hinge rear mounting bolt therefore although the front mounting bolt has to be slackened the hinge should only rotate at the front bolt with the vertical adjustment performed at the rear bolt. Re-tighten the fasteners **Note New GT** the torque figure of $28\text{Nm} \pm 2$ is critical

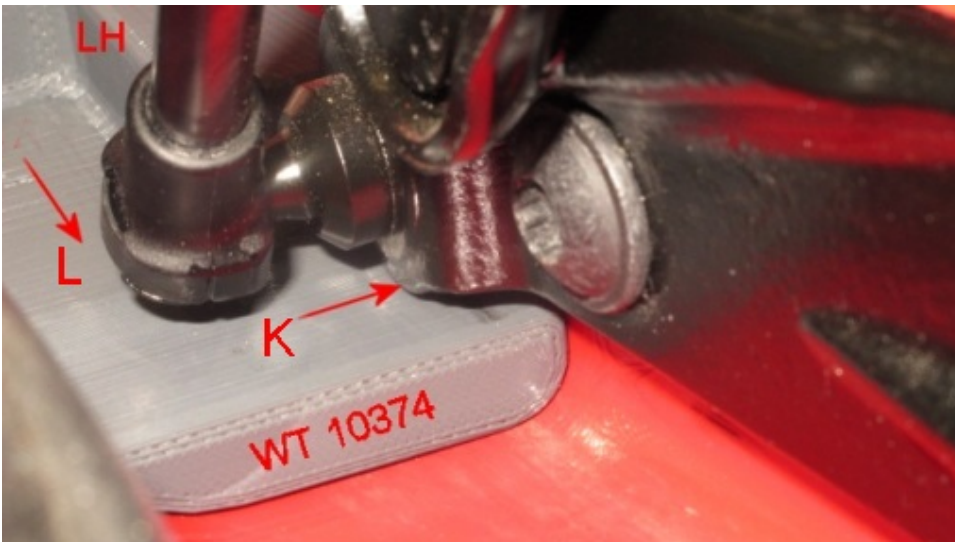
Figure 8

For New Continental GT Convertible – use gauge part number WT10374 left hand or WT10375 right hand

Gauge setting hinge. Clean the drain channel to ensure the gauge will be fully engaged with the channel surface.

The gauge is loaded into the drain channel from the rear of the hinge in direction L. With the gauge correctly positioned the full length of the gauge will be in contact with both vertical sides of the drain channel whilst sitting on the channel bottom

In this position the rearward section of hinge should be touching the gauge at point K (see Figure 8). If the gauge is tight or loose, not touching, at K then slacken both fasteners and adjust hinges to achieve the base setting at K. The gauge adjustment at K is achieved at the hinge rear mounting bolt.

- **Note New Continental GT Convertible** new bolts (increased length) must be fitted and the torque for these bolts are critical at $20\text{Nm} + \text{angle } 45^\circ$ new bolt is part number is N.910.097.01 x 4 off

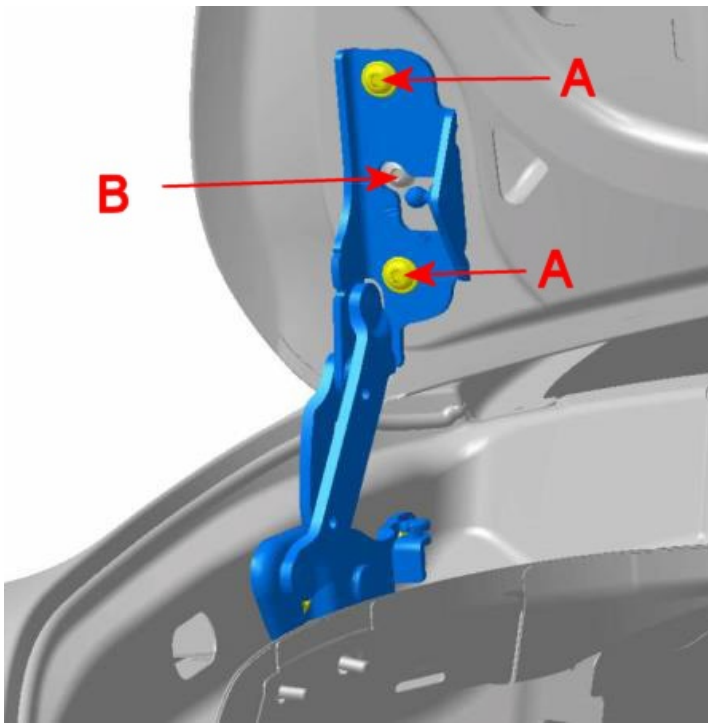
Figure 9

All Cars - Slacken the fasteners (A) securing the boot lid. (see Figure 9) **Note:** do not slacken fastener B at this time. Allow the hinges to “float” ensuring that left and right hinge are not working against each other and operate in same plane without undue resistance. Re-tighten the four fasteners (A) 20Nm \pm 2

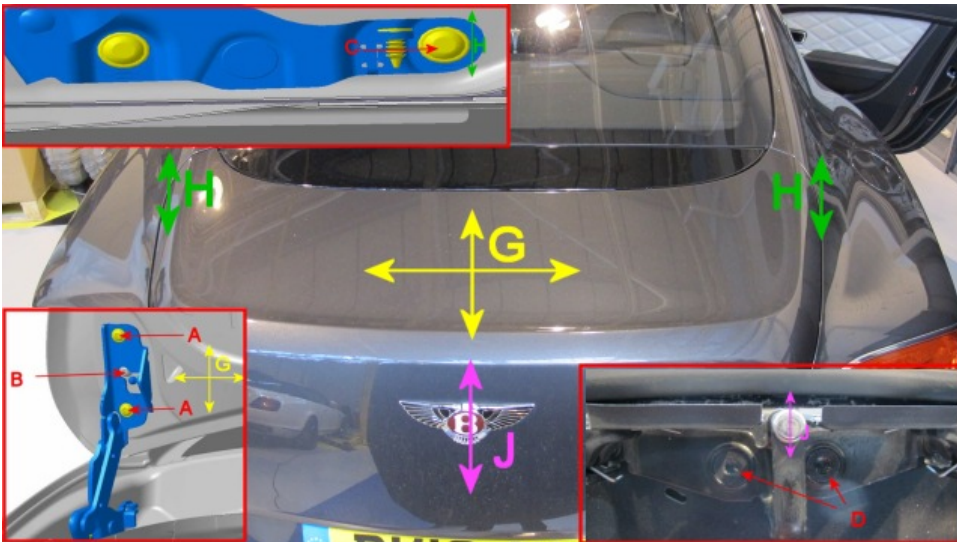
Ensure the boot seal is fitted correctly before manually closing (to control closing avoiding damage in the event that a clash has been introduced by adjustments) the boot lid. Check the boot lid for aesthetic fit and profile.

Reference Figure 10

- (H) Adjustment in height profile adjacent to the rear screen is achieved at the forward, nearest the rear screen, part of the hinge, slacken both hinge fasteners but make adjustments primarily around fastener C to raise or lower at point H. Re gauge check hinge to maintain gauge setting B figure 7 (GT) figure 8 (GTC)
- (J) Adjustment in height profile at the rear of the boot lid is achieved at the striker plate, slacken both fasteners D then raise or lower at point J.
- (G) To achieve panel gaps the boot lid surface can be moved in both axis at the hinge / boot lid connection, slacken fastener B and fasteners A to release the captive plate to allow adjustment

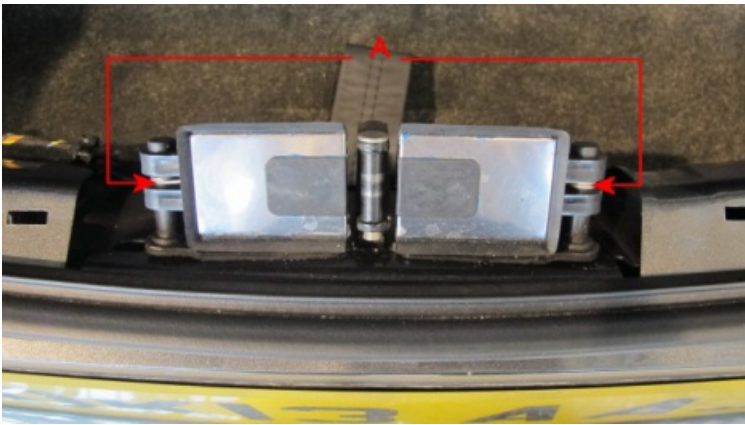
Figure 11

Replace both boot lid striker door springs (A) (see Figure 11). First replace the left hand spring using the right hand as a reference

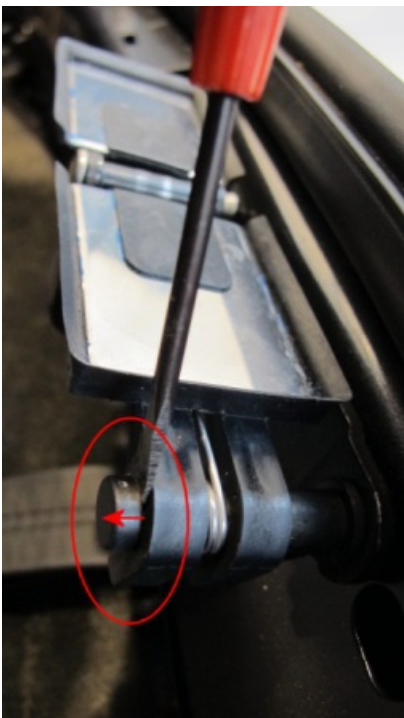
Figure 12

Detached plastic retaining cap and discard (see Figure 12)

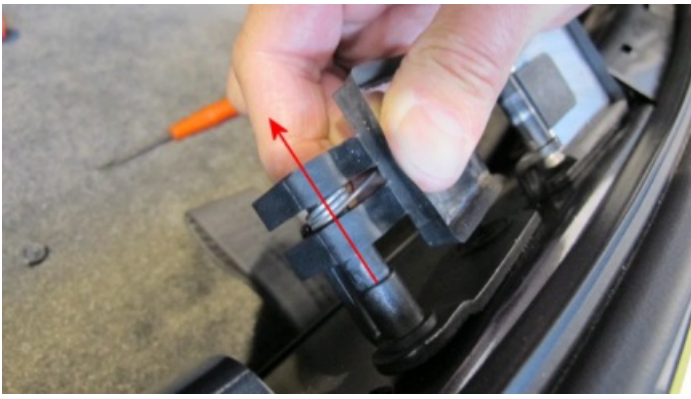
Figure 13

Slide door and spring off the bearing pin discard the original spring (see Figure 13)

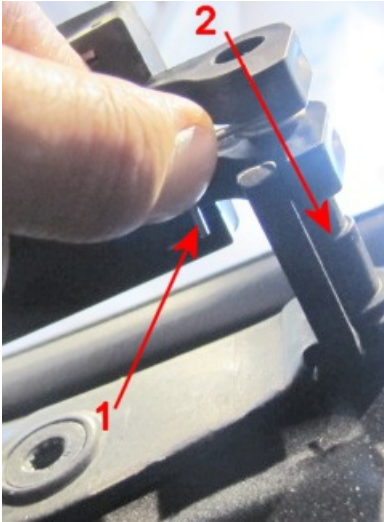
Figure 14

Position the new spring (part number 3W0827441 or 3W0827665) in the removed door. Whilst holding the spring tang back (1) partially fit door and new spring onto bearing pin (see Figure 14)

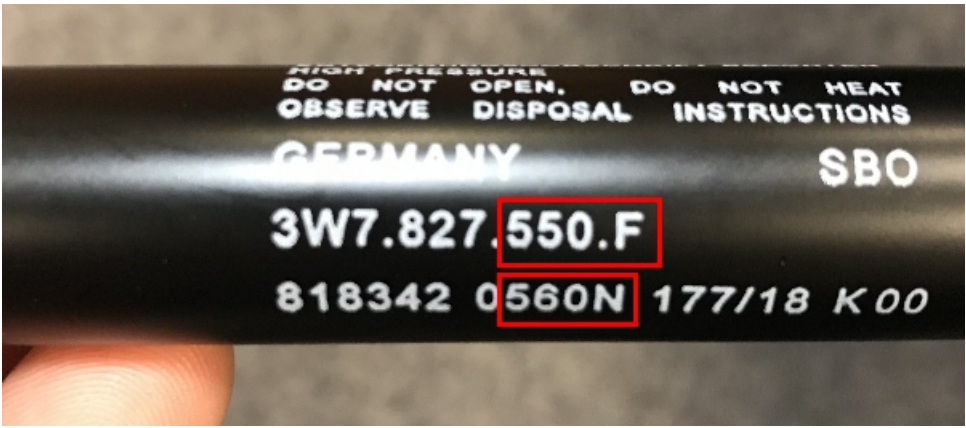
Correct left hand side strut **3W7827550F (560N)** - marked in White writing.

Should any of the boot lid struts not be correct as detailed above, replace the incorrect strut/s according to ETKA.

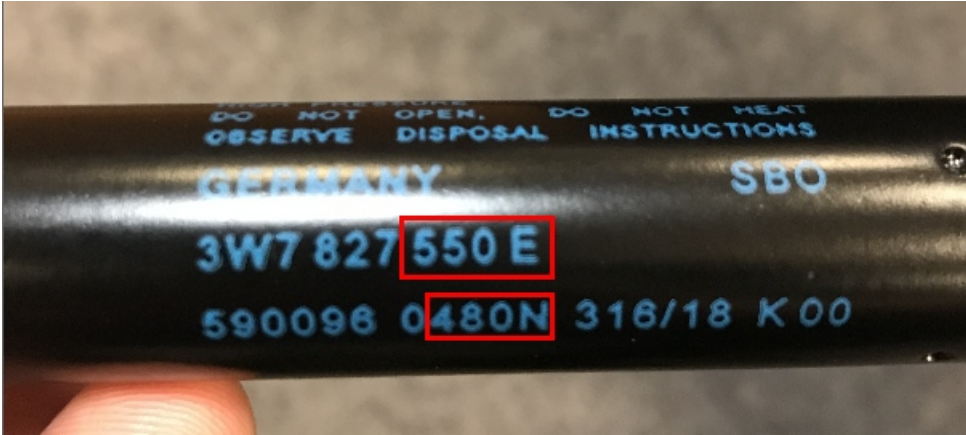
Correct right hand side strut **3W7827550E (480N)** - marked in Blue writing.

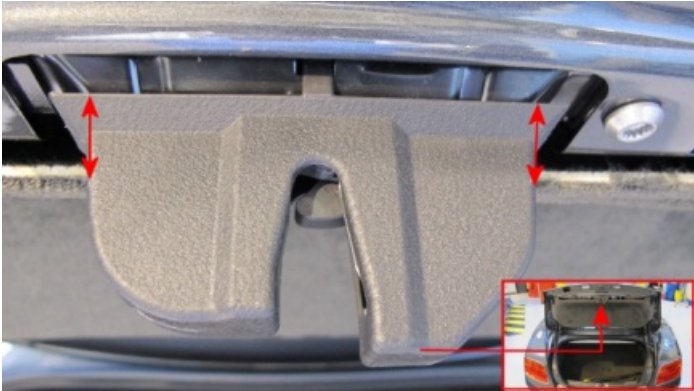
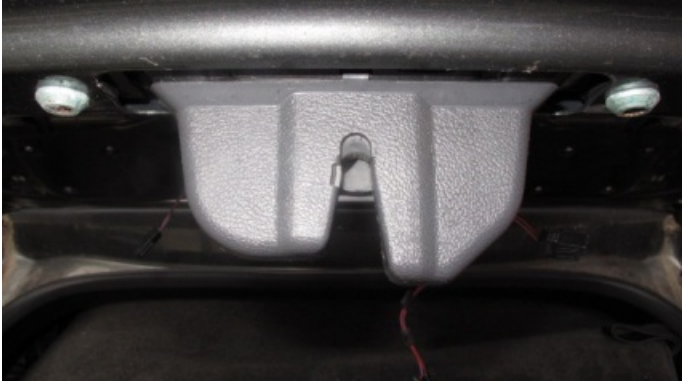
Figure 15

Inspect the area of the latch cover that receives the striker pin if damage is evident indicating a clash with the striker pin then replace the cover with the latest part which has a wider opening "Refer to Boot lid trim panels - To remove and fit" Rep.Gr.70

To replace remove and discard latch plastic cover (see Figure 15). Note: figure 15a shows the original cover, figure 15 shows the new cover

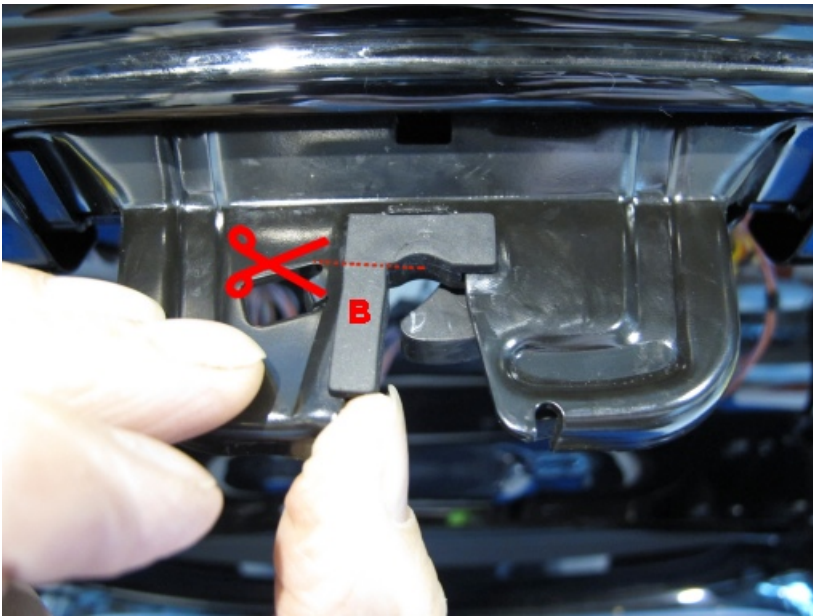
Figure 16a

With the original plastic cover removed modify the latch buffer by removing section B shown in figure 16a

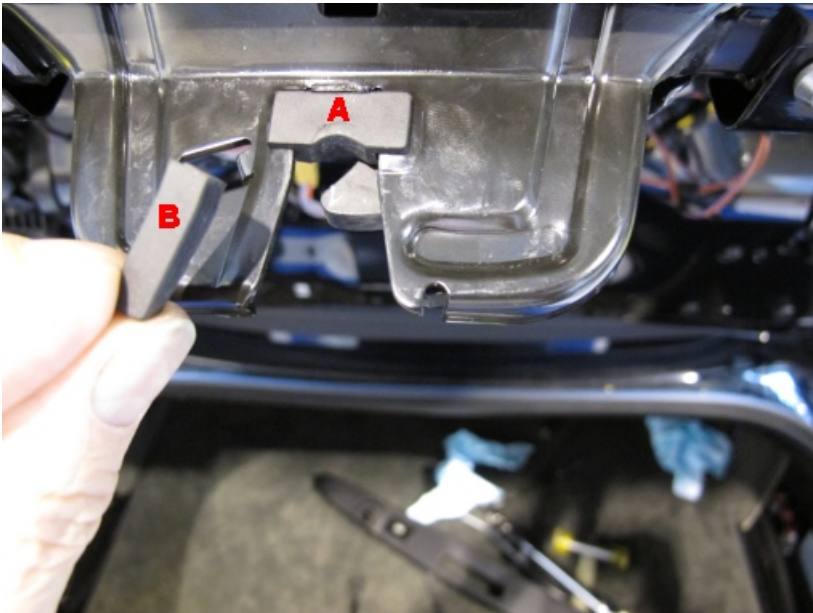
Figure 16b

With section B cut and discarded from the main buffer to form part A (see Figure 16b) then the new latch plastic cover (part number 3W0827520A) can be fitted

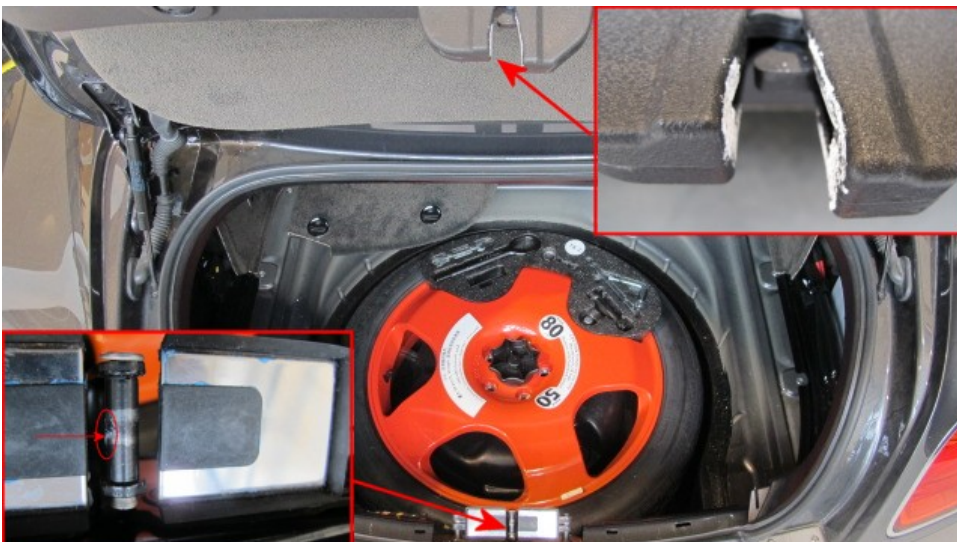
Figure 17

With the fit and profile of the boot lid set check and if necessary adjust the striker plate to ensure it is central in the boot latch striker plastic cover. To do this apply chalk to the boot latch striker plastic cover and operate the boot close function. If chalk is deposited on the striker pin then adjust the striker assembly to the left or right to reduce this occurrence. In the example the chalk is deposited on the left hand side of the pin this would necessitate the striker assembly being adjusted 1 or 2 mm to the right (see Figure 17). Once set remove chalk traces

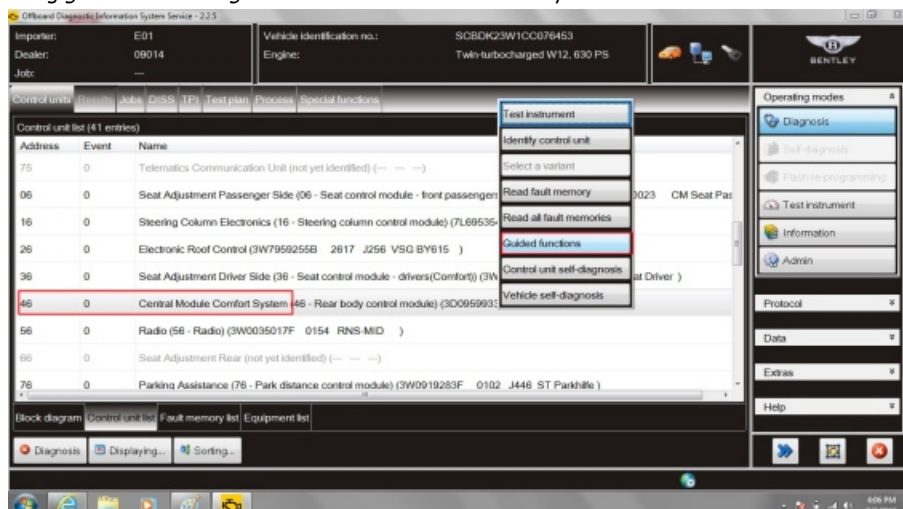
Figure 18

- Within Control units – Select (single touch) *46 Central Module Comfort System* – Reveal drop down menu (extended touch and release), Select *Guided functions* (see Figure 18)

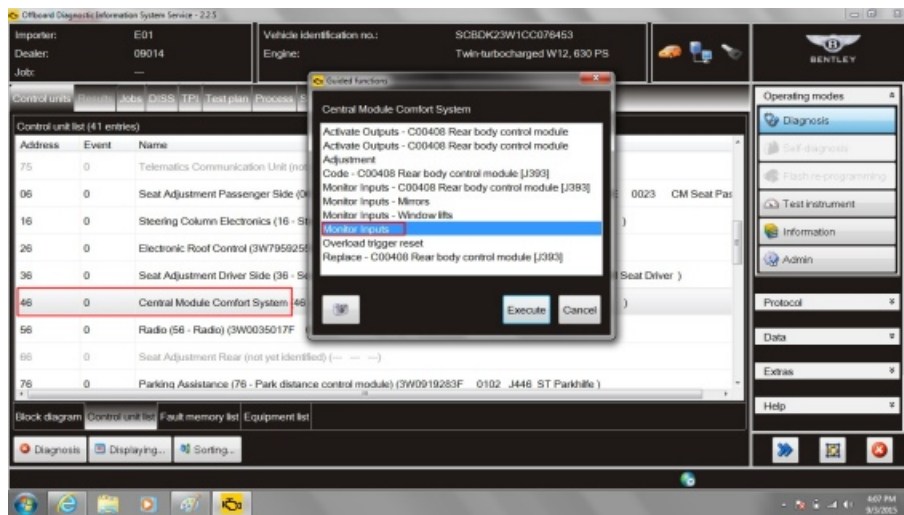
Figure 19

- Within Control units, *Central Module Comfort System*, Select *Monitor Inputs* and then Execute (see Figure 19)

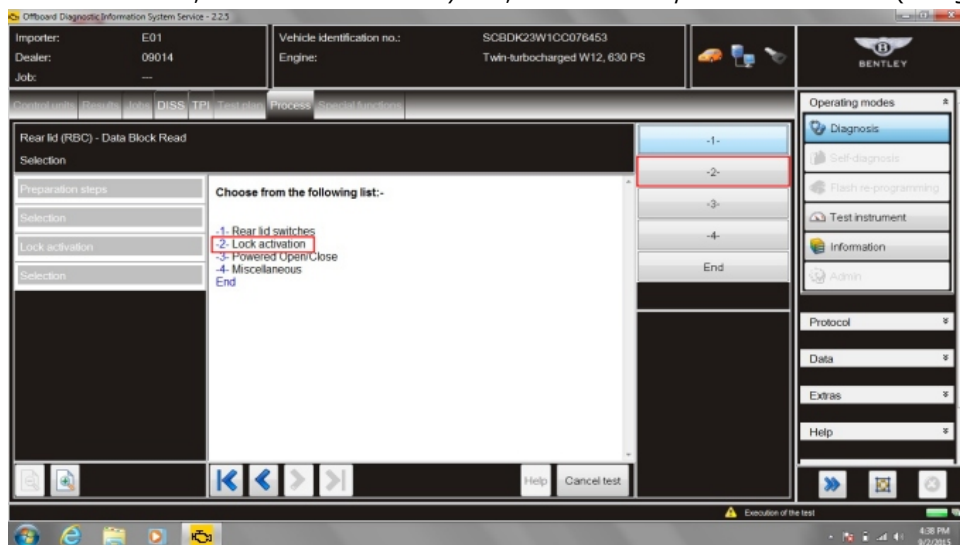
Figure 20

- Within Rear lid (RBC)-Data Block Read select *-2- Lock activation* (see Figure 20)

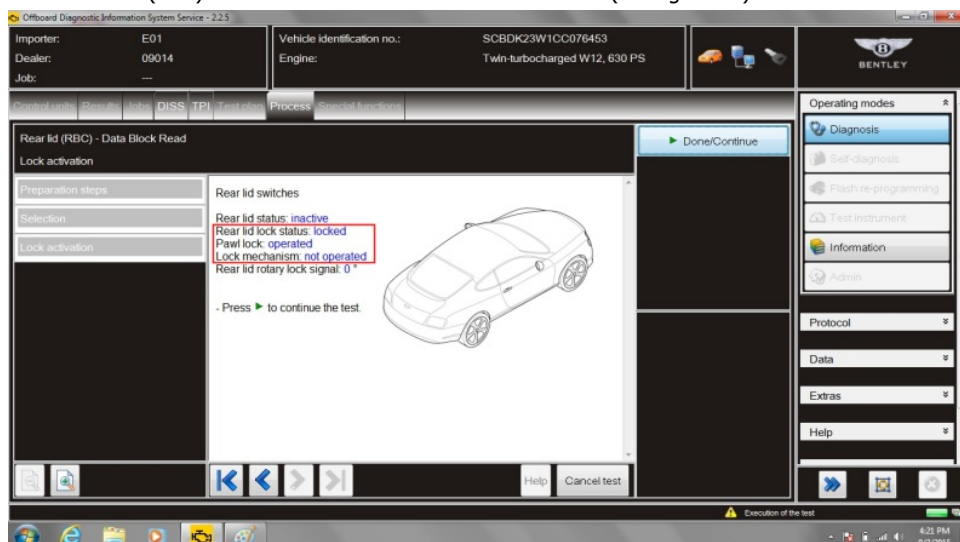
- The correct status for the boot lid micro switch assembly in the closed position is highlighted in Figure 21

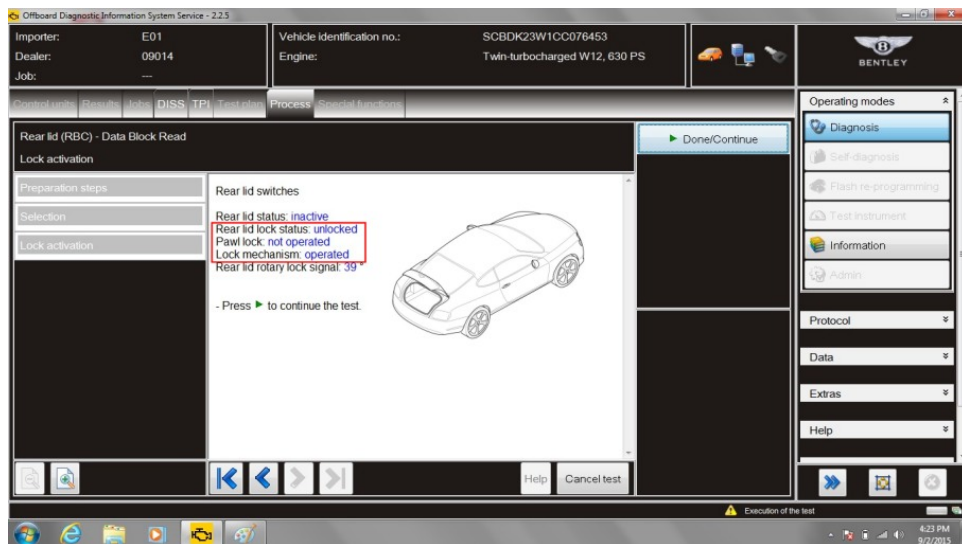
- The correct status for the boot lid micro switch assembly in the open position is highlighted in Figure 22
 - if either open or close status in relation to the micro switch is functioning incorrectly then replace boot latch assembly "Refer to Boot lid and fittings - Boot lid latch – To Remove and Fit – Rep.Gr.55.

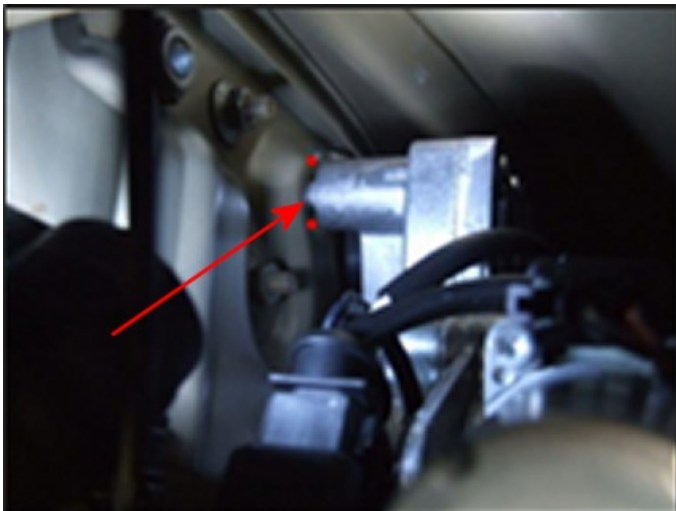
Figure 23

- a. Not applicable to GT Convertible derivatives - Remove tail lamp (right hand) on boot motor side to enable check. Check that the power boot motor is correctly aligned on to the hinge splines and that the locating peg (see figure 23) is fully engaged in the body location and tapping plate - where necessary loosen motor and correct alignment
 - Carry out closing force gauge test – if the load measured to initiate the close cycle is less than 1Kg and the boot completed three consecutive power open and close cycles then the campaign is complete, apply a white campaign identification mark to the boot striker plate (see Figure 23) otherwise continue with stage 3 checks

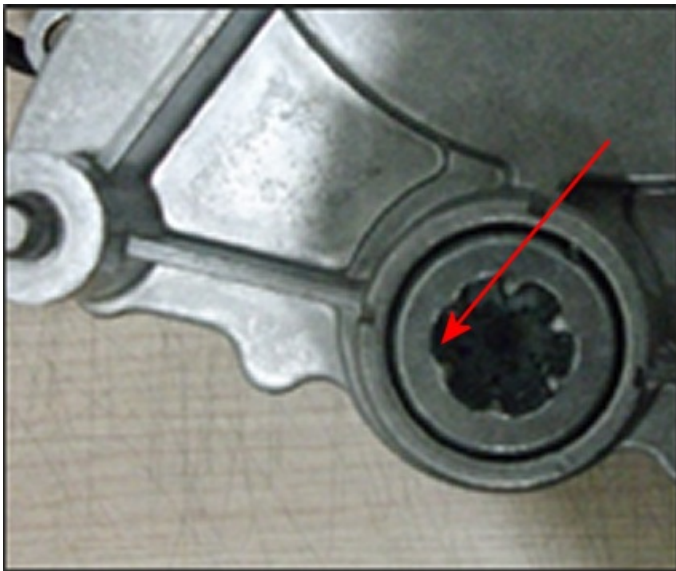
Figure 24

- a. Remove motor and inspect motor spline drive and hinge spline for damage replace damaged components where necessary (see Figure 24)
 - Carry out boot lid function and force gauge test – if the load measured to initiate the close cycle is less than 1Kg and the boot completed three consecutive power open and close cycles then the campaign is complete, apply a white campaign identification mark to the boot striker plate (see Figure 25)

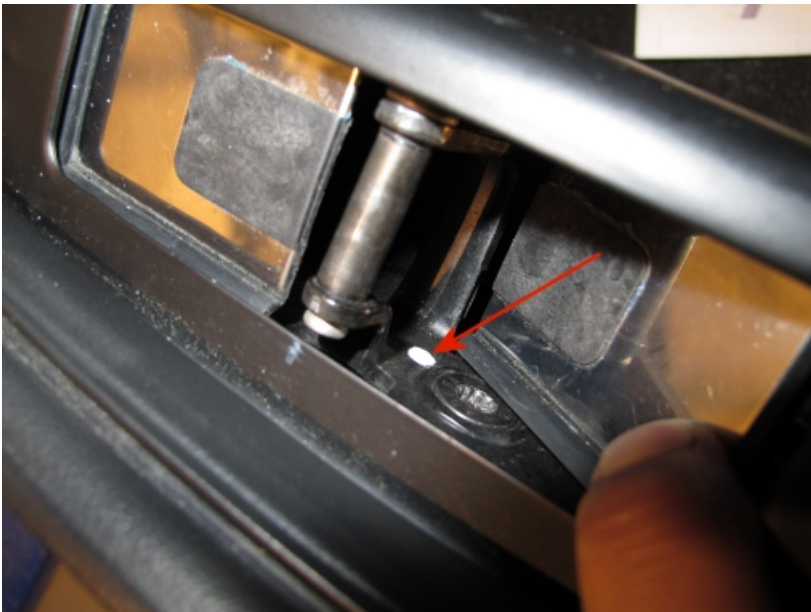
Figure 25

On completion apply a white identification mark to the boot striker plate (see Figure 25)

If the vehicle is not already listed as repaired in the "Repair history" (in Elsa pro), check for the presence of a white campaign identification mark (see Figure 25), should neither be evident carry out the required work in accordance with these instructions
