Technical Service Bulletin

Topic	Air spring fault finding
Market area	Bentley: worldwide (2WBE)
Brand	Bentley
Transaction No.	2053492/4
Level	EH
Status	Released for publishing
Release date	May 17, 2019

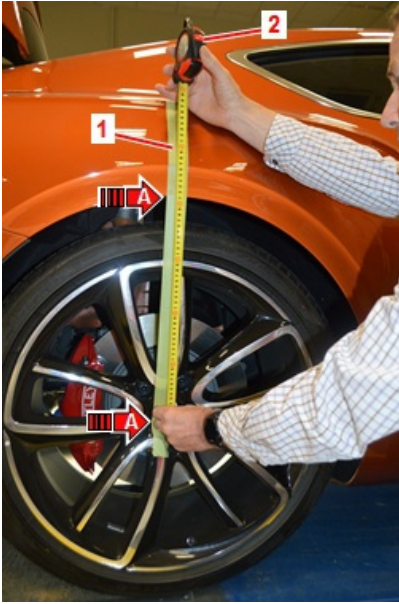
Figure 1

Adhere strips of masking tape (1) from the centre of each wheel to the highest part of the wheel arch as shown, making sure they are applied taut.

Using a tape measure (2), also measure and take note of the ride heights (A-A) at all four corners of the vehicle. See Figure 1.

Leave the vehicle overnight and again measure the ride heights (A-A) at all four corners of the vehicle. Compare these values with those taken previously.

If there is **NO** difference in ride heights, and the strips of masking tape are still 'taut' then no air leak is present. Please explain to the customer the long term storage or changing climate conditions would cause a drop in ride height which is normal. As soon as the vehicle is started, the compressor will level the vehicle automatically. No further action is required.

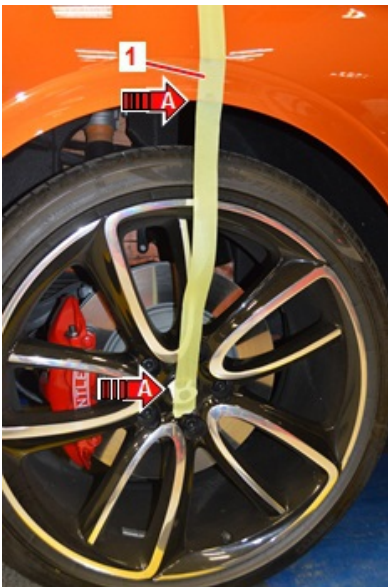
Figure 2

If there **IS** a difference in ride heights, and the strips of masking tape (1) have 'sagged' (shown in Figure 2), then refer to the following leak finding procedures below.

It should be noted that if these checks involve a claim through warranty then photographic evidence of the vehicle sagging and air leak should be included.

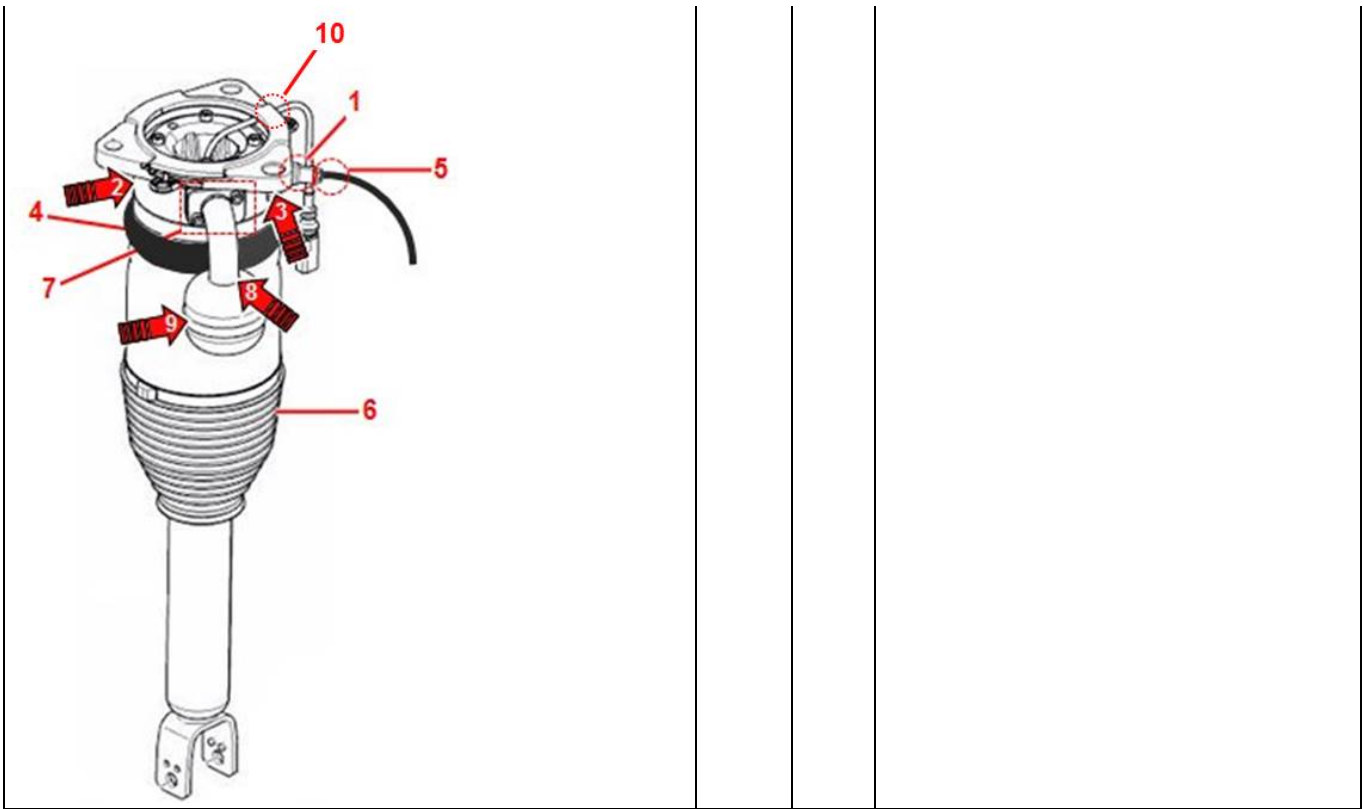
Rear air spring check points - Continental series (pre 2018) and Flying Spur

Check	Yes	No	Comments
Brass fitting to air spring (1)			
Top of air spring (2 & 3)			
Air spring bellows (4)			
Air feed pipe connection (5)			
Air spring gaiter condition (6)			
Air canister and canister to air spring (7, 8 & 9)			
Electrical cable route for air escaping (10)

Before any other checks are made to the rear air springs check to confirm the pipes are fully inserted and firmly connected within the brass fitting.

With the air suspension fully charged, use leak detector spray or a mild soap solution to check the connections for leaks as shown in the accompanying table.
