## PRODUCT CAMPAIGN BULLETIN

**APPLICABILITY:** 2019MY Legacy and Outback

**SUBJECT:** Front Duct Panel Spot Weld

**NUMBER:** WUH-93R

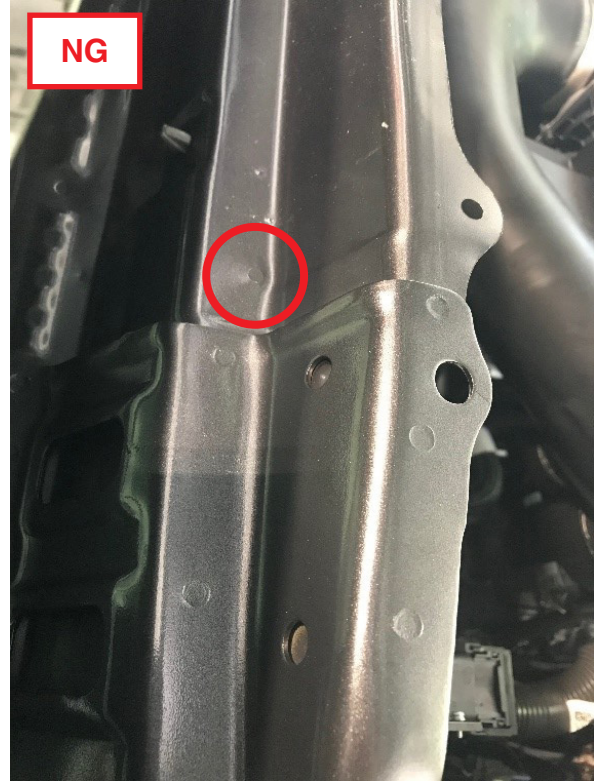
**APPENDIX A: Examples of NG ("B" Jig) and OK ("A" Jig) Duct Panel Weld Inspections**

**NOTE:** In this particular case, the weld is very difficult to see, especially in the supplied photo. Keep in mind, the vehicle's color can make the weld difficult to identify and photograph for making the OK / NG determination.
