LCI 8800 SERIES WINDOW REPAIR

TSB Number:	15-001-19
Product:	LCI Window Repair
Date:	May 20, 2019

Repair of specific 8800 Series LCI windows is needed to eliminate potential leaks and reinforce bond.

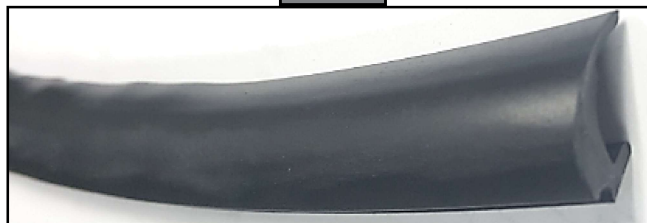
Fig. 1

1. **Vinyl:** Vinyl (Fig. 1) is a rubber seal to function as an initial water management barrier.

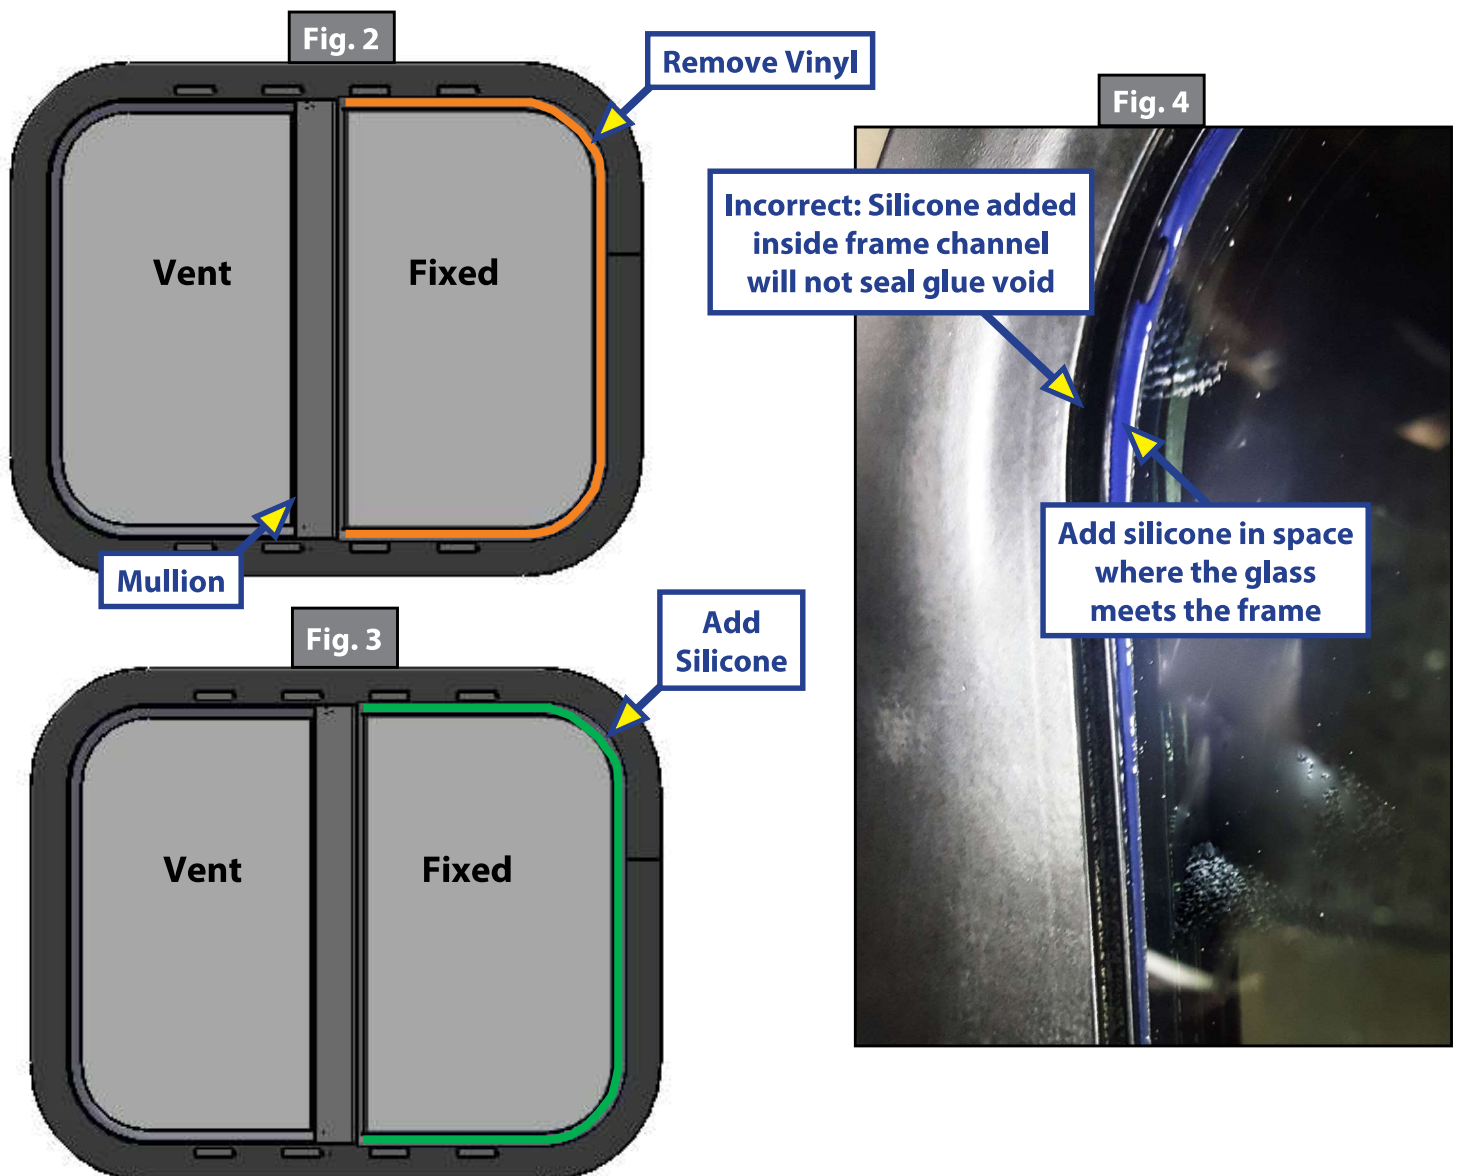
1. Pull out vinyl located around the outer perimeter of the fixed glass (Fig. 2) and save for reuse in areas not covered by a glazing bar.

NOTE: Do not remove vinyl on the mullion side of the glass (Fig. 2).

2. Run a bead of 100 percent silicone around the outer perimeter of the fixed glass (Figs. 3 and 4).
3. Reinstall the vinyl that was removed.

NOTE: Repair is to be completed only on the fixed glass portion of the window, not on every piece of glass.

NOTE: If the window has a glazing bar, it is not required to remove and seal behind the aluminum glazing bar. The bar provides enough compression to keep the seal between the glass and frame tight enough to prevent leaks.

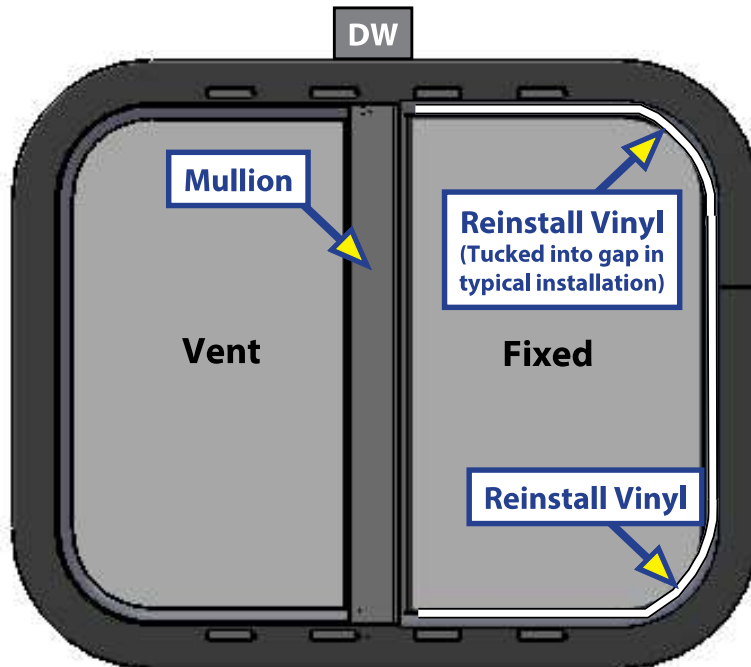
NOTE: Please utilize this table to verify sizes affected of the style window shown above.

8800 Series DW (Dual Weep)
8800 DW 18 X 18 G20 TP BK 8800-44076
8800 DW 18 X 22 G20 TP BK 8800-44077
8800 DW 18 X 22 OBS TP BK
8800 DW 24 X 15 CL TP BK 8800-44380
8800 DW 24 X 15 G20 TP BK 8800-44022
*8800 DW 48 X 29 CL TP BK 8800-44381
*8800 DW 48 X 29 G20 TP BK 8800-44025
*8800 DW 60 X 29 G20 TP BK 8800-44743
*8800 DW 60 X 29 G20 TP BK RED 8800-44402
*8800 DW 72 X 28 G20 TP BK RED 8800-44178

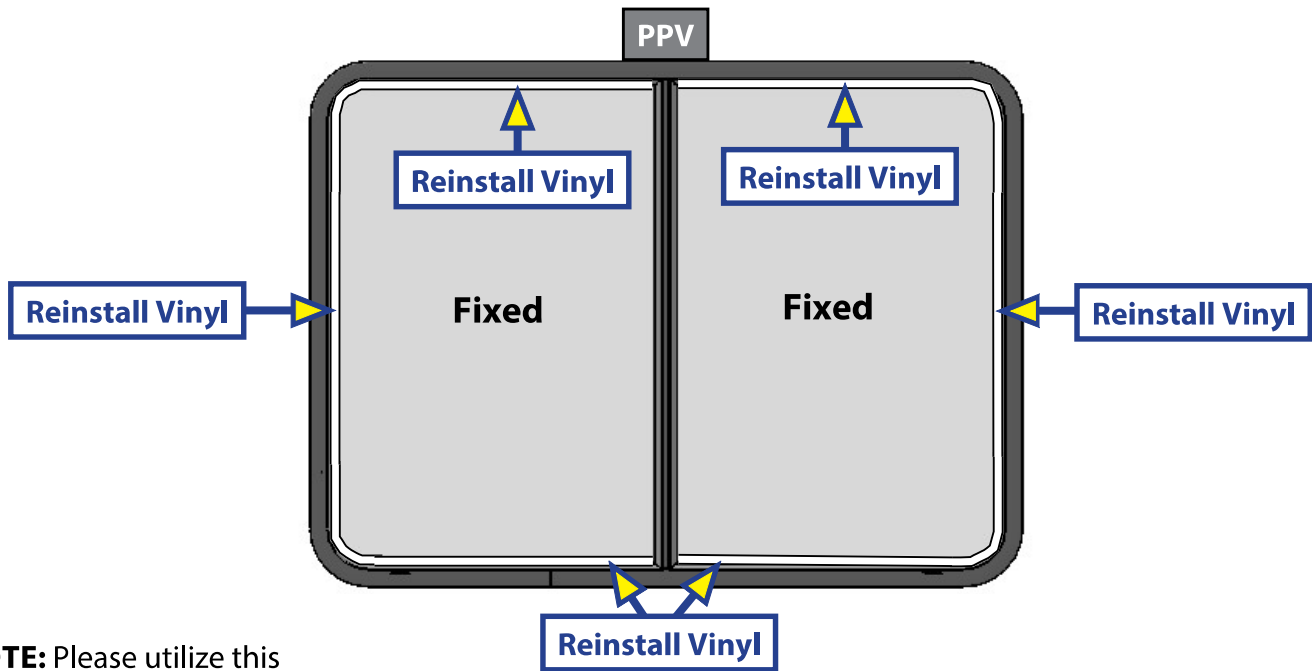
NOTE: Please utilize this table to verify size affected of the style window shown above.

8800 Series PPV (Picture Picture Vertical)
8800 PPV 72 X 22 G20 TP BK

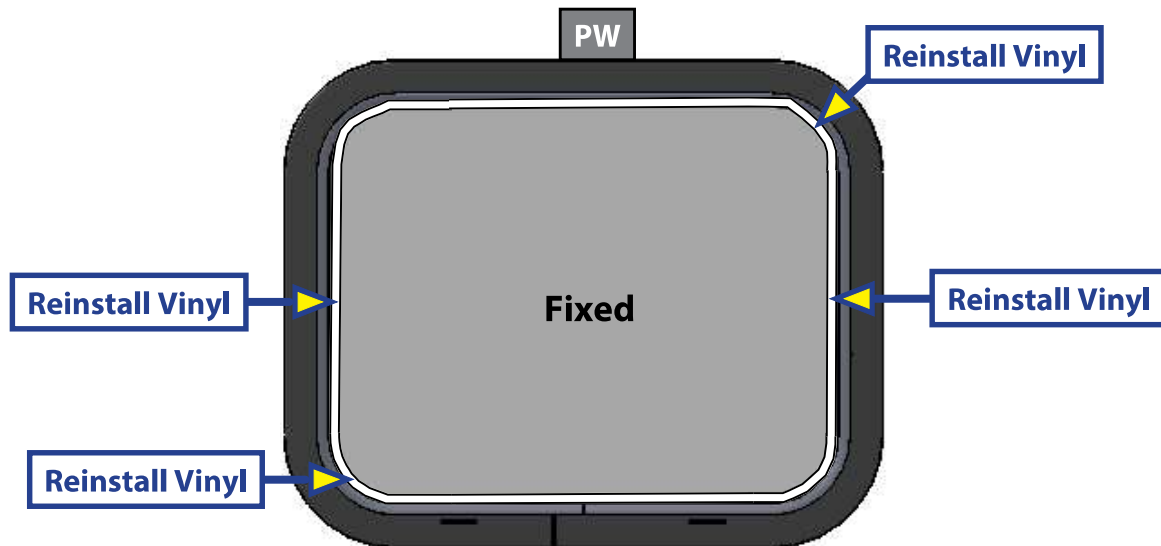
NOTE: Please utilize this table to verify sizes affected of the style window shown above.

8800 Series PW (Picture Window)
8800 PW 18 X 22 G20 TP BK 8800-44070
8800 PW 24 X 15 G20 TP BK 8800-44747
8800 PW 29 X 60 G20 TP BK 8800-44481
8800 PW 60 X 29 CL TP BK
8800 PW 60 X 36 G20 TP BK 8800-44442

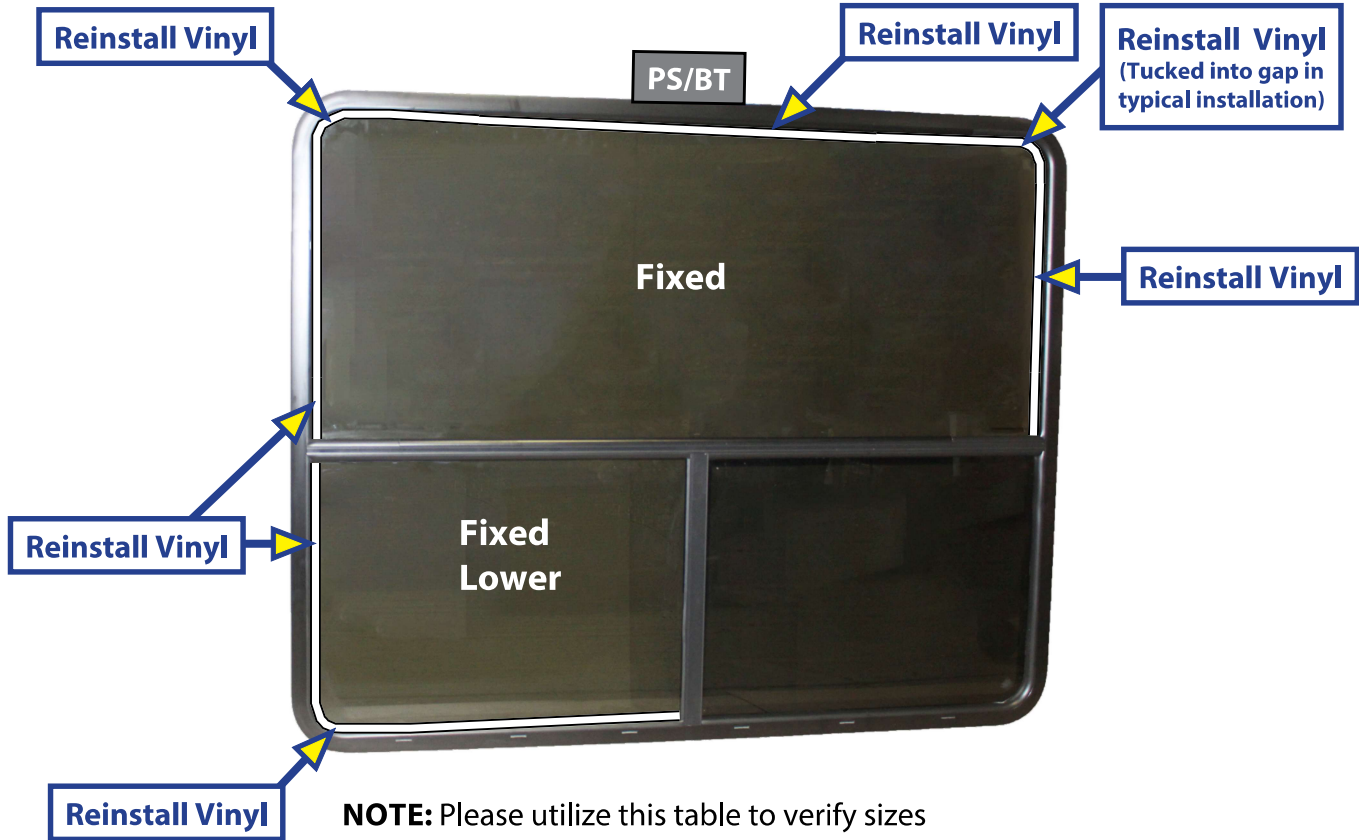
NOTE: Please utilize this table to verify sizes affected of the style window shown above.

PS/BT (Picture Slider Bottom T)
8800 PS/BT 36 X 36 X 9 G20 TP BK 8800-44093
8800 PS/BT 42 X 40 X 9 G20 TP BK 8800-44466
8800 PS/BT 48 X 36 X 9 G20 TP BK 8800-44102
8800 PS/BT 48 X 48 X 20 G20 TP BK 8800-44421
8800 PS/BT 60 X 35 X 20 G20 TP BK RED
8800 PS/BT 60 X 35 X 9 G20 TP BK
8800 PS/BT 60 X 36 X 20 G20 TP BK RED 8800-44172
8800 PS/BT 60 X 36 X 9 G20 TP BK 8800-44106
8800 PS/BT 60 X 42 X 20 G20 TP BK RED 8800-44498
8800 PS/BT 64 X 34 X 20 G20 TP BK RED
8800 PS/BT 70 X 34 X 20 G20 TP BK RED 8800-44176
8800 PS/BT 70 X 46 X 20 G20 TP BK RED
8800 PS/BT 72 X 34 X 20 G20 TP BK RED
8800 PS/BT 72 X 35 X 20 G20 TP BK RED 8800-44036
8800 PS/BT 72 X 48 X 20 G20 TP BK RED 8800-44179

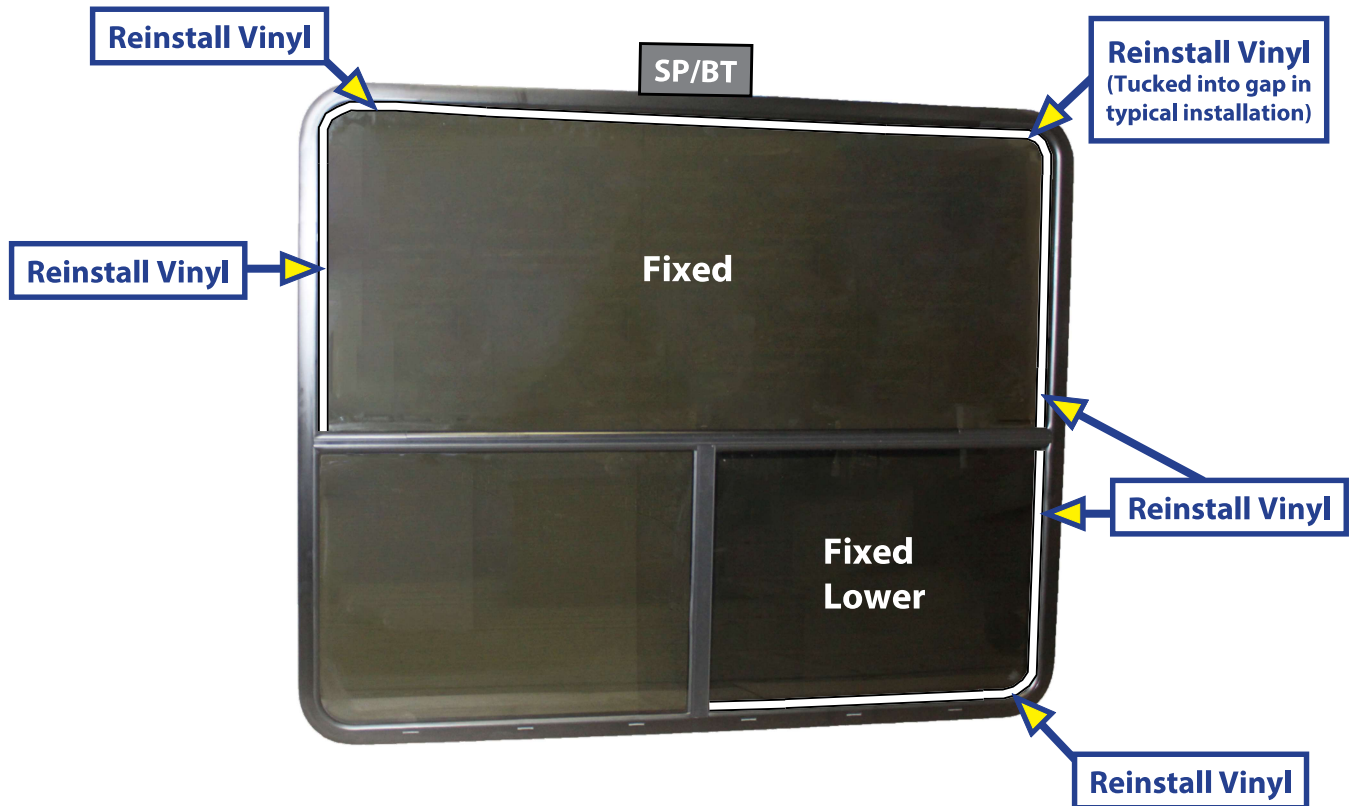
NOTE: Please utilize this table to verify sizes affected of the style window shown above.

SP/BT (Slider Picture Bottom T)
8800 SP/BT 36 x 36 x 9 G20 TP BK 8800-44094
8800 SP/BT 48 x 35 x 9 G20 TP BK
8800 SP/BT 48 x 36 x 9 G20 TP BK 8800-44013
8800 SP/BT 48 X 48 X 20 G20 TP BK 8800-44418
8800 SP/BT 60 X 35 X 9 G20 TP BK
8800 SP/BT 60 X 36 X 20 G20 TP BK RED 8800-44173
8800 SP/BT 60 X 36 X 9 G20 TP BK 8800-44639
8800 SP/BT 60 X 42 X 20 G20 TP BK RED 8800-44499
8800 SP/BT 60 X 42 X 9 G20 TP BK
8800 SP/BT 68 X 36 X 20 G20 TP BK RED 8800-44413
8800 SP/BT 70 X 46 X 20 G20 TP BK RED 8800-44177
8800 SP/BT 72 X 35 X 20 G20 TP BK RED 8800-44454
8800 SP/BT 72 X 35 X 9 G20 TP BK 8800-44403
8800 SP/BT 72 X 40 X 9 CL TP BK 8800-44445
8800 SP/BT 72 X 40 X 9 G20 TP BK 8800-44109
8800 SP/BT 72 X 40 X 9 G55 TP BK 8800-44318

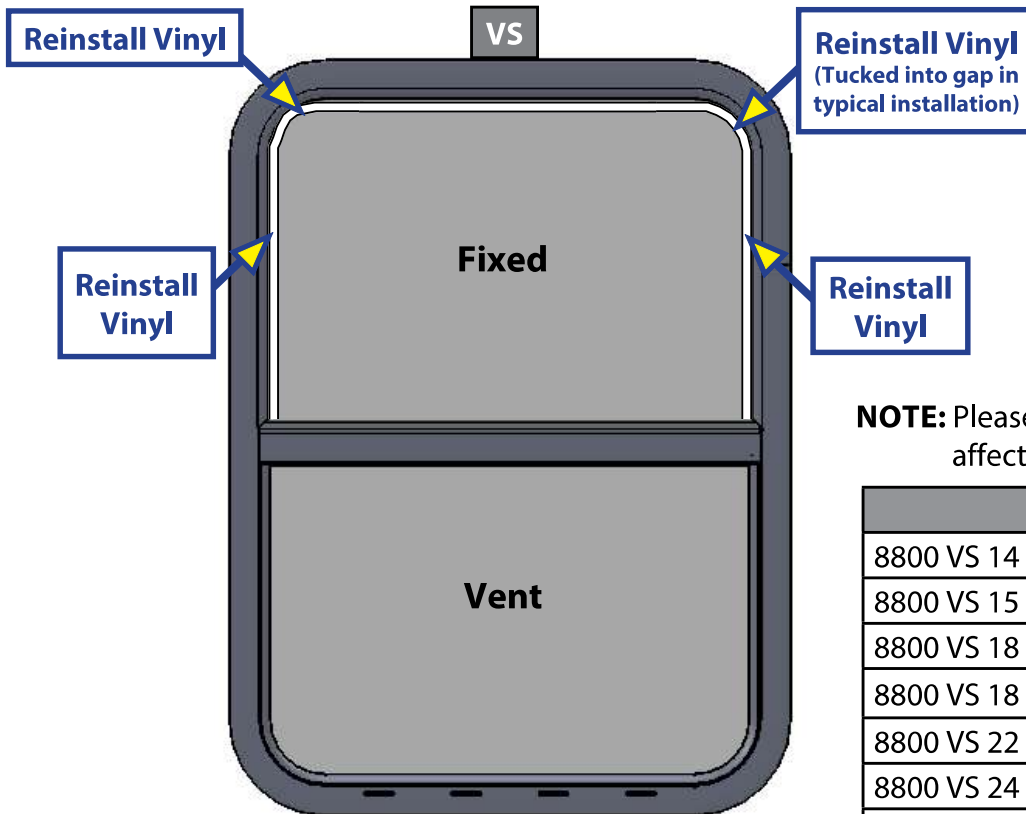
NOTE: Please utilize this table to verify sizes affected of the style window shown.

VS (Vertical Slider)
8800 VS 14 X 22 G20 TP BK 8800-44116
8800 VS 15 X 21 G20 TP BK 8800-44657
8800 VS 18 X 18 G20 TP BK 8800-44124
8800 VS 18 X 22 G20 TP BK 8800-44001
8800 VS 22 X 18 G20 TP BK 8800-44137
8800 VS 24 X 20 G20 TP BK 8800-44142
*8800 VS 27 X 50 G20 TP BK RED 8800-44724
