# Preliminary Information

# PIC5779K Information on Preparation / Washing to Avoid Damaging Bright Aluminum Moldings

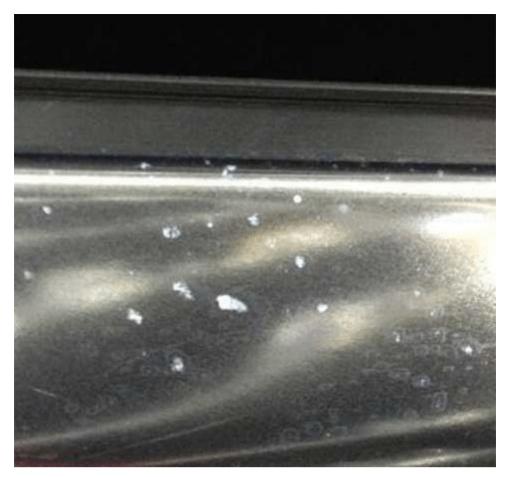
Important: Please ensure this information is reviewed with vehicle owners. In order to avoid damage that may not be covered by your warranty, it is recommended that a non-alkaline solution be used for preparation & washing of the Bright Aluminum Moldings.

If a cleaning solution greater than 11.0 pH is used, the following procedure must be used:

- Prewash the vehicle to bring moldings to room temperature.
- Apply cleaning solution out of the sunlight at room temperature.
- Rinse moldings with clean water within 5 minutes of application of cleaning solution.
