GLOBAL SAFETY FIELD INVESTIGATIONS
DCS5090
URGENT - DISTRIBUTE IMMEDIATELY

Subject: N192219160 - Service Update
Rear Axle Housing Breather Not Properly Installed

Models: 2019 Chevrolet Silverado 4500/5500/6500

N192219160 – Rear Axle Housing Breather Not Properly Installed

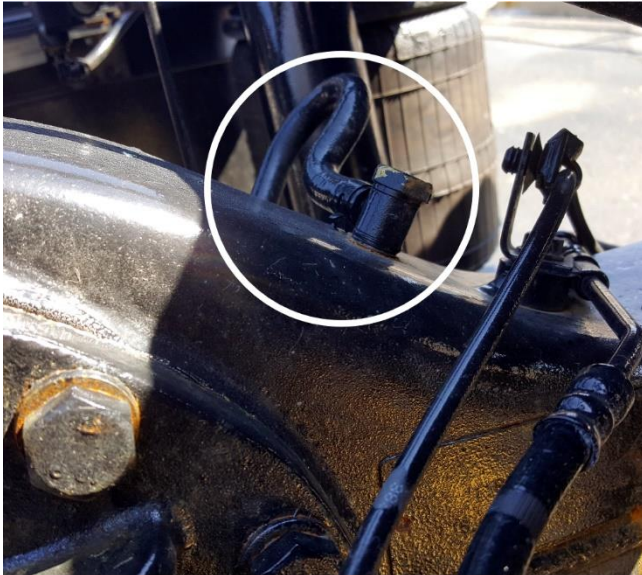
5359983

1. Inspect the Rear Axle Housing Breather (as shown above) to see if it is present.
 - If the Rear Axle Housing Breather is present, no further action is required.
 - If the Rear Axle Housing Breather is **not** present, proceed to step 2.
2. Install a Rear Axle Housing Breather. Refer to *Rear Axle Housing Breather Replacement* in SI.
3. Drain and fill the differential fluid. Refer to *Differential Oil Replacement* in SI.
