**Millimeter Wave Radar Won't Align; DTC P2583-76 Won't Clear**

All models with Bosch millimeter wave radar.

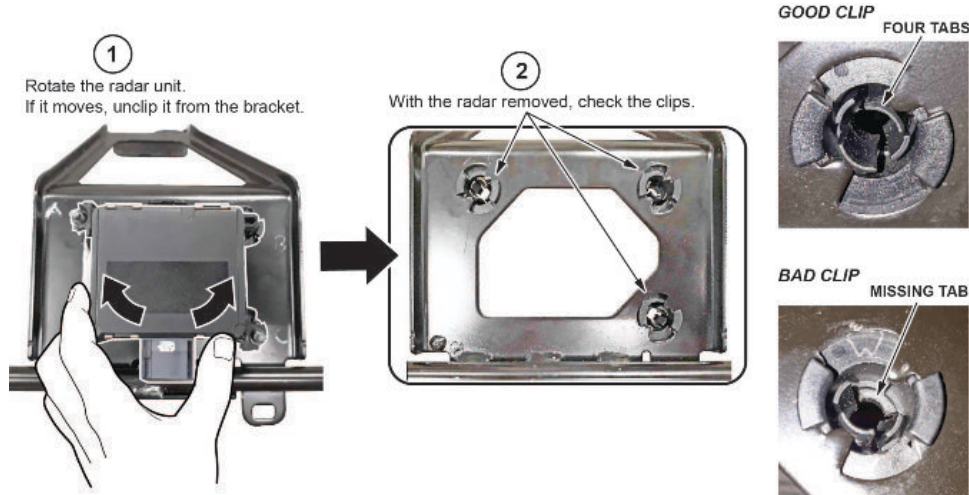
If you're having trouble aligning the front millimeter wave radar, or if DTC P2583-76 is present and does not clear after re-aiming, inspect the radar mounting clips and bracket.

Check that the mounting bracket is not bent or out of shape. Check if the radar unit for play by trying to twist it. If there is play, remove the radar unit and check each mounting clip for damage. Replace all clips that have damage or missing tabs.

These items should be checked first before replacement of the radar unit. If you are still having issues after following this, then replace the radar unit.
