Seat belt does not roll up correctly

Topic number	LI91.40-N-062773
Version	3
Function group	91.40 Seat belts, emergency tensioning retractors
Date	07-11-2019
Validity	Model 447, 906, 907
Reason for change	Content updated and removal of inapplicable vehicles.
Reason for block

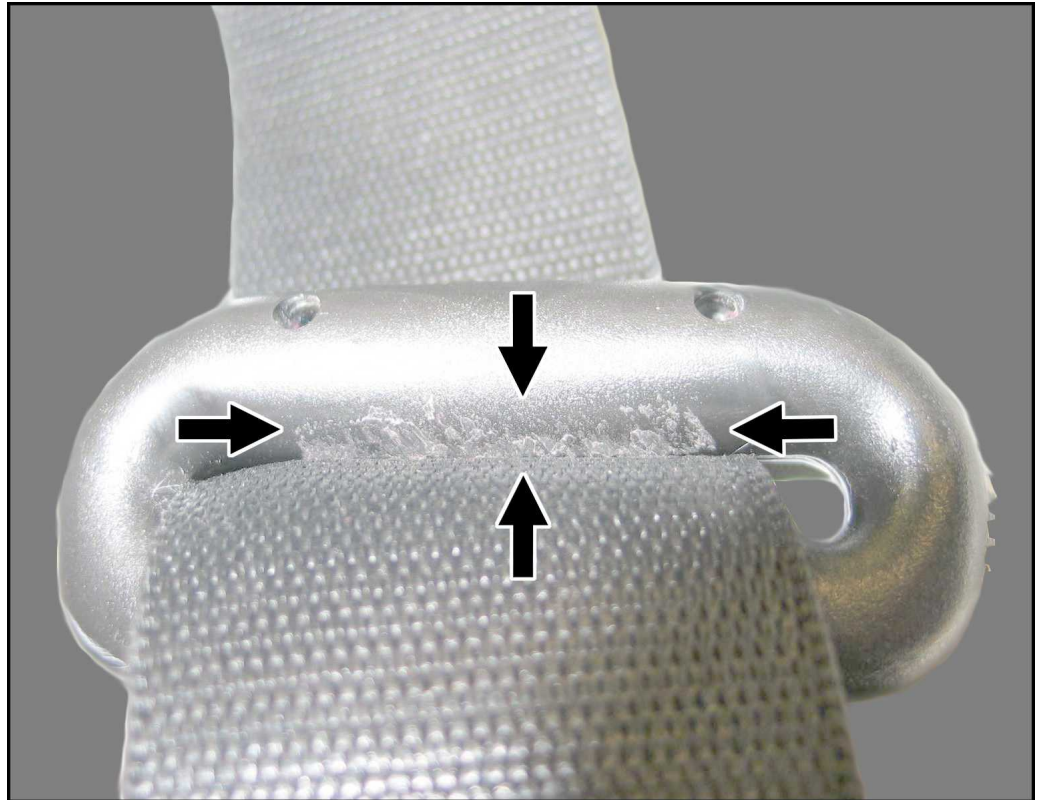
01.jpg:

Dirt deposits on the seat belt guide due to a dirty seat belt (see picture 01).

Attachments	
File	Description
01.jpg	Seat belt guide dirty. The dirt visible here can stop the seat belt rolling up properly.

1. Remove dirt deposits on seat belt using a dry cloth or a soft brush then clean seat belt (see AP91.40-S-1000-01A).

2. Check guide slot of belt guide on B-pillars or passenger seats for soiling, and clean if necessary (see AP68.30-S-1000-01A).

Note: When cleaning the seat belt guide bracket, observe cleaning instructions for seat belts in the owner's manual! Use cleaner for plastic parts. Only treat the belt guide, not the seat belt!

3. If the cleaning does not bring about any improvement, replace the corresponding seat belt.
