IMMEDIATE INSPECTION REQUEST – FUSE BOX BOLT

Subject: IMMEDIATE INSPECTION REQUEST – FUSE BOX BOLT DEALER SERVICE CAMPAIGN (V1904)

Affected Models: Certain Unsold Units in Dealer Inventory Only (Excluding Vehicles at the Body Company)

- **2018-2019MY Isuzu FTR Vehicles**
- **2017-2018MY Isuzu N-Gas Vehicles**

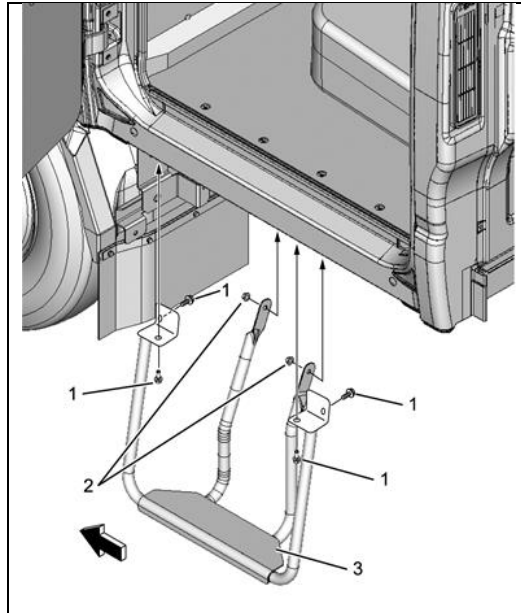
Figure 1

1. Place the vehicle in park, apply the parking brake, and remove the key from the engine control switch.
2. Disconnect the negative battery cable.
3. If the vehicle is a crew cab model, also remove the driver side rear step. (See Figure 1.) If not, proceed to the next step.

1. Bolt
2. Nut
3. Rear Step

17. Install the fuse box cover.
18. If the vehicle is a crew cab model, install the driver side rear step and torque to the provided specifications. (See Figure 1.) If not, proceed to the next step.
Tightening Torque: 13 lb ft. (18 Nm).

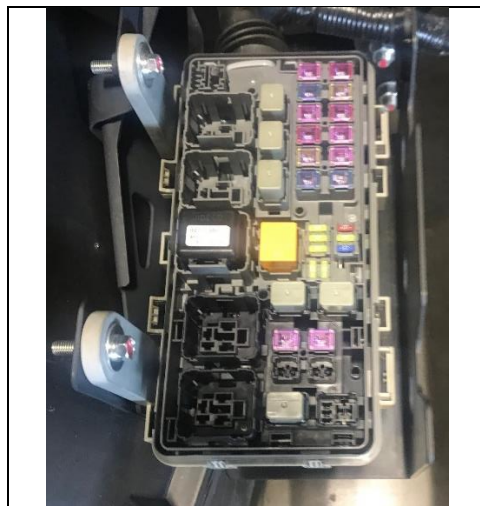
Figure 2

4. Remove the fuse box lid to expose the relays and fuses. (See Figure 2.)

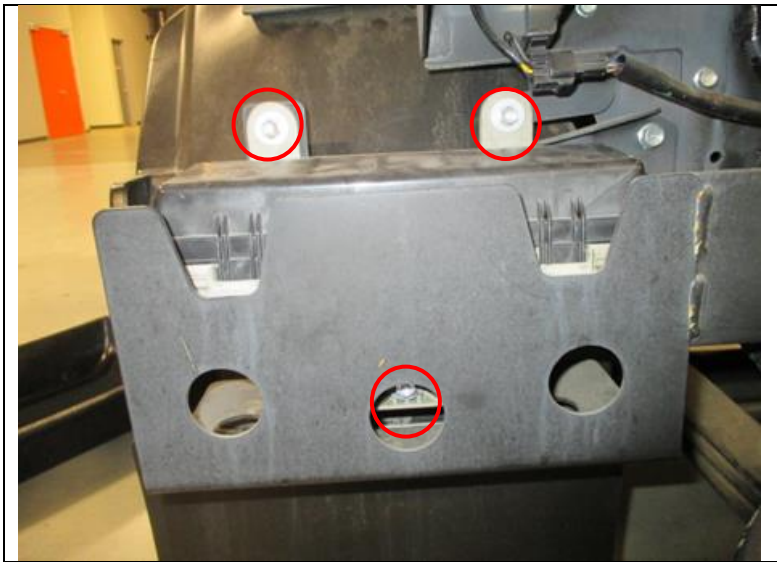
Figure 3

5. Remove the three (3) 12mm fuse box mounting bolts and set these aside for later use. (See Figure 3.)

14. Install the rubber grommet and tape as necessary.
15. Install the fuse box lower cover.
16. Mount the fuse box onto the vehicle using the three (3) 12mm mounting bolts removed in Step 5. Tighten the bolts to the provided specification.
Tightening Torque: 5.3 lb ft. (7.1Nm).

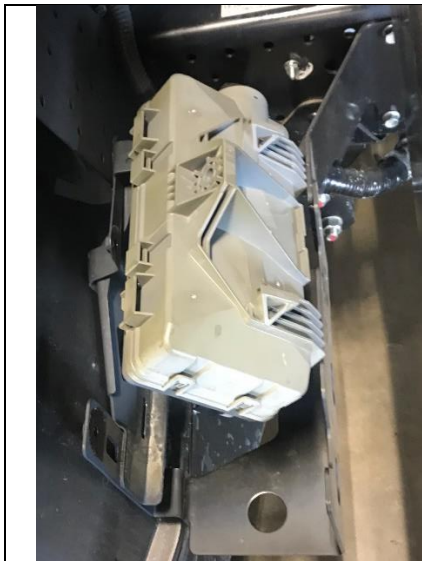
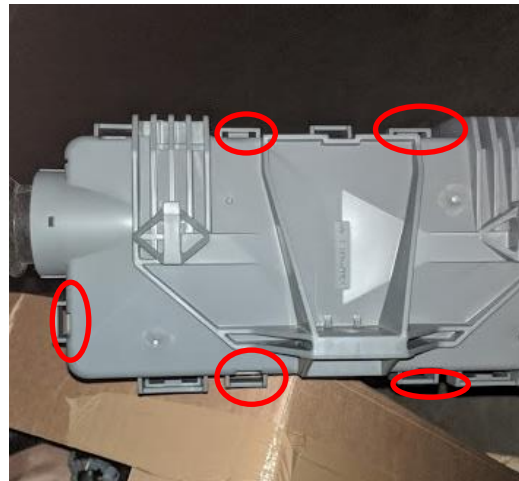
6. Flip the fuse box over and remove the lower cover using a flat blade screwdriver to release the five (5) locking tabs. Set lower cover to the side for later use. (See Figures 4 and 5.)

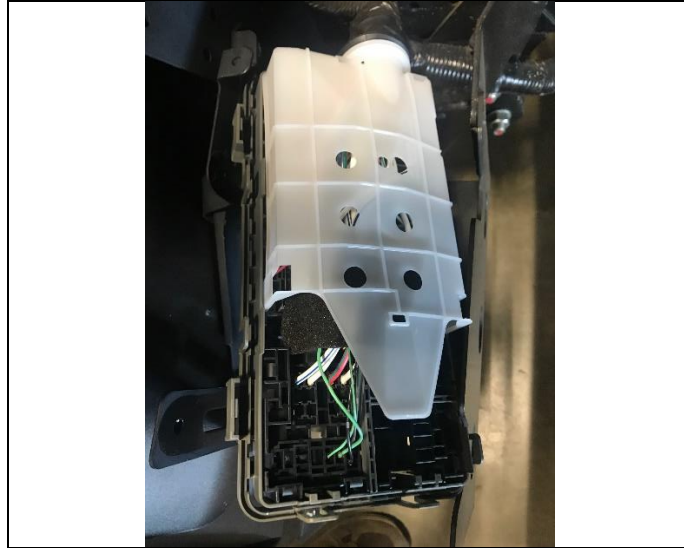
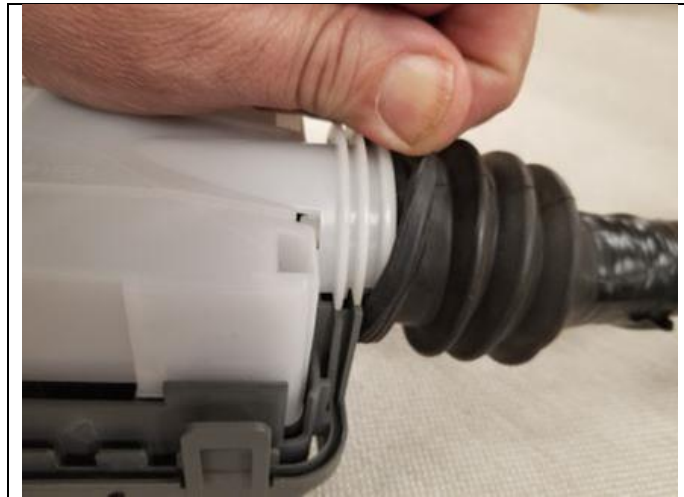
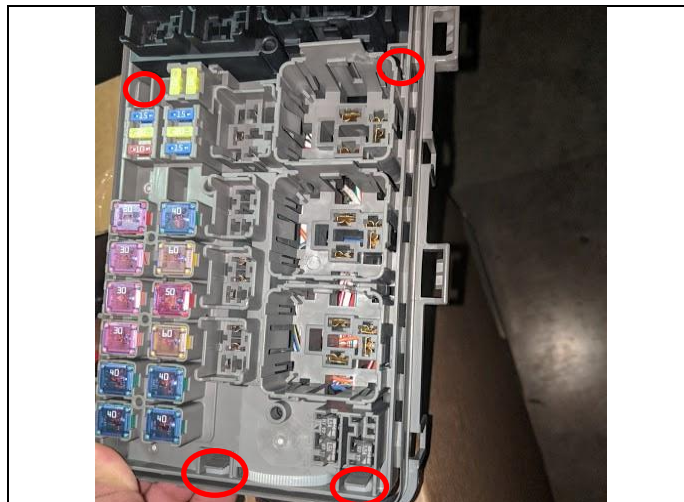
7. Remove the inner cover by removing the PVC tape, pulling the grommet off the end of the fuse box halves and using the same process to release the locking tabs as in Step 4. Set the cover to the side. (See Figures 6, 7 and 8.)

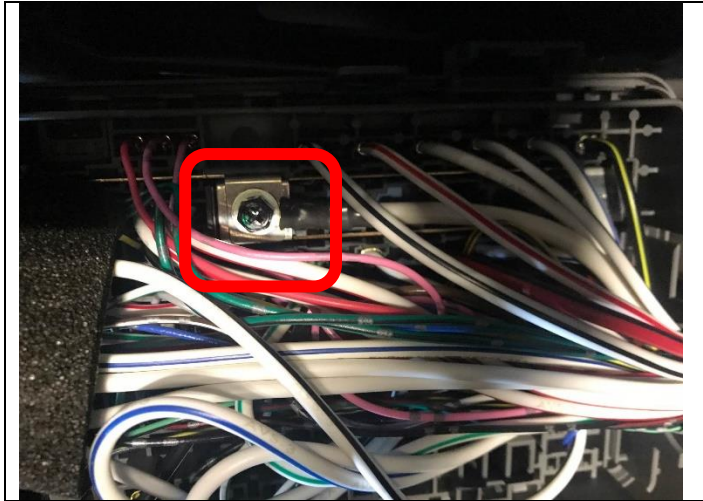
Figure 9

- Using no tools, check the power supply terminal bolt with your fingers only for looseness. (See Figure 9.) Document on the repair order whether the bolt is able to be loosened with your fingers.

12. Torque the power supply terminal bolt to the provided specification.
Tightening Torque: 30.1 lb in. (3.4 Nm).
13. Install the white inner fuse box cover.

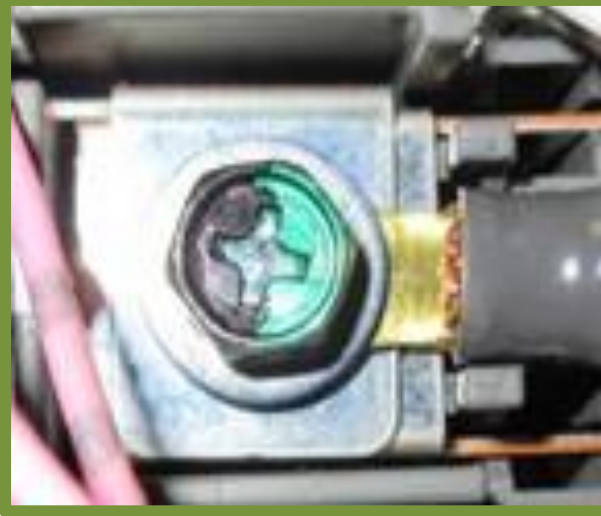
- Inspect the wire terminal insulation for excess insulation. (See Figures 11 and 12.) If the insulation is OK, proceed to Step 12. If the insulation is Not OK, proceed to Step 11.

Figure 11 – OK Condition

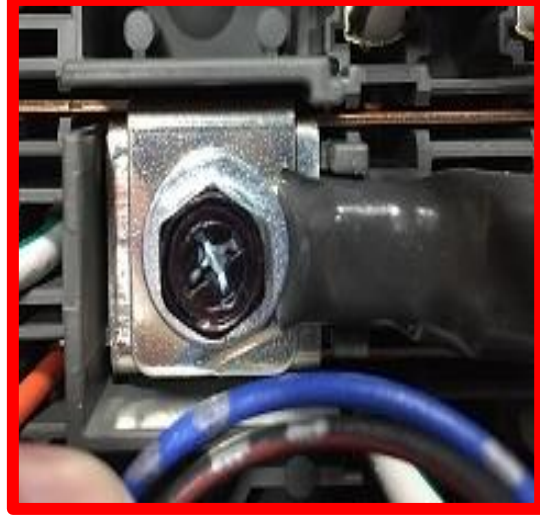
Figure 12 – Not OK Condition

11. Remove the terminal bolt and lift the terminal away from the fuse box. Using a razor blade, carefully trim away any excess insulation as necessary. Then reinstall the bolt.
