**DOORS**

This document describes the procedure to replace the vertical mullion in the center of the screen door of an RV entry door.

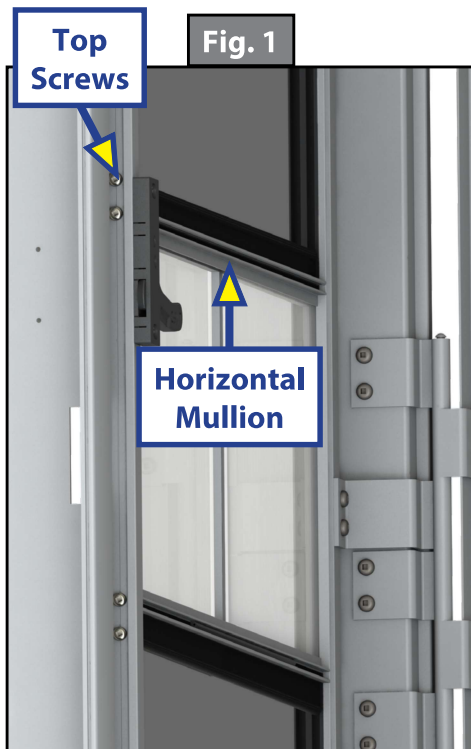
1. Remove both top screws on each side of the screen's horizontal mullion (Fig. 1).
2. Pull out enough of the screen spline in order to provide room to maneuver during the replacement procedure, about 4" past the vertical mullion (Fig. 2).
3. Pull out on vertical mullion to remove it (Fig. 2).
4. Install replacement vertical mullion by tapping it softly to seat it.
5. Replace the spline using a rubber mallet or a flat screwdriver and hammer to reinstall.
6. Reinstall the top horizontal mullion screws (Fig. 1) on both sides of the screen.
