J Coach Engine Door Rework

This procedure outlines the rework to address Engine compartment door de-bonding The procedure applies to J4500 coaches with 03-31-4155 engine door.

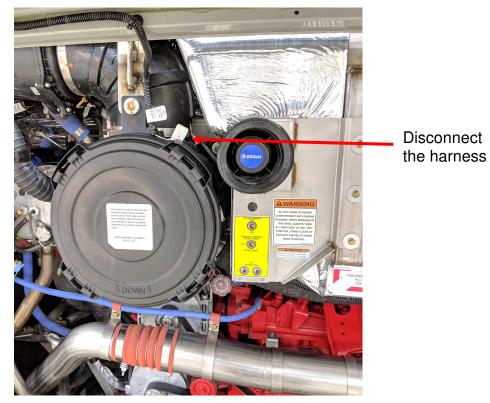
Disconnect the license plate harness from the engine compartment harness.

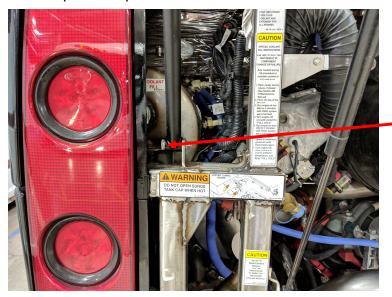
On the driver side, remove the shoulder screw, lock nut attaching the long link assembly to the bracket of coach frame. Save the lock nut and screw for later use. Repeat the process for the curb side.

Remove and save the shoulder screw, lock nut

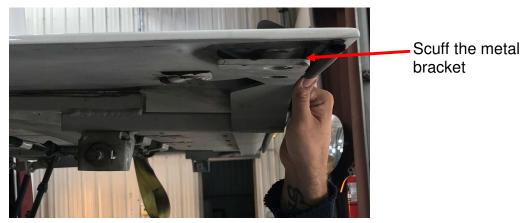
Scrape the existing adhesive from the fiberglass door, metal frame surface and holes in the metal frame at the detached location.

Using scotch brite abrade the metal bracket where the detachment is observed.

Clean the scuffed metal frame and the fiberglass door with 23-02-0012, adhesive promoter.
