# Technical Service Bulletin

SUBJECT:		No: <b>TSB-19-51-003</b>	
<b>GLUE REMOVAL ON DOOR MIRROR</b>		DATE: <b>August 2019</b>	
		MODEL: <b>All</b>	
<b>CIRCULATE TO:</b>	<input type="checkbox"/> GENERAL MANAGER	<input checked="" type="checkbox"/> PARTS MANAGER	<input checked="" type="checkbox"/> TECHNICIAN
<input checked="" type="checkbox"/> SERVICE ADVISOR	<input checked="" type="checkbox"/> SERVICE MANAGER	<input checked="" type="checkbox"/> WARRANTY PROCESSOR	<input type="checkbox"/> SALES MANAGER

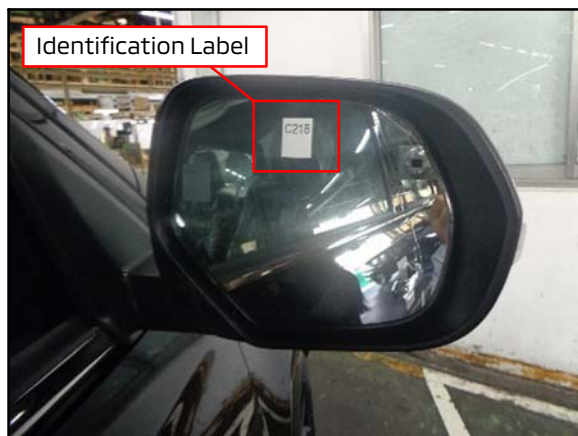
Dealers have reported peeling of the chrome plating on vehicle door mirrors. This is occurring when dealers are removing glue residue left by the identification label, during the PDI process. The peeling of the chrome plating may be due to improper removal of the glue by using a razor blade, box cutter, sand paper, polishing machine, or any polishing compound.

1. While conducting the PDI process, remove the identification label.
2. Use Isopropyl Alcohol (IPA) to remove any glue residue left behind by the label.

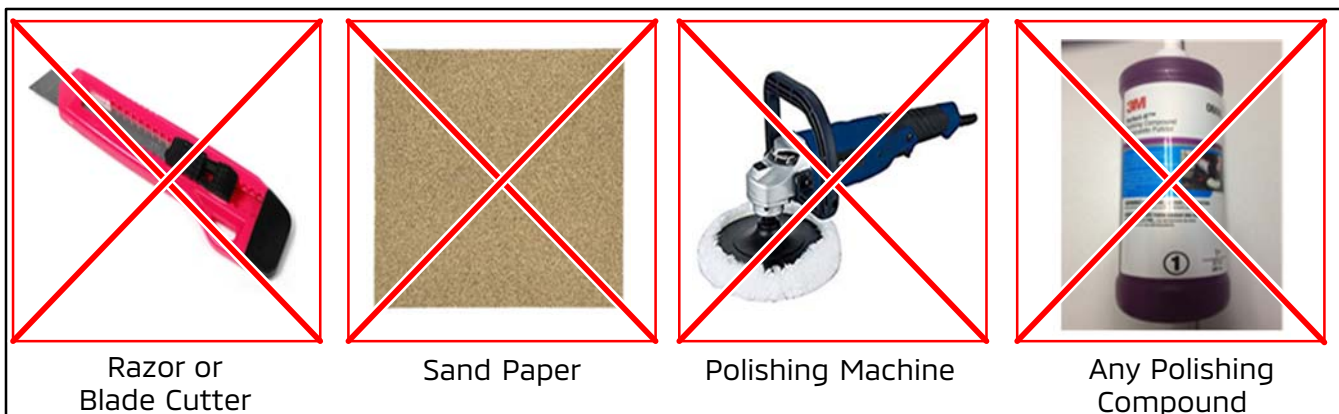
**Do NOT** use any of the equipment listed below to remove glue residue.
