**HYUNDAI**
Technical Service Bulletin

GROUP INTERIOR	NUMBER 19-BD-004H
DATE AUGUST 2019	MODEL(S) Genesis (DH)

SUBJECT: SEAT BACKBOARD CLIP REPLACEMENT

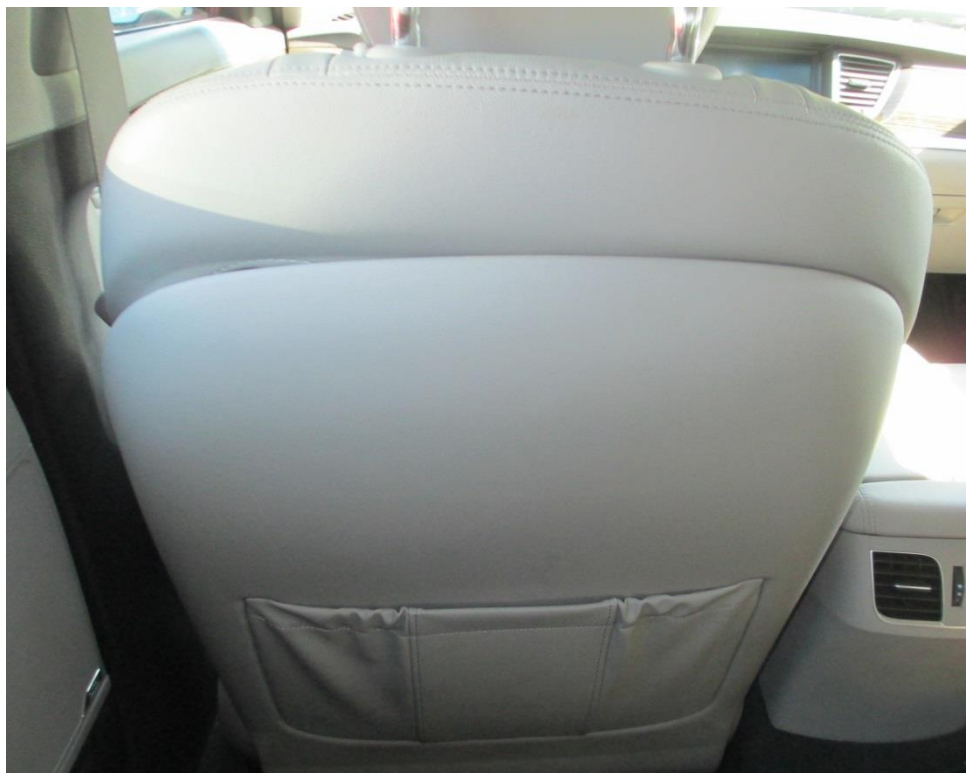
Description: This bulletin describes the procedure to replace the seat backboard clip. Some vehicles may experience the seat backboard coming loose.

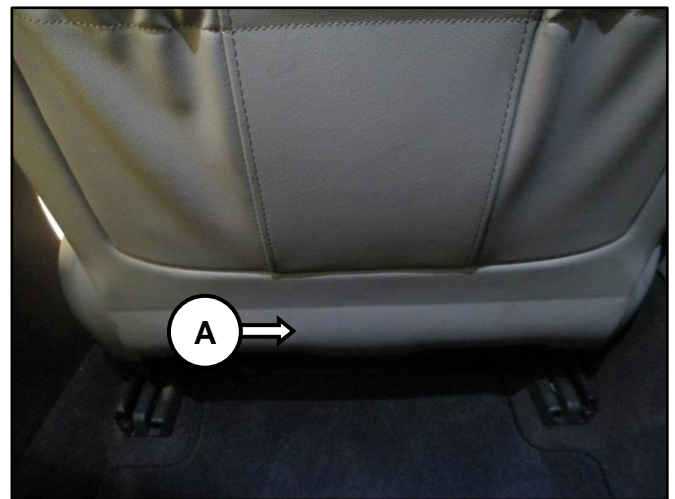
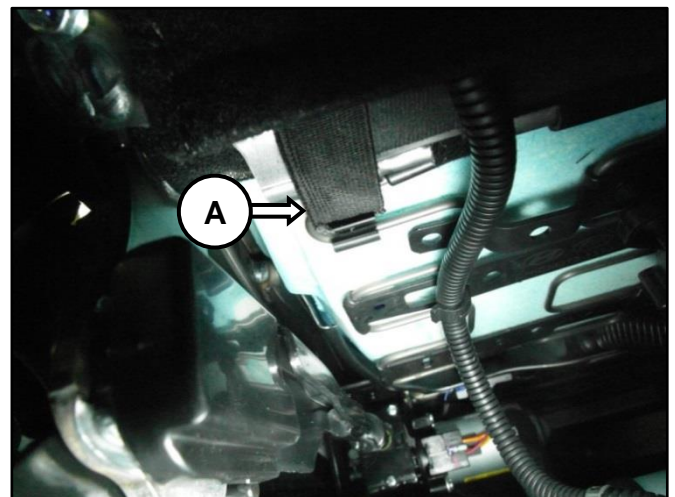
1. Remove the protector (A) bottom straps located under the seat.

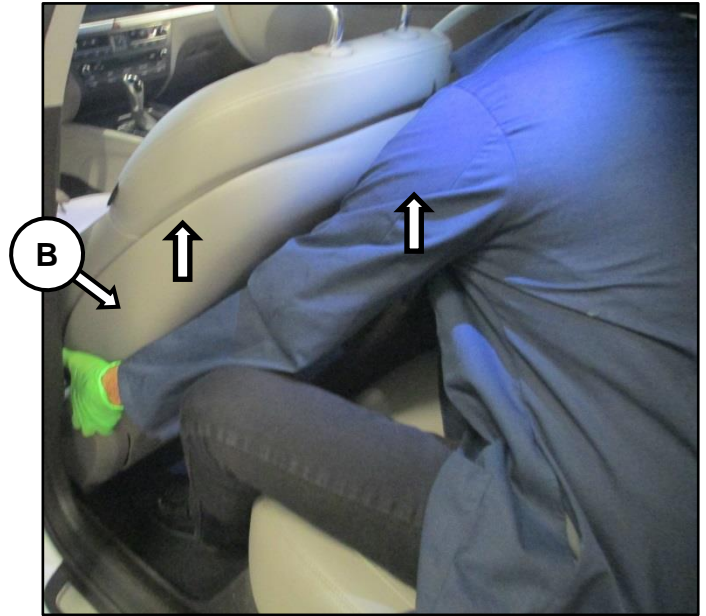
- 2. Place both hands at the bottom of seat backboard (B) and lift to remove from the seat assembly.

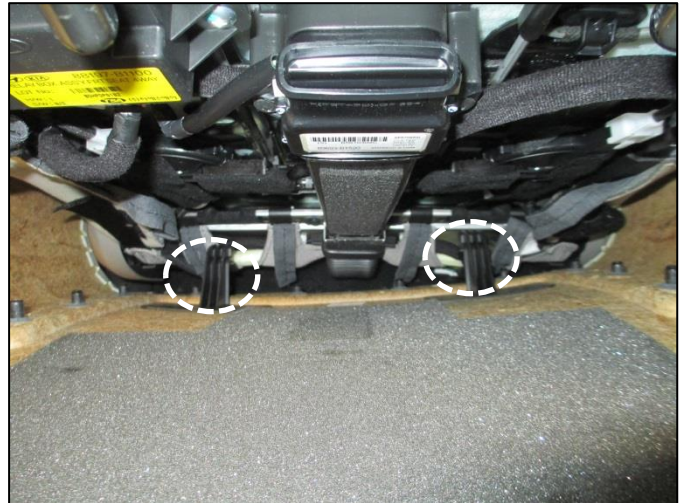
⚠ CAUTION
When removing, ensure not to damage bottom seat back retention hooks.

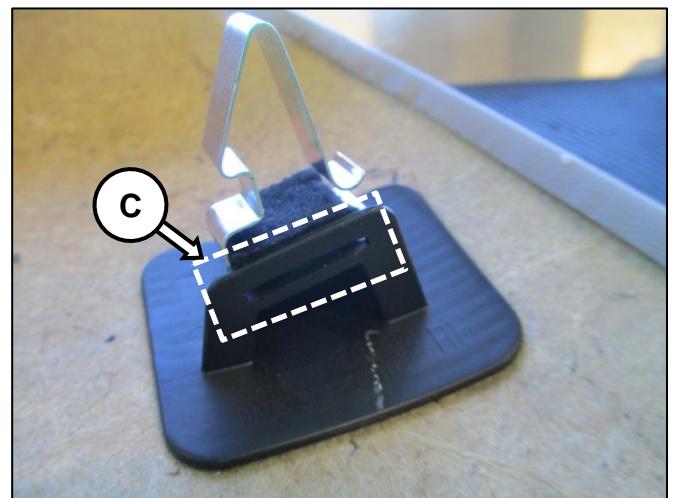
- 3. Lay the seat backboard on a clean workbench and inspect base clips (C).

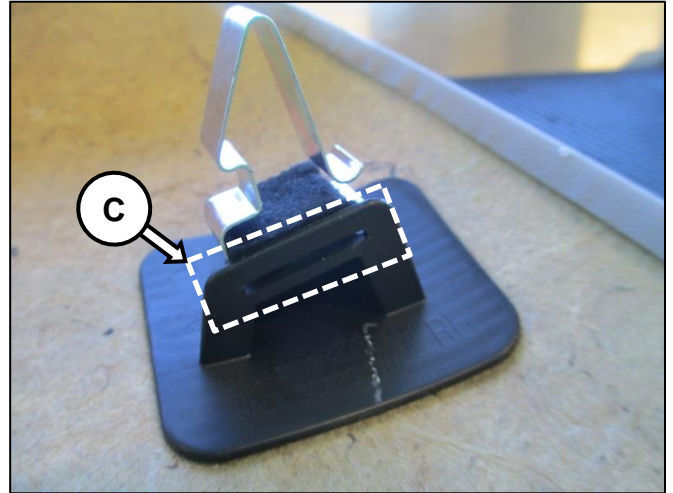
Base clip (C) appears normal.

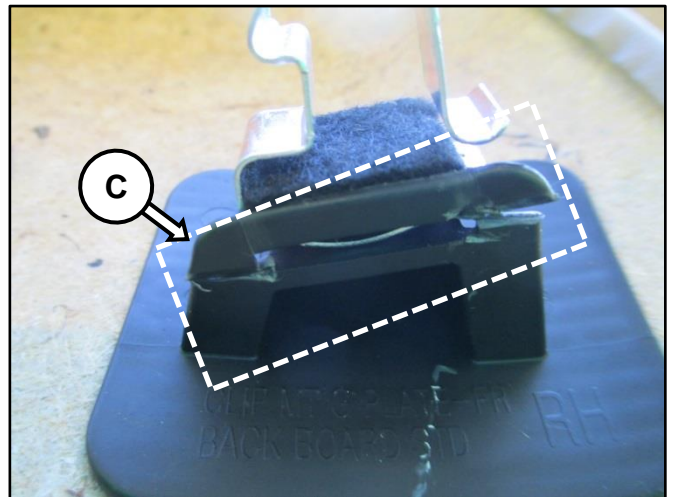
Base clip (C) is broken.
