Title	Vehicles With An Automated Manual Transmission (AMT) - Power Take-Off Diagnosis And Repair; PTO Air Leaks, Oil Leaks, Engagement, Noise
-------	---

Cause	The service instructions for the gearbox mounted AMT PTO have not been readily available to the NA market when the PTO was made available for the AMT in NA. Although many of the parts have been available for the PTO in the NA parts system, not all parts are available because major components like gears and housing can quickly drive the cost of repair higher than the replacement cost. The parts that are available in NA parts system represent a reasonable repair option when internal inspection of the PTO and the failure mode show that a simple repair in the field is possible. See the failure mode and repair option information below for more information.
-------	---

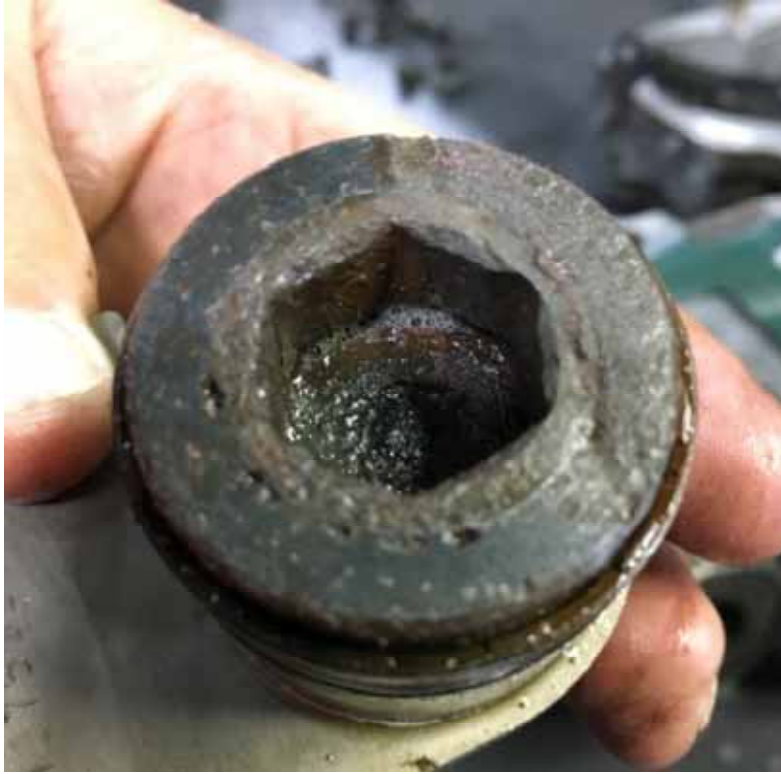
- **If Rust is found on the piston face**, then there has been water intrusion to the piston. An example is shown below.

Check the vehicle air system for moisture and correct the root cause of the water intrusion.

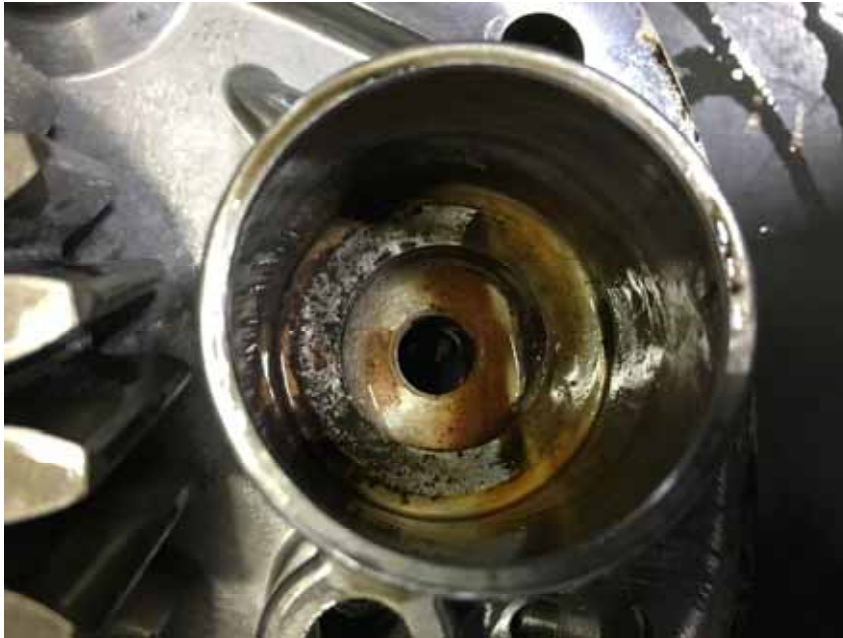
- **If rust damage is found in the bottom of the piston bore**, clean the bore and inspect the sealing surface for damage. Rust in the bottom of the bore will not affect operation.

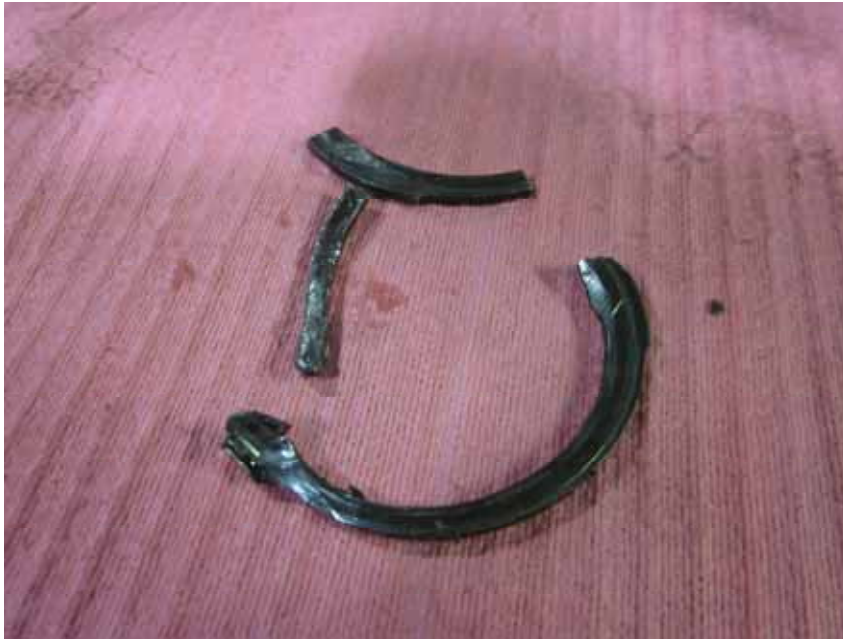
- **If the vehicle air system is dry and properly serviced**, the solenoid should be checked for a good rubber cap on the top.

If the cap seal is damaged then replace the solenoid.

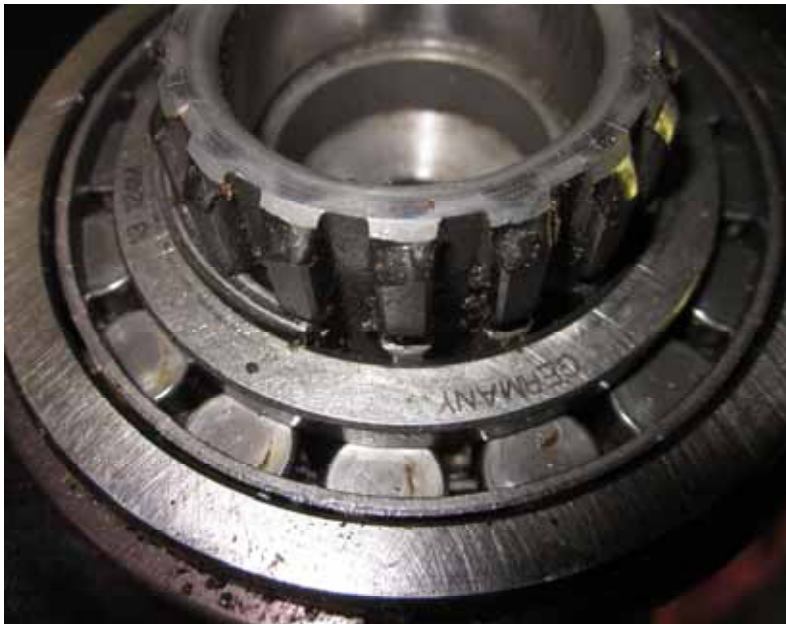
- The PTO drive shaft in the rear of the gearbox has a snap ring that contains the bearing to the shaft. If this snap ring breaks the pieces may end up in the PTO and get lodged under the shift fork and bind the fork.

Examples of snap ring failure can be found below:

Disassemble and inspect the PTO for repair or replacement.

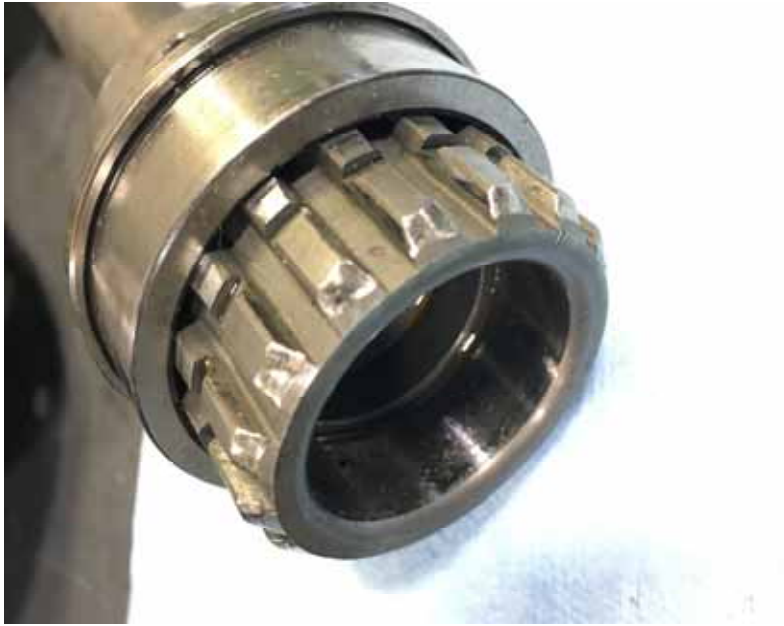
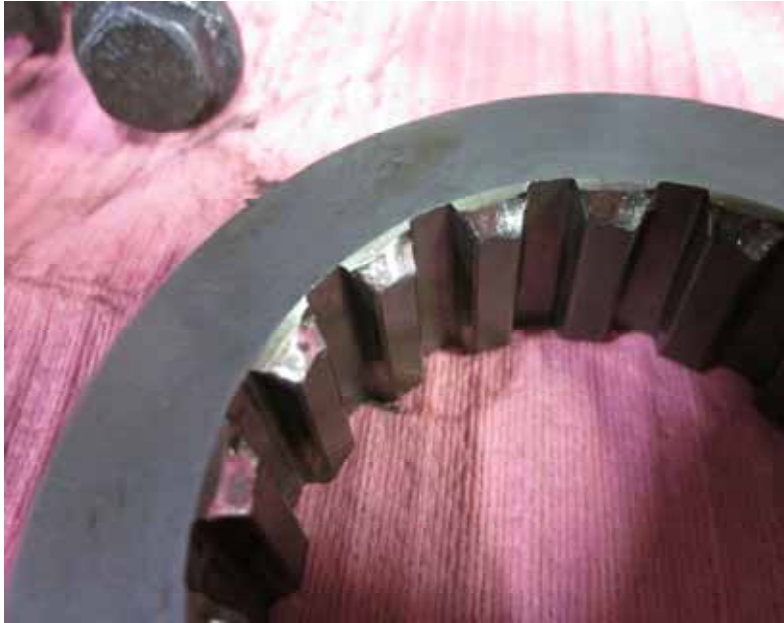
Pieces of ring get into the PTO and cause operational issues.
