Water entry into vehicle interior through roof air conditioner (H08)

Topic number	LI83.50-N-059306
Version	1
Design group	83.50 Rear air conditioning
Date	07-08-2014
Validity	TYP 906.6/7 with CODE H08
Reason for change	
Reason for block

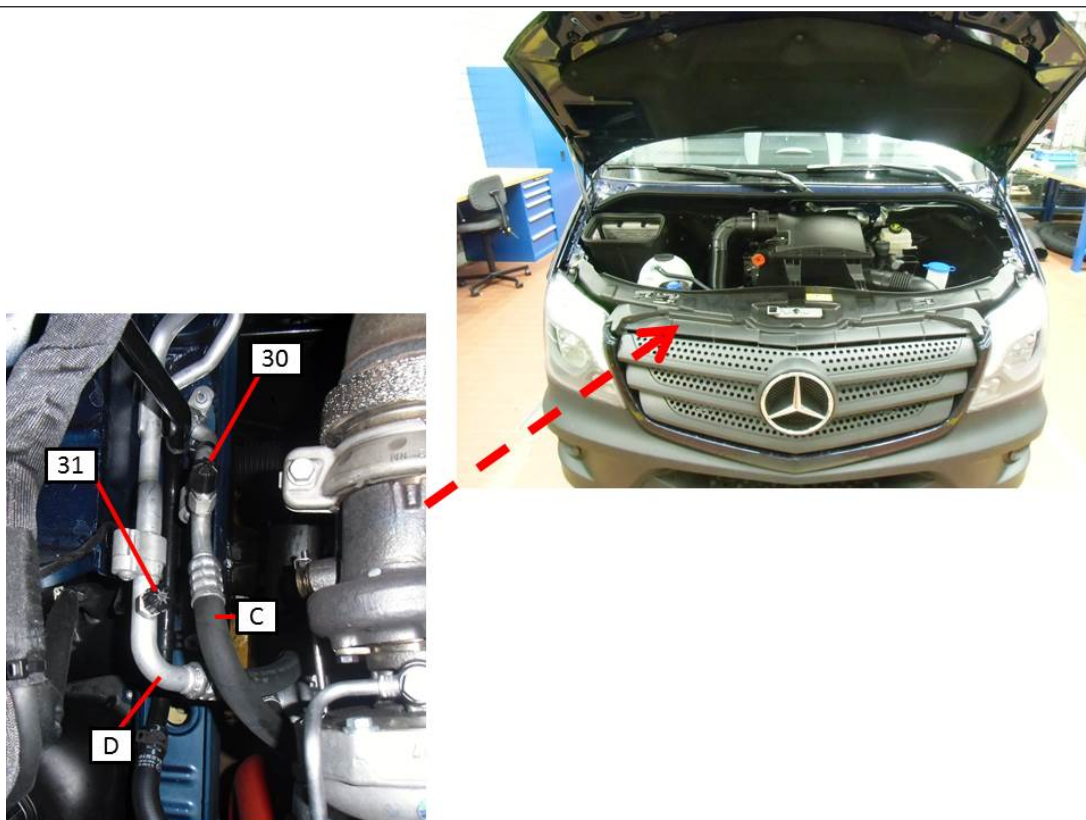
01.jpg:

Note: The test and filler connections of the refrigerant circuit of the roof air conditioner are located on the right of the longitudinal member in the engine compartment (viewed in direction of travel) (see picture 01.jpg).

Info: To do so, unscrew the protective caps (30 and 31) on the test and filler connection of the high-pressure line (C) and low-pressure line (D) (see picture 01.jpg). Connect AC service unit (R134a AC service unit, gotis://E_83_05.0) (see picture 01.jpg) and extract refrigerant. Note down the quantity of compressor oil extracted.

2. Disconnect AC service unit (R134a AC service unit, gotis://E_83_05.0) and screw on protective caps (30 and 31) on test and filler connection of high-pressure line (C) and low-pressure line (D) (see picture 01.jpg).

29. Disconnect AC service unit (R134a AC service unit, gotis://E_83_05.0) and screw on protective caps (30 and 31) on test and filler connection of high-pressure line (C) and low-pressure line (D) (see picture 01.jpg).

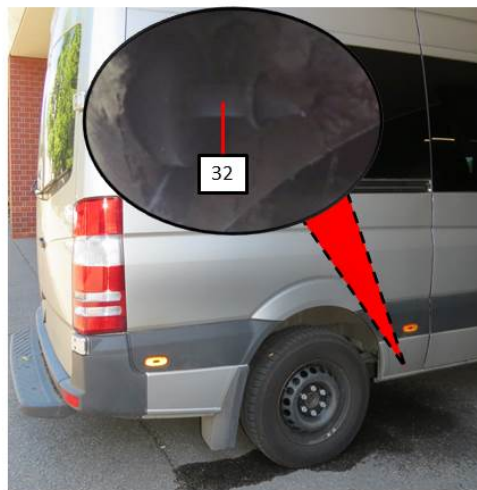
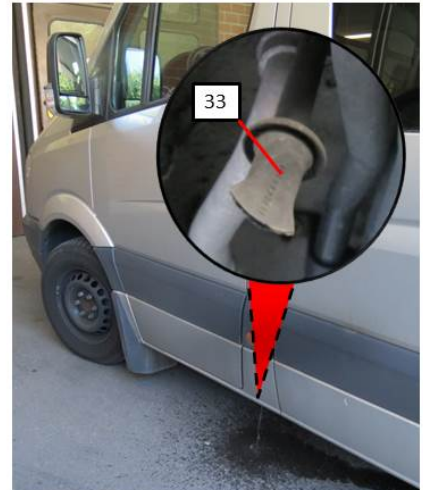
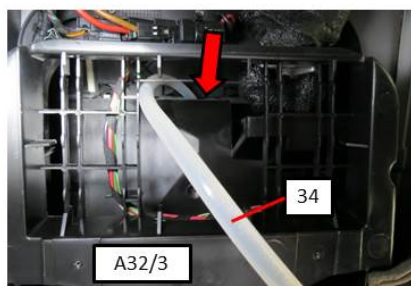
02.jpg:

22. Check drain hoses for condensation for unobstructed flow (see picture 02.jpg).

Info: To do so, introduce water through the opening on the filter of the rear AAC air recirculation unit (A32/3) with a hose (34). Water must be seen exiting the outlet points (32 and 33) of the condensation hoses, otherwise the water drainage system must be reworked.

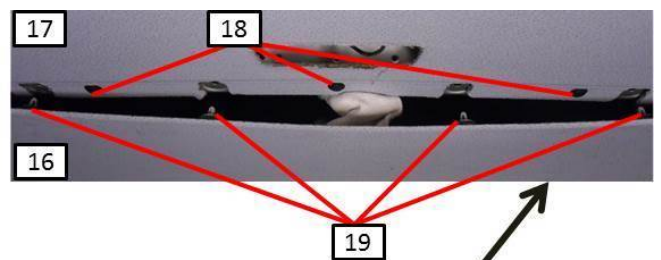
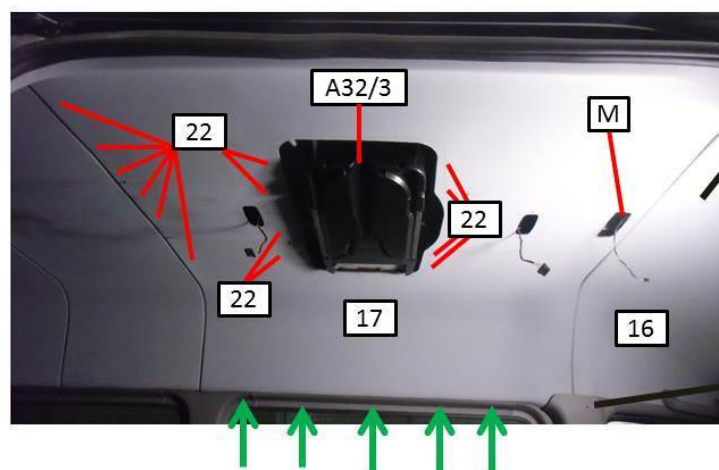
03.jpg:

6. Remove center headliner (17) (see picture 03.jpg and picture 04.jpg).

Info: To do so, unclip interior sensor (M) and disconnect electrical connector. Partially unclip B-pillar trim on driver side and passenger side (21 and 20) in upper area (see AR68.30-D-4700A). Unclip clips (19) of front headliner (16) in rear area. Remove expansion rivets (18) of center headliner (17) in front area. Unclip clips (22) of center headliner (17) in rear area and in area of evaporator unit. Remove expansion rivet (15) on passenger-side C-pillar. In order to unhook the center headliner (17) from the body and remove it, press the center headliner (17) upwards with a plastic wedge

31. Install center headliner (17) (see picture 03.jpg and picture 04.jpg).

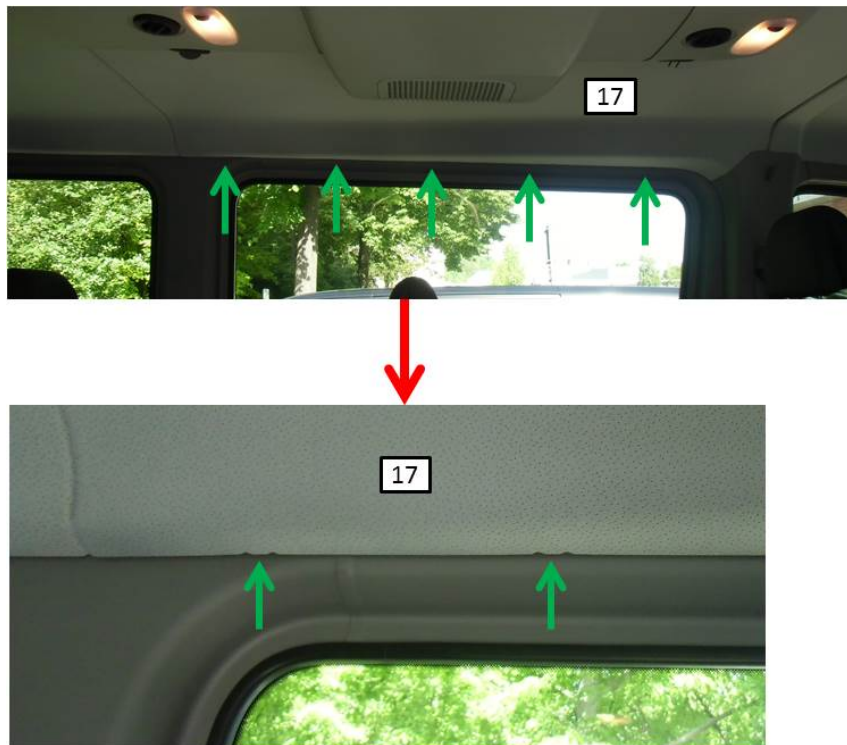
04.jpg:

and pull it slightly inwards in the process. This should be done on the left (viewed in direction of travel) between each of the cutouts of the center headliner (17) (see picture 04.jpg (green arrows)).

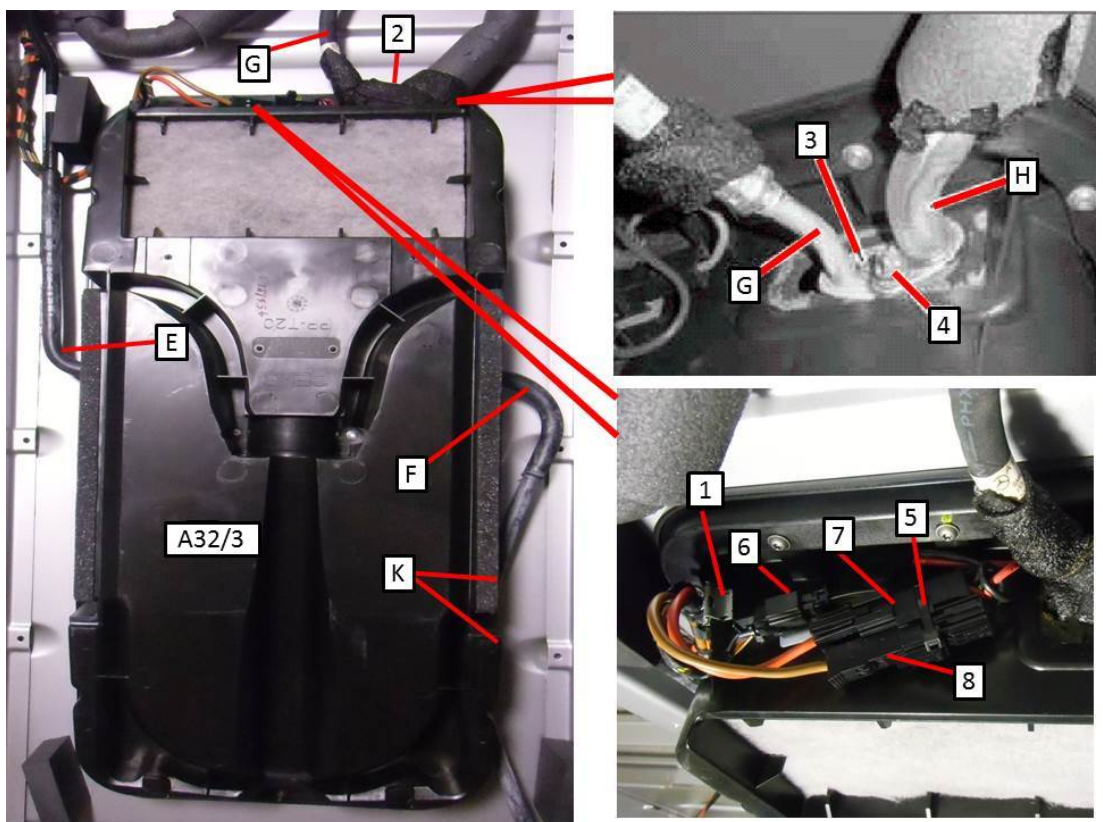
05.jpg:

7. Remove refrigerant lines (G and H) from expansion valve (see picture 05.jpg).

Info: To do so, remove insulation (2) in connection area of refrigerant lines (G and H). Remove nuts (3 and 4) and detach refrigerant lines (G and H) from expansion valve.

8. Unclip clips (K) which attach condensation hose (F) to rear AAC air recirculation unit (A32/3) and disconnect condensation hoses (F and E) from rear AAC air recirculation unit (A32/3) (see picture 05.jpg).

9. Remove cable ties (5), disconnect electrical connectors (6, 7 and 8) on rear AAC air recirculation unit (A32/3) and unclip retaining clip (1) (see picture 05.jpg).

21. Install condensation hoses (E and F) on rear AAC air recirculation unit (A32/3) (see picture 05.jpg).

24. Connect electrical connectors (6, 7 and 8) on rear AAC air recirculation unit (A32/3), fit cable ties (5) and clip in retaining clip (1) (see picture 05.jpg).

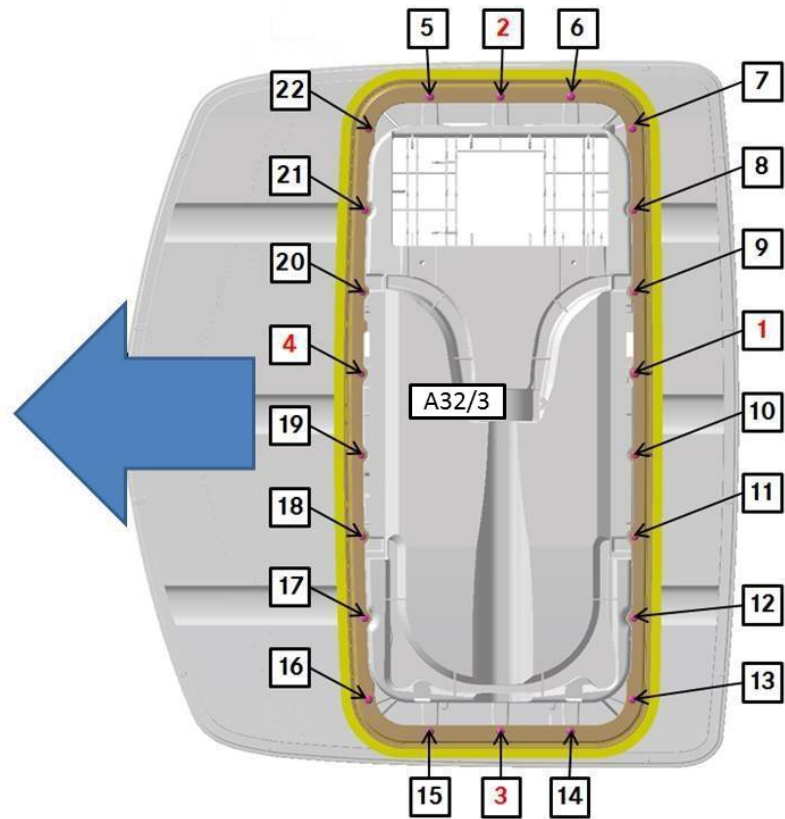
06.jpg:

10. Remove mounting screws/bolts of rear AAC air recirculation unit (A32/3) and remove frame (see picture 06.jpg).

17. Install installation frame (see picture 06.jpg). Important: Make sure you observe the torque (4 Nm) and tightening sequence (see picture 06.jpg), arrow (blue) indicates direction of travel.

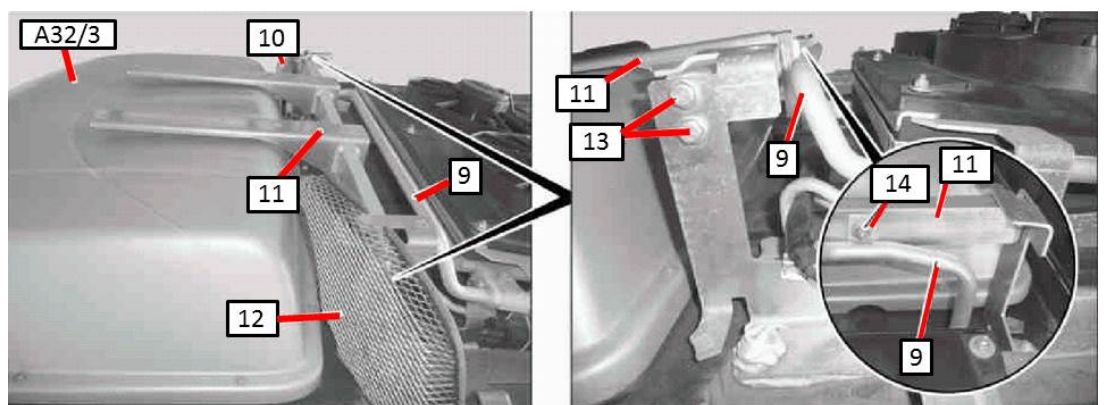
07.jpg:

12. Remove left (12) and right (10) air grilles. Unscrew nut (14) of refrigerant line (9) on strut (11). Remove screws/bolts (13) on left and right of strut (11). Remove strut (11) (see picture 07.jpg).

19. Install strut (11). Tighten screws/bolts (13) on left and right of strut (11) to specified torque (13.5 Nm). Screw on nut (14) of refrigerant line (9) on strut (11). Install left air grille (12) and right air grille (10) (see picture 07.jpg).

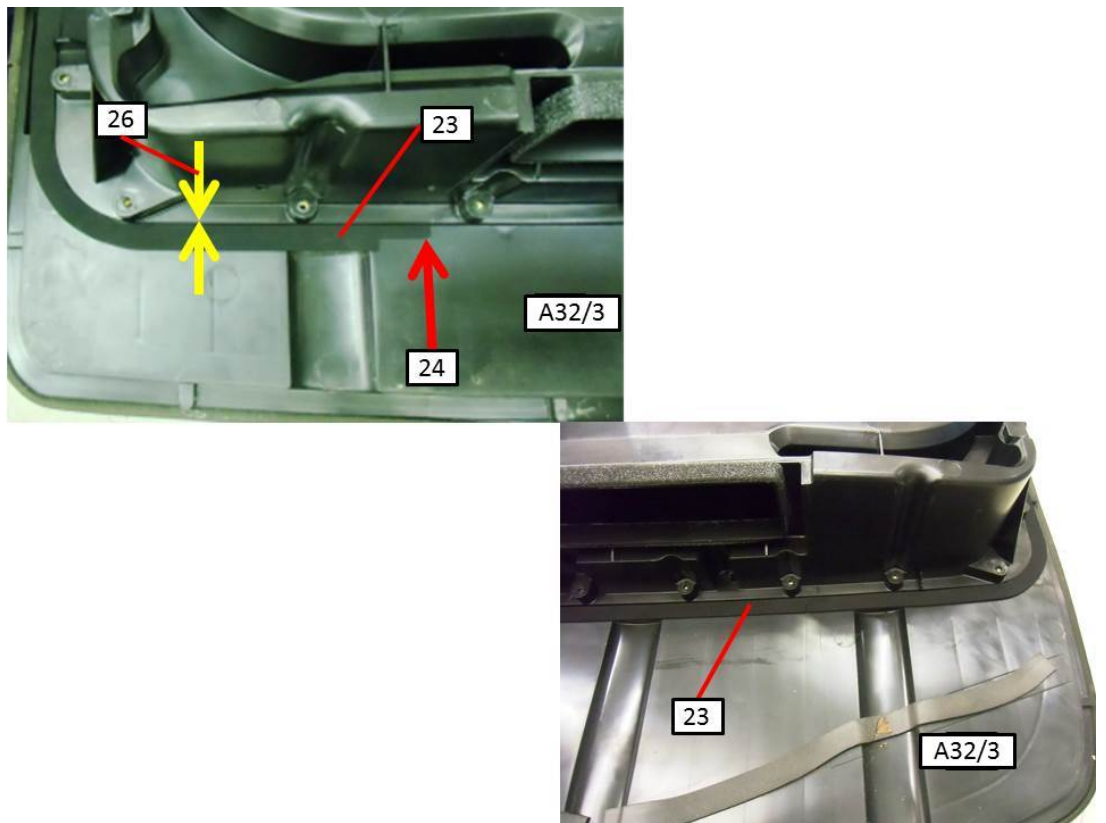
08.jpg:

15. Replace sealing frame (23) on rear AAC air recirculation unit (A32/3) (see picture 08.jpg) (only use the specified part number).

Info: To do so, remove the old sealing frame (23) and clean bonding area for new sealing frame (23) on rear AAC air recirculation unit (A32/3). Start by bonding the shorter sealing frame section (23) at the position indicated (see red arrow) (see picture 08.jpg). Only remove as much protective foil of the sealing frame (23) as can be stuck on in one go. Make sure you avoid getting the adhesive side of the sealing frame (23) dirty. The joints of the sealing frame (23) must not be in the radius area. The sealing frame (23) must not be separated from/have a gap (26) between the end stop/edge (see picture 08.jpg).

If the sealing frame (23) is too long, the joint must be shortened accordingly to match the original L-shape.

Note: Stick on sealing frame (23) without tension otherwise the sealing cross-section is reduced.

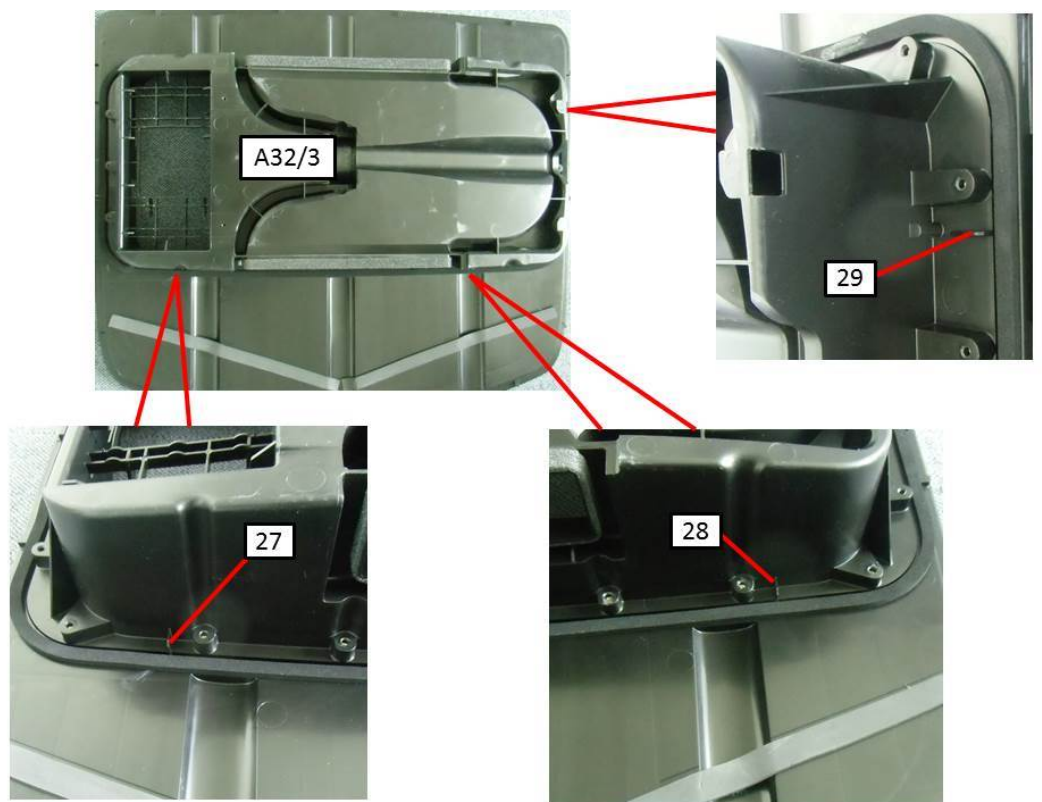
09.jpg:

16. Insert rear AAC air recirculation unit (A32/3) in vehicle roof and align (see picture 09.jpg).

Info: The rear AAC air recirculation unit (A32/3) is aligned based on the end stops (27 and 28) (in direction of travel) and end stop (29) (passenger-side). These must contact the roof cutout (see picture 09.jpg).
